ADMINISTRATIVE REPORT  
PUBLIC HEALTH SERVICE/CDC/NIOSH/DSR  
FACE-98-11

SUBJECT: Electrical Mechanic Dies After 45-Foot Fall Through  
Unguarded Floor Opening--North Carolina

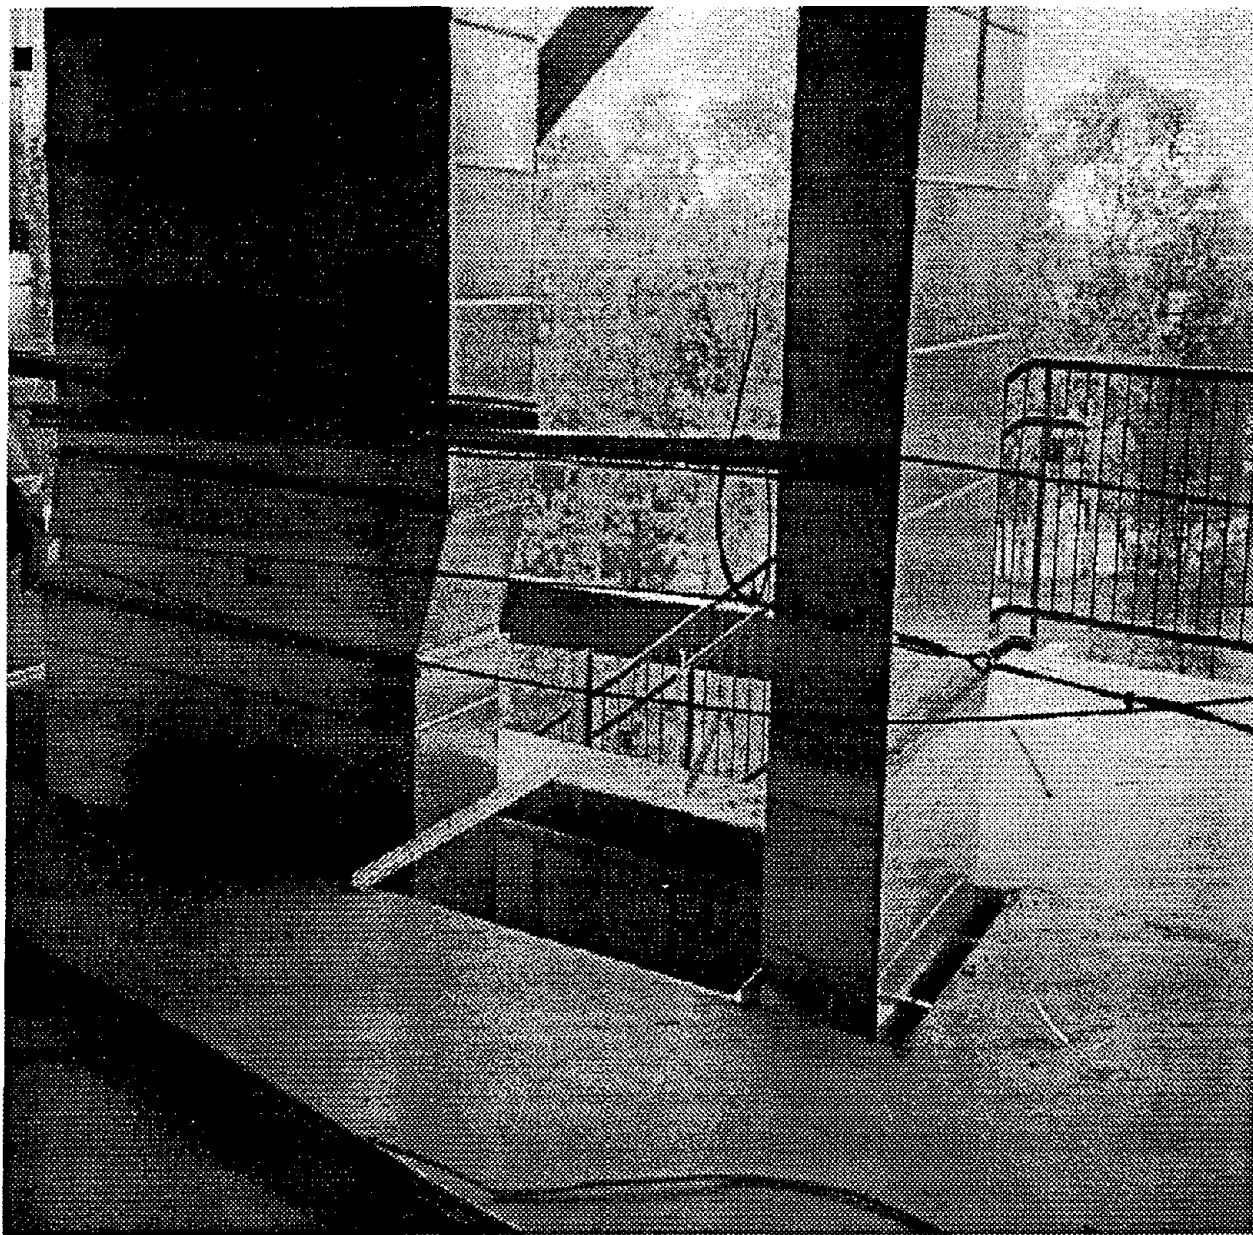
**FIGURE 1. Unguarded Floor Opening**

An unguarded floor opening which measured 54 inches wide by 43 inches long was located about 12 feet from the end of the floor and about 100 feet from the electrical room where the workers had placed the spools of cable. The coworkers were unrolling cable in the direction of the floor opening. According to witness statements, a standard guardrail system had been installed by the metal framing contractor in January and the guardrail was in place when the HVAC subcontractor finished work around the opening. The floor opening was not guarded the day of the incident, and witnesses estimated that the guardrail had been down for between 2 and 3 weeks prior to the incident. The coworker placed the wooden spools on their sides near the electrical room and pulled and cut five 56-foot lengths of cable. At approximately 2 p.m., the victim joined his co-workers on the fourth floor. To avoid obstacles (building materials located on the floor), they chose to unroll the cable near the center of the floor, which placed the work performed in line with the unguarded floor opening (Figure 1). While one coworker color-coded the cables that had already been cut, the other coworker and the victim unrolled the last length of cable. The remaining cable was less than the 56-foot piece needed, so they decided to wind it back onto the spool. At approximately 2:30 p.m., the victim walked to the end of the cable, picked it up, and pulled on it while walking backwards to straighten it so that it could be rewound more easily. While walking backwards and pulling on the cable, he apparently stepped into the unguarded floor opening. The coworker who had been manually re-winding the cable onto the spool felt the spool jerk out of his hands and saw it go down the floor opening. Neither coworker saw the victim fall into the floor opening. The victim fell 45 feet, landing on concrete on the first floor, and the spool fell on top of him. The coworker yelled for help and workers on the first floor, who heard the victim fall, ran to assist the victim. The coworker then ran to

Discussion: The victim was pulling on the end of a cable and walking backwards when he stepped into an unguarded floor opening on the fourth floor of a building under construction. Although guardrails were installed initially, they were removed at some point after HVAC duct work was completed. Ensuring the use of personal fall arrest systems, standard guardrails or covers secured against displacement as required by CFR 1926.501(b)(4)(i) and (ii) respectively could have prevented this incident from occurring.

**At the time of the incident employees were not protected from falling through the unguarded floor opening by a personal fall arrest system, a cover, or a guardrail system. Following the incident, a wire warning line was placed around the opening and a cover was secured over the opening.**

***Recommendation #1: Employers should ensure that employees on walking/working surfaces are protected from falling through holes more than 6 feet above lower levels by personal fall arrest systems, covers, or guardrail systems erected around such holes.***
