DATE: February 26, 1998

FROM: Division of Safety Research, NIOSH

SUBJECT: Tower Worker Dies After Falling 130 Feet From Hoist Cable To Ground--Pennsylvania

FACE 98-05

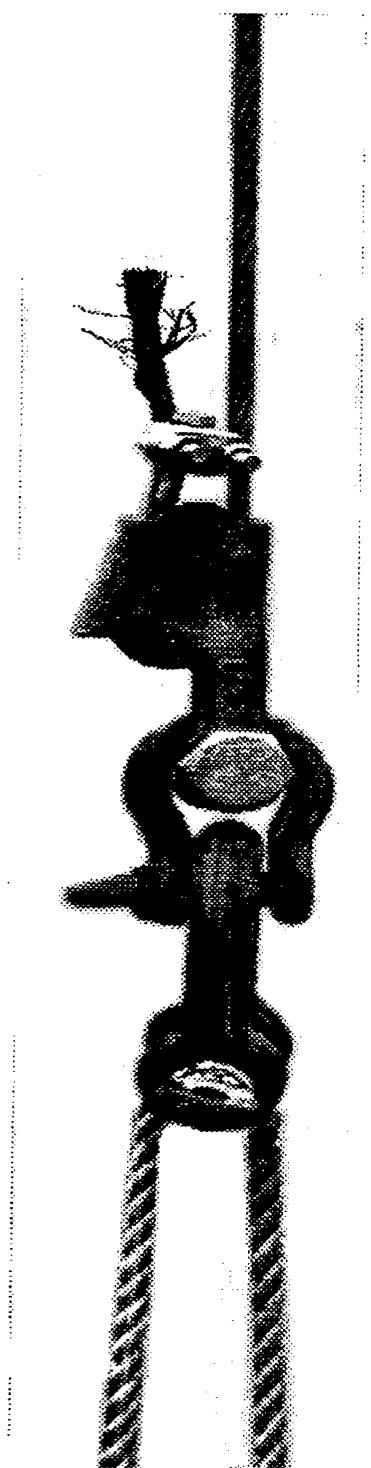
Figure 1

Investigation revealed that a wedge socket was attached to the end of the hoist line. Immediately attached to the wedge socket was a 2-inch clevis. A 3-inch clevis was attached to and below the 2-inch clevis (Figure 1). The large clevis measured 1½-inches thick by 4-inches wide at its largest. The inside dimensions of the snap hook on the victim's lanyard were 4¾-inches wide by 7¾ -inches long at its largest (Figure 2). If the victim had tried to attach his snap hook to the hoist line, it would have slipped over the large clevis allowing the victim to fall to the ground. It is also possible that the victim reached to connect the snap hook to the clevis but either missed the clevis or did not make a good connection. Additionally, one of the cradle legs on the victim's snap hook was bent open, jeopardizing the integrity of any attachment the victim would have attempted to make.

Wedge Socket -----

2-inch clevis -----

3-inch clevis -----

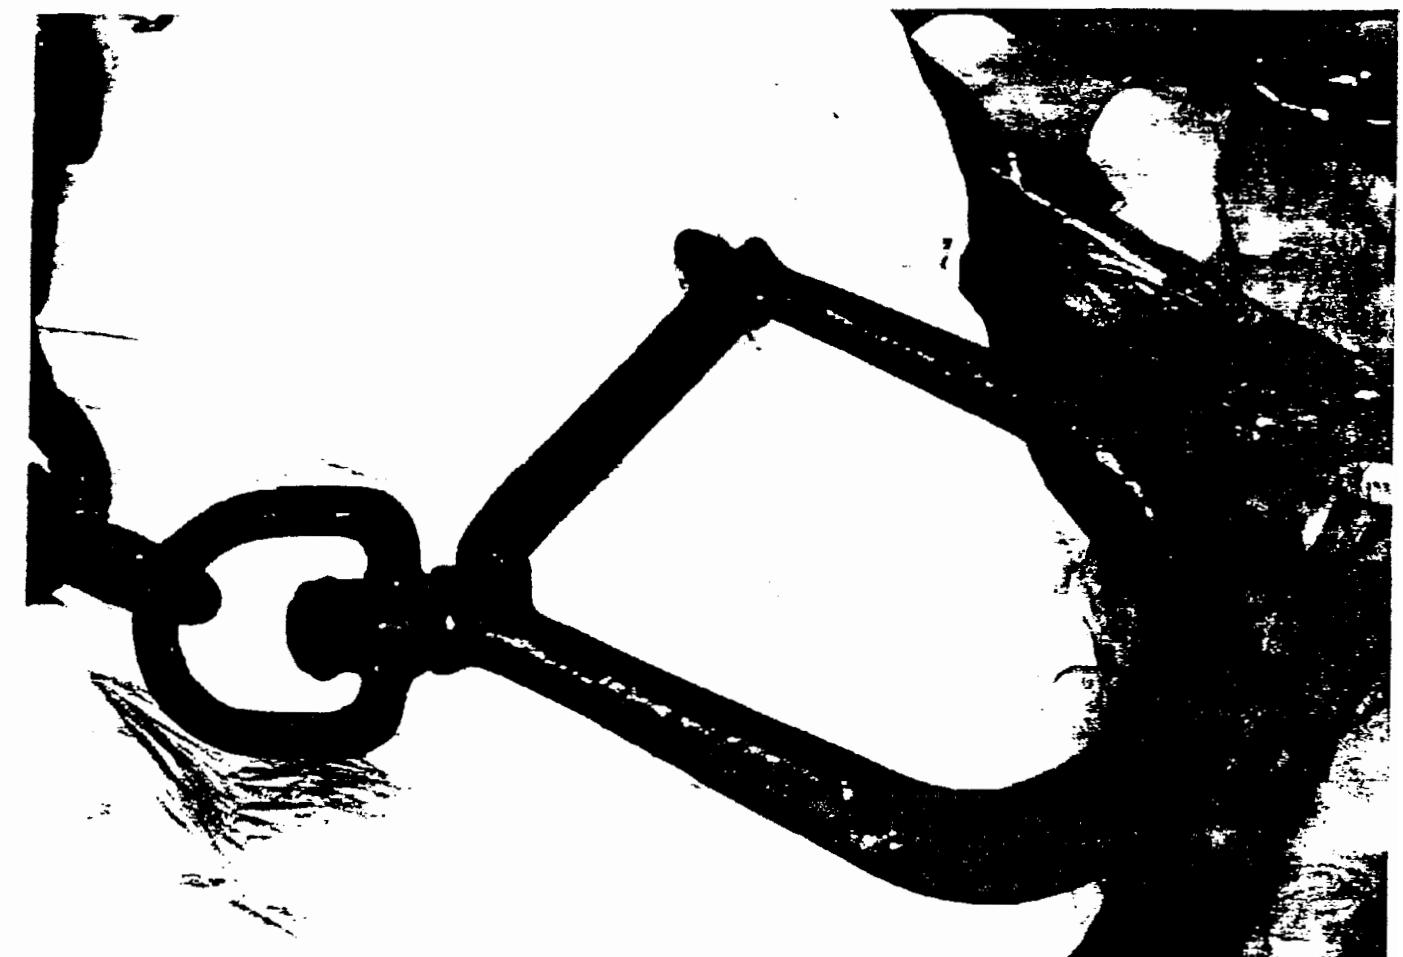
Figure 2

Discussion: In this instance, the victim either hooked directly to the hoist cable and the large hook slipped over the smaller components of the cable's terminal device or attempted to hook to the clevis and failed. 29 CFR 1926.502 (d)(5) states that snap hooks shall be sized to be compatible with the member to which they are connected to prevent unintentional disengagement; or shall be a locking type snap hook designed and used to prevent disengagement. 29 CFR 1926.502 (d)(6)(i) states that unless the snap hook is a locking type, it shall not be engaged directly to webbing, rope, or wire rope. The snap hook in this instance was not a locking type and was not compatibly sized to the components of the cable's terminal device. A smaller locking snap hook or a connection to one of the clevises may have prevented this fatality. Additionally, one of the cradle legs on the snap hook was bent open, increasing

the possibility of a cable rollout. It is possible that this damage occurred during the incident; however, PPE should be inspected on a daily basis to ensure that it is in proper working condition. When contacted, the manufacturer of the hook stated that the hook was not intended to lift personnel. Beginning January 1, 1998, locking snaphooks are required.

Victim's snaphook

Recommendation #2: Employers should provide workers with proper personal protective equipment (PPE), ensure its use, ensure that it is properly maintained, and instruct workers in the proper methods of tying off.
