**ADMINISTRATIVE REPORT  
PUBLIC HEALTH SERVICE/CDC/NIOSH/DSR  
FACE 97-03**

**SUBJECT: Mechanic Fatally Injured During Dismantling of Crane Boom at Scrap Metal Yard -- Pennsylvania**

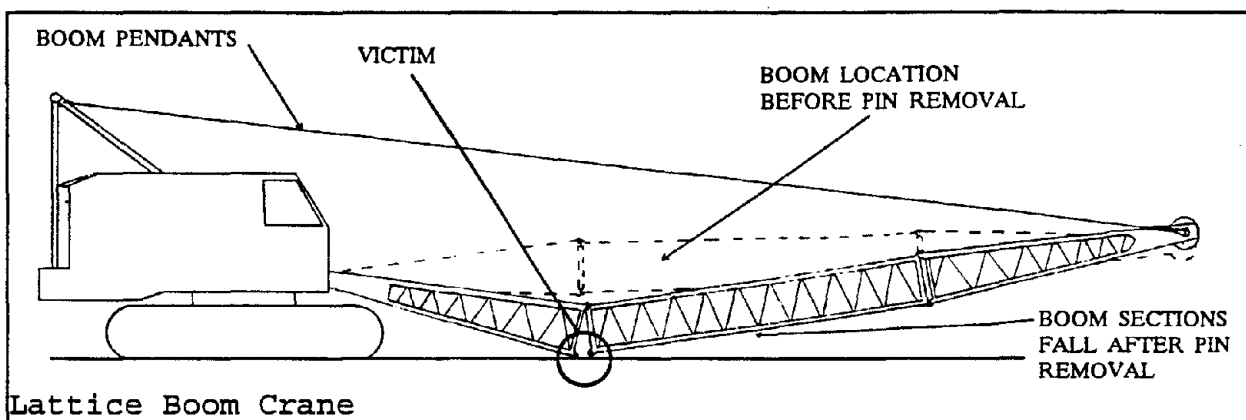
After this discussion, the victim and crew began dismantling the crane. The more experienced crane operator left the immediate area around the crane and went to get the support crane. The victim and the other crane operator began dismantling the boom at the joint between the inner section and the center section. While the second crane operator observed, the victim removed the bottom pin from the right side of the joint. He then went under the boom and struck the left side bottom pin twice with a hammer. The pin flew out of the joint and the boom sections fell, striking and pinning the victim to the ground. The second crane operator called the yard manager by radio to notify him of the

occurrence and the yard manager called 911. Co-workers got a nearby forklift, raised the fallen sections, and pulled the victim from under the boom. The emergency medical service arrived approximately 10 minutes after being called and transported the victim to a local hospital emergency room where he was pronounced dead.

*Recommendation No. 1: Employers should ensure that proper blocking and support procedures to prevent movement of the boom sections are implemented when dismantling cranes.*

Discussion: While the method discussed with the victim prior to the incident may have provided support at the proper points to prevent the boom from collapsing, it does not follow accepted industry practice. During dismantling, booms should be supported and blocked against motion by cribbing. After the load line and

attachments had been removed, the boom in this incident could have been dismantled using the method recommended by the Construction Safety Association of Ontario, Mobile Crane Manual:

- Lower the boom tip section onto solid blocking until the boom pendants are slack
- Remove the boom pendants and reattach them to the boom inner section
- Lift the boom up slightly, engage the boom hoist pawl (e.g., brake) and remove the bottom pins only
- Lower the boom onto solid blocking until the pendants are slack and remove the top pins from the boom sections.
