**ADMINISTRATIVE REPORT**  
**PUBLIC HEALTH SERVICE/CDC/NIOSH/DSR**  
**FACE-97-01**

**DATE: December 9, 1996**

**SUBJECT: Company President Killed When Forklift Overturns-- North Carolina**

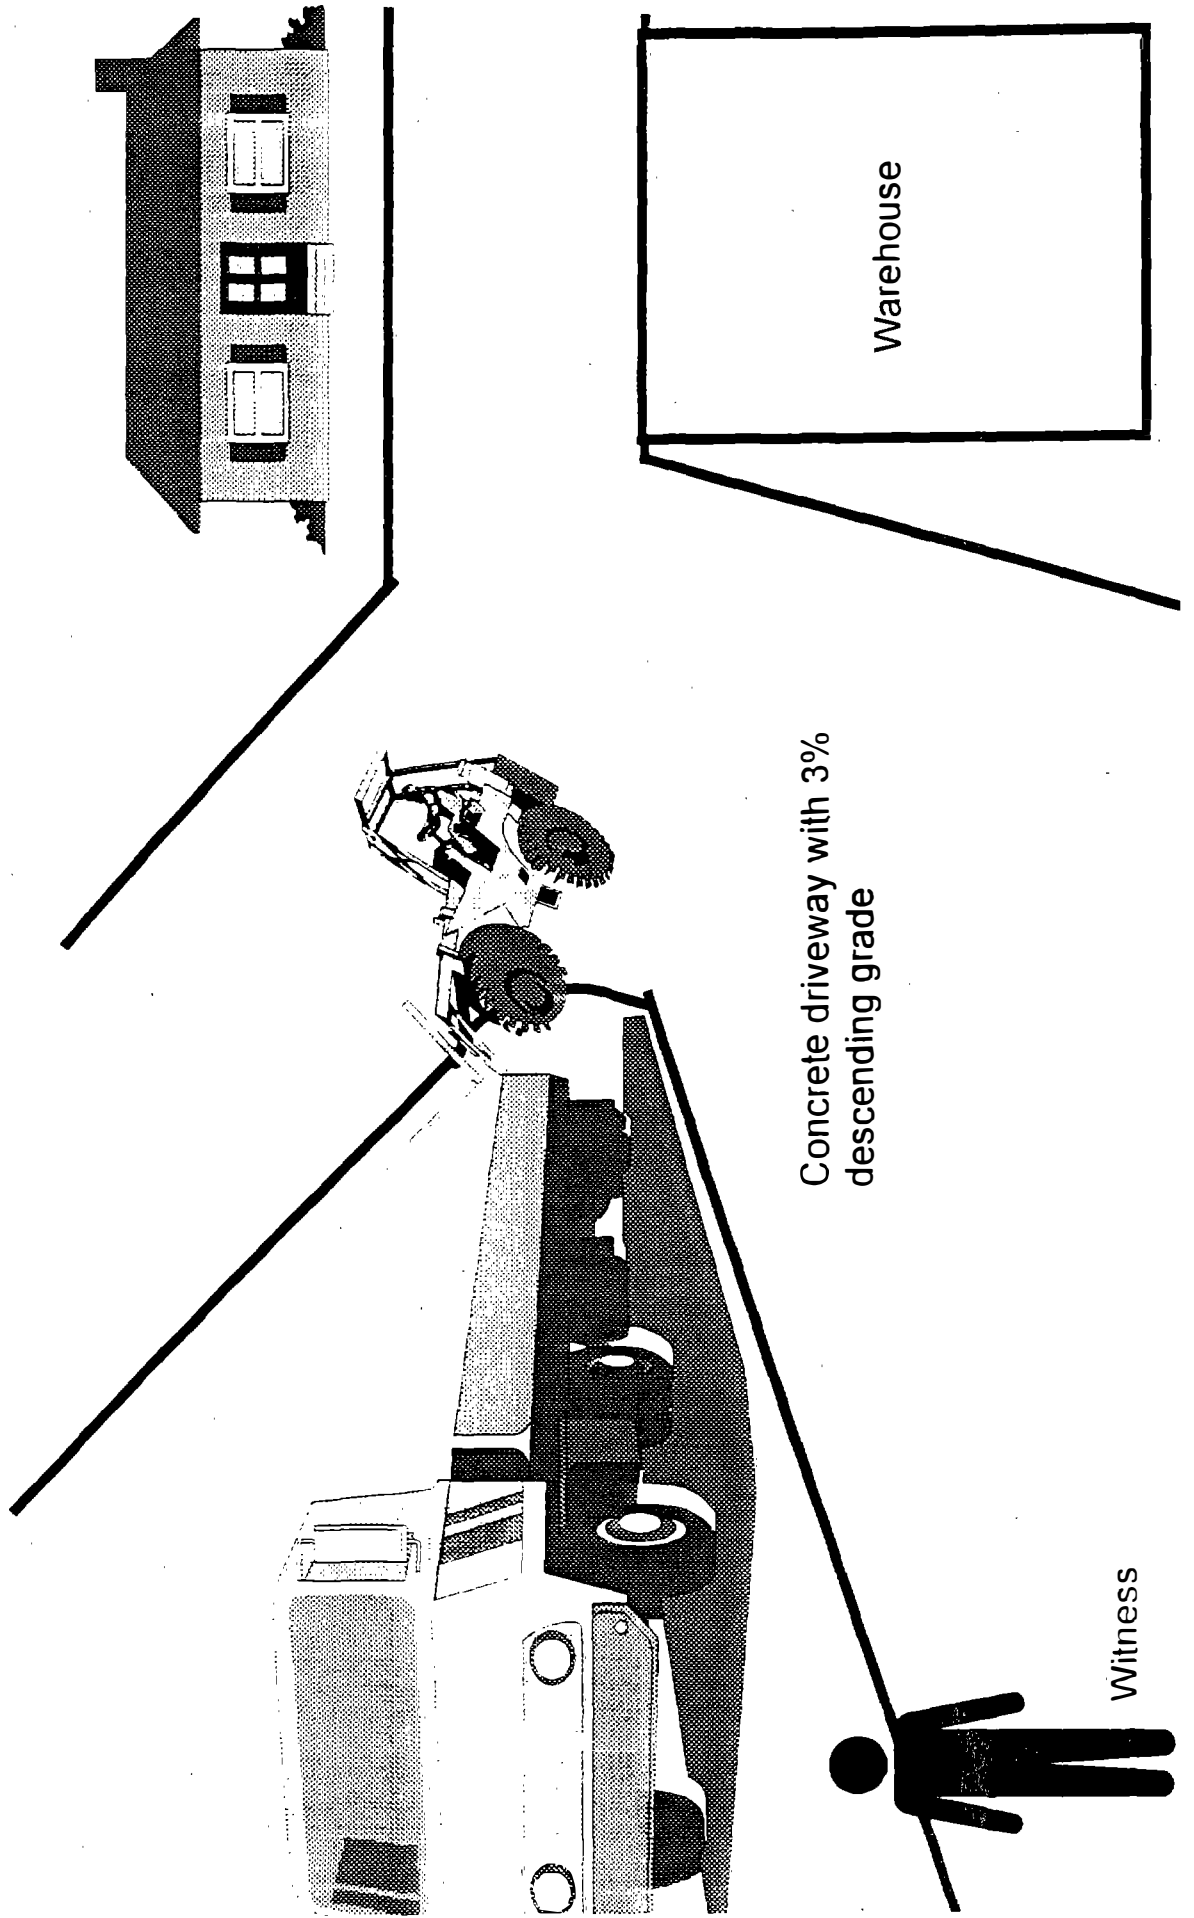
Figure 1. Overturned Forklift  
FACE 97-01

By 8 a.m. the victim had unloaded two-thirds of the steel tubing from the flatbed trailer. He then drove the forklift, with the forks about 6 inches above the concrete driveway, down the left side of the trailer. As he approached the rear of the trailer, traveling about 5-miles per hour down a 3-percent grade, he turned left to go behind the trailer. At that time, the forklift began to tip over and the victim tried to jump from the operator's seat to the concrete driveway. As the forklift overturned on its right side, the victim became pinned between the top of the ROPS/FOPS and the concrete drive. The witness looked in the direction of the victim at the time the forklift tipped over and saw the victim get pinned. He ran to the scene, turned off the forklift, and summoned the EMS. EMS arrived in about 10 minutes and with the aid of an air bag and compressor, lifted the forklift off the victim. The victim was checked immediately for vital signs, but none were found. The coroner arrived 25 minutes later and pronounced the victim dead at the scene.

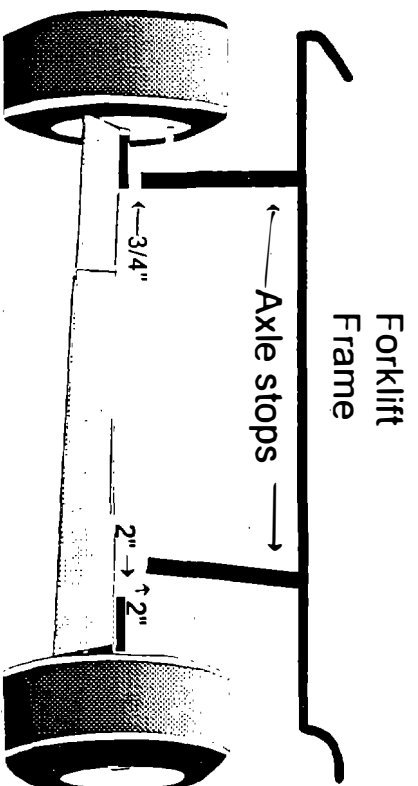
Figure 2. Forklift Axle Stops  
FACE 97-01  
Back View

The company had received a shipment of steel tubing via flatbed tractor trailer, which had to be unloaded. The victim and the director of field operations (the witness) arrived at the plant about 6:40 a.m. on the day of the incident to unload the tubing. As the witness began other chores, the victim began unloading the flatbed trailer using a 1961-62 Clark, model FL1002, forklift. The forklift had a 2,000-lb. capacity and had been retrofitted with a steel roll-over/falling object protection structure (ROPS/FOPS), but had not been retrofitted with a seat belt. The propane-powered forklift was approximately 9-feet 8-inches long, 3-feet wide, with a wheel base 45-inches long by 28-inches wide. The solid-rubber tires were extremely worn. The front tires measured 19½-inches in diameter by 6-inches wide, while the rear tires were 14½-inches in diameter and 4-inches wide. The forklift had front-wheel drive and rear-wheel steering. Also, axle-stop steel bars, about 9-inches long and 1-inch wide, by 3/8-inch thick, were positioned above each rear-wheel axle. The bars were welded to the frame of the forklift and extended downward to within 3/4-inch of the top of the axle, next to the tire rim (Figure 2).

The axle-stops prevented the body of the forklift from contacting the tires, and limited the amount of vehicle lean due to shifting loads or excessive speeds in turns.

Discussion: The victim, in addition to being the company president, provided maintenance to the forklift. Although he had general mechanical training he was not trained and authorized to maintain, repair, adjust and inspect forklifts. The American Society of Mechanical Engineers ASME/ANSI B56.1-1993, 6.2.7 Safety Standard for Low Lift and High Lift Trucks states "Brakes, steering mechanisms, control mechanisms, warning devices, lights, governors, lift overload devices, guards and safety devices, lift and tilt mechanisms, articulating axle stops, and frame members shall be carefully and regularly inspected and maintained in a safe operating condition." The axle stop located over the right-side-rear articulating axle had been damaged sometime prior to the incident. The axle stops are critical in the operation of the forklifts because they limit the amount of lean of the forklift in turns, and in instances of shifting loads which might cause an overturn. The axle stop, according to manufacturer's specifications, should have been

positioned directly above and within 3/4 of an inch of the axle. The stop was off-center by 2 inches to the side and 2 inches above the axle. Forklifts, like other industrial and agricultural equipment, have articulating steering axles to allow them to go over uneven terrain. Movement of the articulating axle is limited by axle stops which are normally welded directly into the frame of forklifts. Additionally, if the axle stop is not aligned properly with the axle or is damaged or even missing, the forklift tires may contact the frame, causing the machine to stop suddenly and contribute to the potential for an overturn. Also, slack in the steering mechanism required the operator to turn the steering wheel slightly more than half a revolution before the tires/wheels would start to turn. These factors of the articulating-axle stop being damaged/distorted and out of position, the slack in the steering mechanism, and the forklift being operated around a corner down a 3-percent grade, all contributed to the overturn of the forklift and the eventual death of the victim.

**Recommendation #1: Employers should ensure that only trained and authorized personnel be permitted to maintain, repair, adjust, and inspect industrial trucks (e.g., forklifts), and only in accordance with manufacturer's specifications.**
