**ADMINISTRATIVE REPORT  
PUBLIC HEALTH SERVICE/CDC/NIOSH/DSR  
FACE-96-22**

**DATE: September 4, 1996**

**SUBJECT: Two Truck Drivers Die After Cement Tank Collapses--  
Virginia**

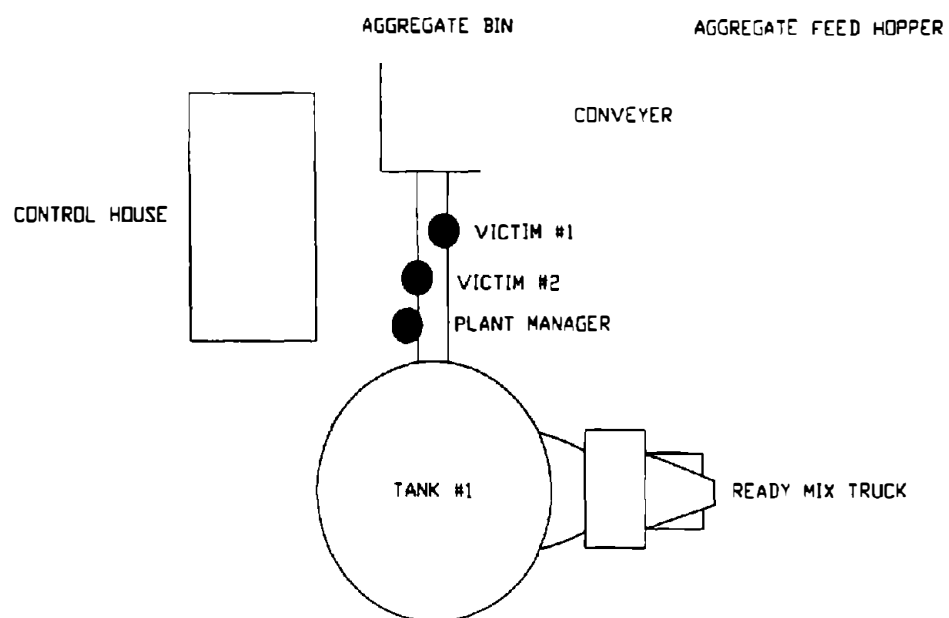
FIGURE: FACE 96-22 CEMENT TANK COLLAPSE

The ready-mix facility where the incident occurred included an aggregate bin, two tanks (#1 and #2) containing cement and flyash, and a conveyor system (Figure). Tank #1 had been on-site when the company purchased the facility in 1974. At that time it had been used to store cement. The tank was equipped with a weigh hopper which weighed both the material discharged from the tank, and that which was discharged from the aggregate conveyor. The hopper was controlled by the plant operator from the control room. Over the years the facility had been upgraded by the addition of other equipment. Specifically tank #2 had been erected beside tank #1. Tank #2 was then used for storage of cement and tank #1 was used for flyash storage. The weigh hopper remained mounted under tank #1 and material from tank #2 was transported to the weigh hopper by a pneumatic conveyor system. Because tank #2 did not have a ladder, a catwalk had been installed between tank #1 and tank #2. During the last few years, the size of jobs the company was called on to supply increased, and the facility was undergoing modernization to accommodate larger batches of concrete. As part of the modernization, both tanks were scheduled to be taken down, refurbished and then re-erected. All connections between tank #1 and tank #2 had been cut approximately 24 hours before the incident and tank #2 had been emptied and taken down. In order to continue production, the 330-barrel tank #1, under which the weigh hopper was mounted, had been filled with cement, and contained about 50 tons of material. On the day of the incident, the plant manager had begun loading trucks at 7:24 a.m., and had loaded out 18 loads by 11 a.m., when the coordinator system which transported the aggregate to the weigh hopper under tank #1 began to malfunction. According to the safety coordinator, this was not uncommon. The plant manager began a trouble-shooting procedure starting at the aggregate

Investigation later revealed severe corrosion damage to the legs supporting the tank. While it could not be determined which structural member of the tank's supporting frame may have initiated the collapse, the corroded legs would have been weakened in their ability to support the tank. Further, although the tank was reported to have collapsed without warning, evaluation suggests that the tank was already starting to lean around 11 a.m. This is evidenced by the slipping drive belt between the conveyor head roller and the motor. Since the motor was mounted on the tank structure, rather than the conveyor frame, as the tank leaned toward the conveyor, tension was lost in the drive belt.

the legs. All four legs, wide flange 6¼ inches by 8 inches columns at 24 pounds per foot, had experienced corrosion damage beginning at the foot and extending upward for 12 to 18 inches. The severity of the corrosion varied from moderate scale on one leg to a 1 to 1¼ inch hole in the web of one of the other legs. Since the incident the employer has implemented a system of inspections which include visual examinations conducted daily by the plant manager, weekly by maintenance personnel, and yearly by an independent structural engineer. Results of these inspections are recorded and reviewed by the company president. Inspections of this kind can detect defects due to corrosion and mishaps-such as mobile equipment collisions-and correct them before further damage or injury occurs.

***Recommendation #1: Employers should conduct regular structural inspections and evaluations to ensure that plant structures are maintained in good repair to prevent injury.***
