**ADMINISTRATIVE REPORT  
PUBLIC HEALTH SERVICE/CDC/NIOSH/DSR  
FACE-96-15**

**DATE: September 23, 1996**

**SUBJECT: Tree Trimmer/Climber Dies After Falling 40 Feet With an Uprooted Tree Trunk--Virginia**

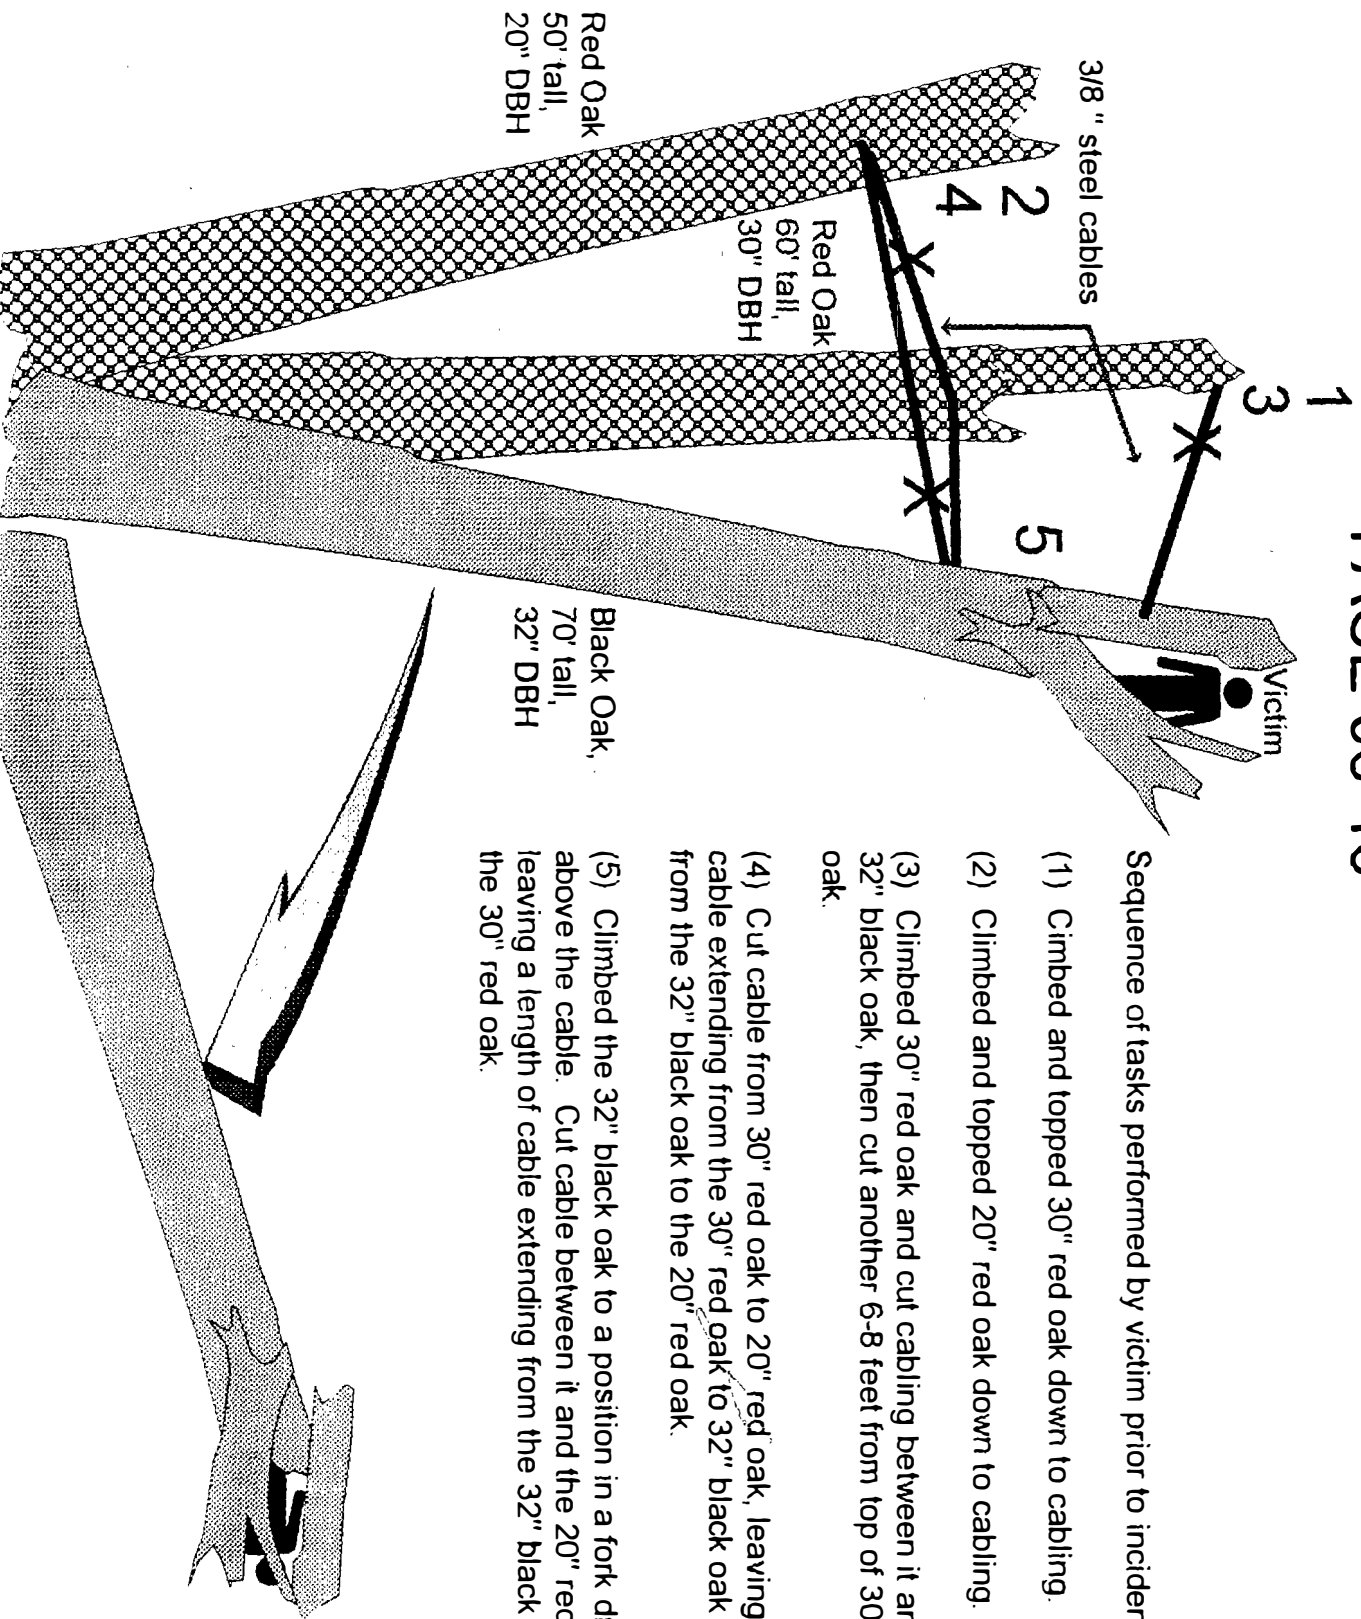
# Figure. Tree with Three Trunks and Cabling

The company had been contracted to clear brush and trees from around an existing utility-line right-of-way. The victim and four co-workers (two foremen, one groundsman, and one other tree trimmer/climber) began work about 8:30 a.m. on the morning of the incident. The incident occurred in the backyard of a private residence in proximity to utility lines on a relatively flat area of land. Several trees were on the property, including a tree with three trunks. The tree had two red oak trunks (30 and 20 inches in diameter at breast height [DBH]) about 60 feet tall, and a black oak trunk (32 inches DBH) about 70 feet tall. The trunks had been secured together with 3/8-inch-diameter steel cables probably 15-20 years prior to the incident. One steel cable was strung through eye bolts which had been screwed into each of the three trunks and strung from one trunk to another, forming an incomplete triangle about 40 feet above the ground. The second cable was strung from eye bolts and connected the 32-inch tree with the 30-inch tree.

- (1) Climbed and topped the 30-inch red oak down to the cabling.
- (2) Climbed and topped the 20-inch red oak down to the cabling.
- (3) Climbed the 30-inch red oak and cut the cabling between it and the 32-inch black oak, then cut another 6-8 feet from the top of the 30-inch red oak.
- (4) Cut cable from the 30-inch red oak to the 20-inch red oak, leaving a cable running from the 30-inch red oak to the 32-inch black oak and from the 32-inch black oak to the 20-inch red oak.
- (5) Climbed the 32-inch black oak to a position in a fork directly above the cable. He used a climbing saddle, boots with spikes, and ropes to climb the trunk and secure himself in the fork of the tree. He cut the cable between it and the 20-inch red oak, leaving a length of cable remaining from the 32-inch black oak to the 30-inch red oak.

Approximately 10-15 seconds after the cable was cut the two co-workers heard a loud "pop," and the 32-inch tree which the victim was tied into uprooted and fell to the ground. The coworkers rushed to the area where the victim was pinned between two large limbs. The co-workers checked the victim and concluded he was dead from obvious massive crushing injuries to the head and neck. The coroner arrived about 10-15 minutes later and pro-nounced the victim dead at the scene.

foreman and the victim had checked the tree trunks for rot, the rotted trunk went undetected. The area at the base where the three trunks meet is often a weak point and a site of "butt rot." If one of the vertical trunks is weak, it should be assumed that all three of the trunks are weak. A hollow sound from rapping on the tree (though this may be less reliable when at the butt of the tree) should also be considered in determining if a tree is rotted. Additionally, an instrument called an increment core is available to arborists for detecting tree rot. This is used to drill into the tree to extract a sample of the wood at the core of the tree. The wood core is visually inspected for damage. The increment core can be used only for trees which will be felled; it should not be used on healthy trees which need only to be trimmed.

Do all trimming/topping of the trunks with the initial cable intact. Take off the sections above the cable. Decide where the next cut will be and insert an eye hook on each of the vertical limbs below that point. Run a wire rope through the eye hooks to form a triangle. Use a come-along or chain stretcher to tighten the wire, using caution not to over tighten the wire. This supports the trunks and affords stability so the next sections and the cable can be cut.
