# Press Operator Dies After Forklift Rams Scrap Bin– North Carolina

FACE 9604

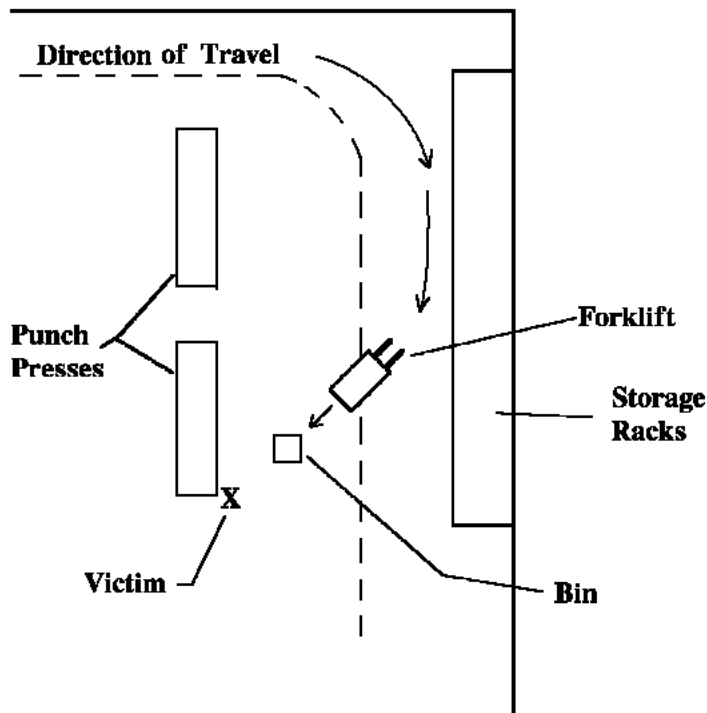
Figure.

The victim's work station was a four-station punch press which produced steel chassis components for personal computers. The press was located in line with other presses adjacent to and parallel to the east wall of the plant building (see [Figure](#)). A pallet rack system was mounted against the building wall and between the pallet rack and the press was a 7-foot 10-inch wide aisle, designated for forklift travel.

Recommendation #1: Employers should ensure that work areas in manufacturing plants are isolated from designated vehicle travel ways by the installation of physical barriers.

press configuration, it is necessary to provide forklift access to the press so that they can be used to change-out move heavy press parts during the set-up. For this reason, physical barriers had been viewed as being impractical. However, it might be possible to install removable barriers which would allow access to the presses for die change-out.
