Trash Collector Dies After Being Caught In Compactor of Refuse Vehicle—North Carolina

FACE 9603

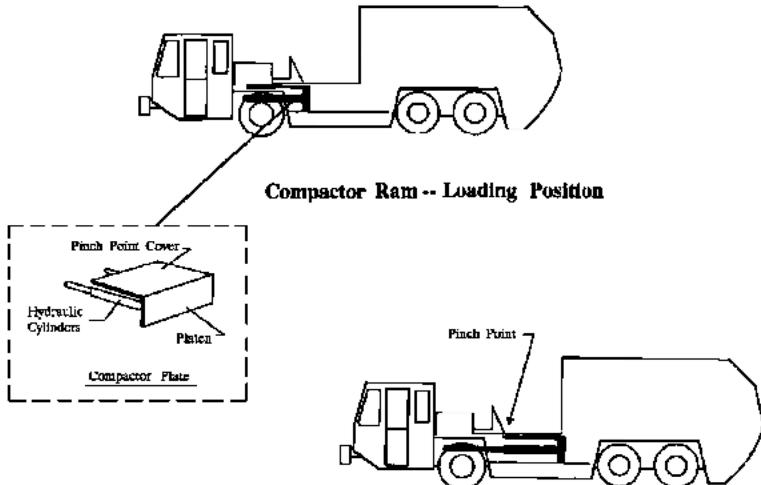
FACE 96-03 Mobile Trash Compactor

As the compactor body becomes full, automatic operation does not advance the platen far enough into the body to completely fill the truck, and it is necessary to override the automatic cycle. Override is accomplished by pressing the platen start switch while holding the platen lever to the right until the desired amount of compaction is attained. The victim used this override feature to advance the platen inside the compactor body and entered the hopper behind the platen.

Discussion: The vehicle involved in the incident was equipped with a system to automatically retract the compactor platen at the end of its stroke during operation in the automatic mode. When operated automatically, the compactor platen advances about 48 inches, then retracts. During this cycle, the pinch point behind the compactor platen is guarded by a pinch-point cover formed by the back of the compactor platen. When the platen extension is increased by overriding the automatic controls, the pinch point is exposed. To protect against injury from inadvertent activation of the return limit switch, an anti-retract (interlock) switch is located on the street side of the loading hopper above the compactor platen guide rail. After the incident, it was found that the linkage for this switch was malfunctioning and would not prevent retraction of the compactor platen. It may be possible to incorporate a second identical switch above the curb side guide rail of the compactor, arranged so that both switches must be activated before the compactor platen will retract.

Compactor Ram -- Limit of Automatic Advance

**Compactor Ram -- Manual Override
Pinch Point Exposed**

Recommendation #3: Manufacturers and designers of automatically operated equipment should consider including redundant safety features to protect against injury from inadvertent activation of automatic controls.
