Shipping Department Employee Dies After Falling Into Floor Opening on Conveyor Line—Virginia

FACE 9515

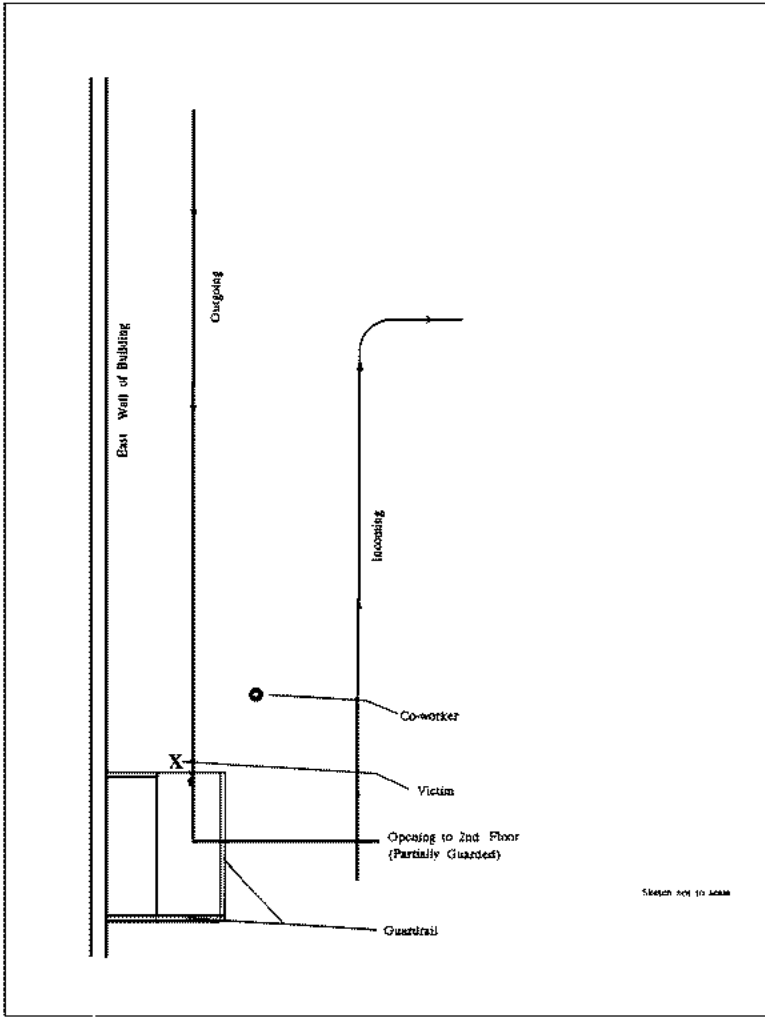
Figure 1.

On July 12, 1995, workers at the warehouse began work on the 7 a.m. to 3:30 p.m. shift. The normal work week is 32 to 40 hours, depending on the volume of orders to be filled. Two conveyor lines operate on the third floor of the five-story warehouse ([Figure 1](#)), one which moves furniture from an adjacent manufacturing plant into and throughout the warehouse (the incoming line), and the other which moves furniture to the first floor for shipment out of the warehouse (the outgoing line). Furniture is loaded onto "hangers," which are chairlike cars suspended from the powered overhead trolley-type conveyor. The hangers have ¾-inch plywood covered load platforms, 30" by 31", bolted to the metal frames. The platforms are about 1 foot above the floor and 7 feet below the conveyor trolleys. The backs of the hangers are covered by another sheet of ¾-inch plywood extending up from the platform about 50 inches. The hangers are spaced approximately 6 feet apart, and travel approximately 42 feet per minute.

The incident occurred at a transfer location where furniture is transferred from the incoming line to the outgoing line before the outgoing line drops through a floor opening to the second floor. The outside edge of the 26 foot 7 inch by 6 foot 6 inch floor opening (the east side) was located 20 inches from the outside wall. A ledge (4¼ inches wide and 2-5/8 inches high) was located 1 foot from the opening, and extended the full width of the south side of the opening ([Figure 2](#)). A shutoff switch for the incoming conveyor was located about 12 feet from the southwest corner of the floor opening. The outgoing conveyor's shutoff switch was located on the outside building wall 5 feet 2 inches across from the conveyor line and 3 feet 6 inches up the line from the edge of the floor opening.

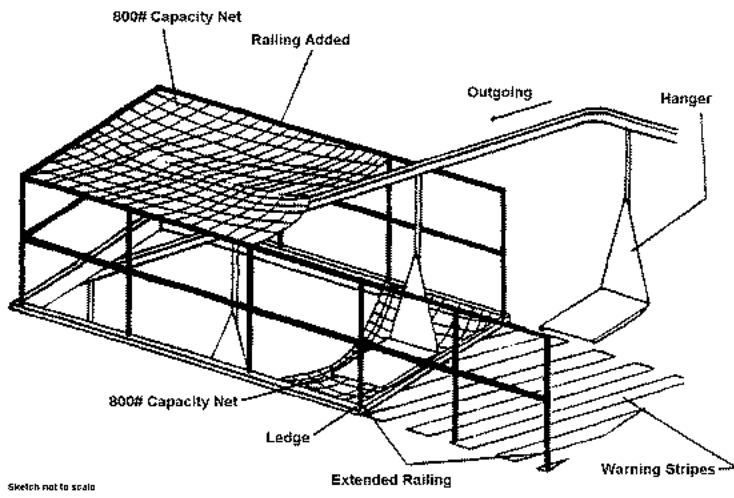
Figure 2.

At the time of the incident, the south edge of the floor opening providing conveyor access was not guarded. The employer has since covered the opening with an 800-pound-capacity cargo net which extends about 10 feet from the south edge (Figure 2). This method of covering offers fall protection yet still allows the conveyor to descend unimpeded through the opening. In response to reports that workers commonly sat on standard railings during break periods, the employer has also covered the north end with a second net secured to the top rail.

Recommendation #1: Employers should ensure that floor openings are guarded by standard railings or covers.

Discussion: At the time of the incident, the floor opening was partially guarded by standard railings (i.e., 42-inch high top rail, midrail, and toeboard). One railing extended along the full 26 foot 7 inch length of the west edge of the floor opening. Another extended across the 6½-foot width of the north end of the floor opening and continued to the building wall. At the south end of the opening, the standard railing extended from the southwest corner of the floor opening 20 inches to the building wall. Since the incident, the employer has extended the west 26 foot 7 inch standard railing an additional 8 feet beyond the southwest corner of the floor opening, and has added a standard railing the full length of the east edge of the opening.
