# Janitorial Worker Dies As Result of Injuries Sustained In Fall With Personnel Lift—Virginia

FACE 9516

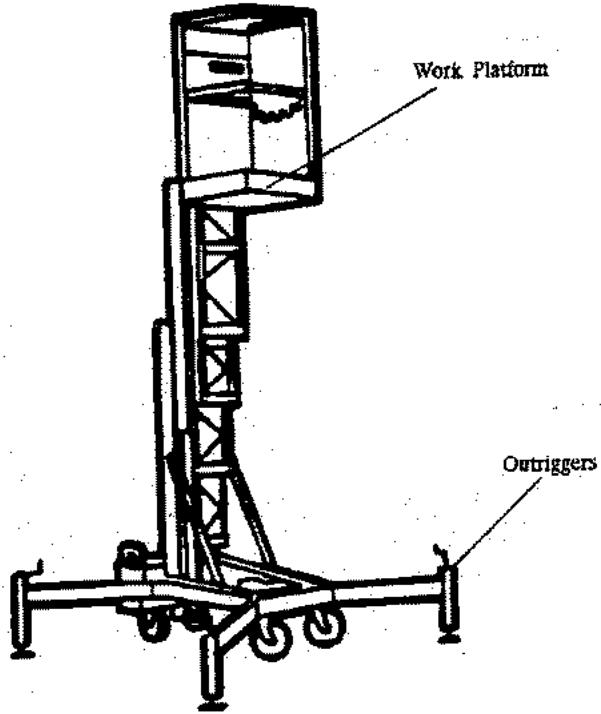
**FIGURE: FACE 95-16 PERSONNEL LIFT**

On the day of the incident, the victim and a co-worker started work at 7:00 am. They had been engaged in dusting water pipes suspended from the ceiling of a three-level parking garage adjacent to the shopping mall for 2 days prior to the incident. Access to the pipe was provided by a small manually propelled personnel lift that extended to 14.5 feet. This lift was routinely used by the two workers while replacing light bulbs, cleaning windows, and dusting signs inside the shopping mall and was normally set up and used without attaching the outriggers. On the 2 days prior to the incident, the lift had been used to dust suspended pipes with one of the workers dusting off a pipe from the elevated work platform of the lift while the other remained on the ground to stabilize the lift. After a section of pipe had been dusted, the lift would be partially lowered and the worker on the ground would push the lift to the next section of pipe while the other remained on the work platform. The pavement in the incident area sloped approximately 1°.

At about 8:15 a.m. on the day of the incident, the victim was dusting a section of pipe near one of the concrete supporting columns of the parking garage. The co-worker, who was located on the other side of the support 10 to 20 feet away, heard a noise from the direction of the victim, looked over toward him, and saw the personnel lift tipping over and the victim grabbing for the pipe. The lift continued to tip, and the victim fell with it 14.5 feet, striking his head on the pavement. The co-worker went to the nearby mall business office and called EMS which responded within minutes. The victim was transported by helicopter to a local hospital where he died 12 hours later.

Discussion: The personnel lift in this incident was manufactured and sold in 1983 and was supplied with outriggers equipped with leveling jacks. These are intended to provide stability to the machine when being used for lifting personnel. The manufacturer's setup and operating instructions, originally included inside a plastic container attached to the machine, specifically state that all outriggers must be installed and the lift leveled before use. When examined just after the incident, the operating instructions were missing from the plastic tube. The lift had been routinely used without outriggers for performing maintenance such as replacing light bulbs, dusting signs, and cleaning windows inside the mall. While use without the outriggers is not acceptable under any circumstances, the conditions inside the mall, where the floor was level, could have decreased the likelihood of tipping from instability. However, using the lift on the slightly sloping parking lot pavement for a task involving horizontal reach from the platform would increase the likelihood of instability.

**Recommendation No. 1: Employers should ensure that personnel lifts are properly erected with all safety features including outriggers in place before use.**
