Shift Supervisor Dies From Injuries Received After His Arms Were Caught Between Two Paper Machine Rollers—Tennessee

FACE 9513

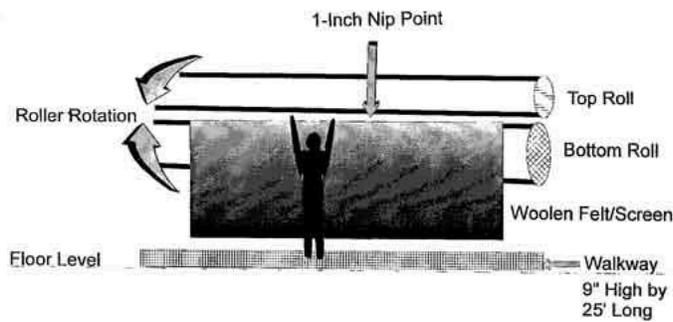
Figure. Paper Machine Rollers
FACE 95-13

The victim, without first raising the top roller, entered the unguarded access roller area and began feeling the felt for possible damage that may have caused the break. Although the event was unwitnessed, it appears that the victim was standing directly in front of the operating rollers nip point, which was located about 6 feet above the access walkway, feeling the woolen felt screen, when his hand or hands became caught between the top and bottom rollers. His arms were consequently pulled up into the rollers at the nip point (the area between any two in-running rolls) [Figure]. A co-worker, walking by the area, looked over and saw the victim caught in the rollers and immediately activated the lever on the control panel (approximately 10 feet from the ends of the rollers) which raised the top roller, allowing the victim to fall to the floor. The co-worker ran to aid the victim and discovered the victim's right arm had been partially amputated at the shoulder area. The victim was momentarily conscious and said "I'm hurt bad." The co-worker ran to the nearest phone and called the plant's nurse who arrived within 2 minutes and checked for vital signs. The nurse found the victim unconscious, bleeding profusely, and without a pulse. An ambulance was called while the

Discussion: Access to the rollers was provided by a stainless steel walkway raised about 9 inches from floor level; the walkway was about 2-foot wide and adjacent to the 25-foot section of rollers. The walkway had no physical barriers at the entrances and exposed anyone on the walkway to the moving woolen felt screen and rollers. Employers should ensure that access to hazardous areas are sufficiently guarded against personnel entry by physical barriers or locked gates. Note: the employer has installed chain guarding at both entrances since the incident.

Recommendation #1: Employers should ensure that access to hazardous areas is sufficiently guarded.

Recommendation #2: Employers should consider the development and installation of permanent interlocking gates which protect workers from hazardous areas.

Discussion: Because of the ever-present danger of entanglement when working near moving-machinery components, employers should consider installing machine guarding in the areas where work is actually performed upon the material being processed. The paper-making machine was put into operation around 1964 and is still operating as originally set up. Advances in engineering technology may be such that machine guarding may be applicable to this particular machine. Employers should contact machine manufacturers and retrofit, if applicable, guards that prevent any part of the body from contacting the machine's moving parts. Note: the employer has contacted the machine manufacturer representative, who conducted an evaluation of the machine. Currently, plans are being devised to install an interlocking gate at the entrances of the walkway, which would activate a switch, raising the top roller and thereby eliminating the nip point. Also, the representative is considering other guarding mechanisms that may be applicable.
