Sanitation Worker Run Over at Solid Waste Transfer Station—Virginia

FACE 9511

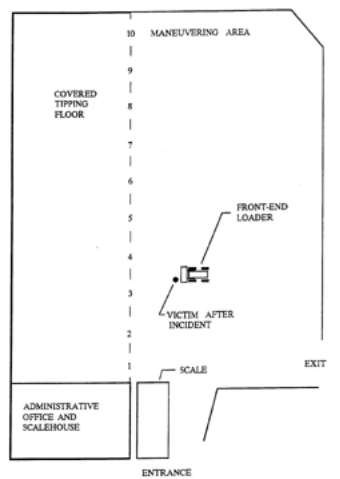
Figure.

The transfer station consists of a 178 foot by 123 foot maneuvering apron located in front (north) of a steel and brick building containing a lo-bay tipping floor, administrative offices and a scale house (Figure). Truck access to the open bay of the tipping floor is through 16-foot wide garage-type doors. Trucks are directed to a bay by a flagman.

FACE 95-11 SOLID WASTE TRANSFER STATION
