# Mill Operator Dies From Injuries Received After His Upper Torso Was Caught Between Lamination Rollers – Tennessee

FACE 9502

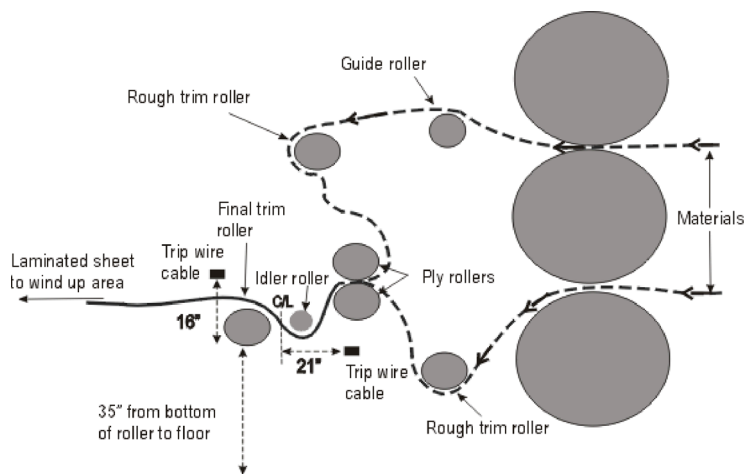
Figure.

Discussion: The victim was apparently removing excess material from around the final trim roller when his right hand became caught between the final trim roller and the idler roller. Employers should explore the application of special hand tools (e.g., gripping devices) for jobs requiring personnel in proximity to moving machine parts.
