Laborer Dies After Being Struck by Overturning Crane—Virginia

FACE 9419

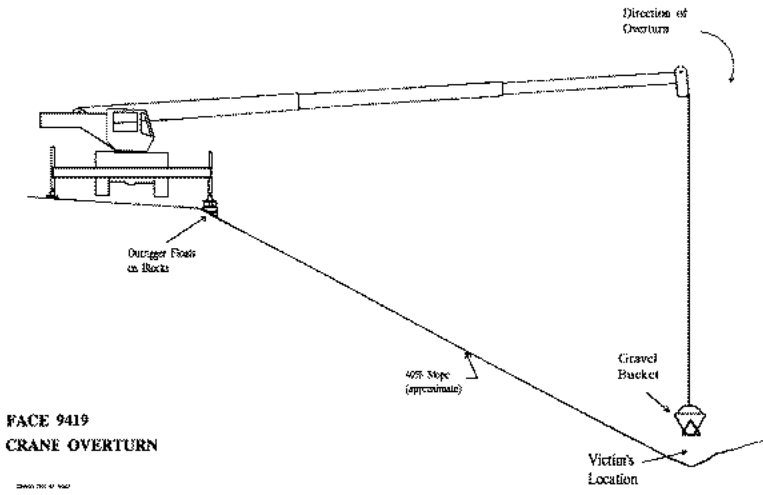
**FACE 9419
CRANE OVERTURN**

Discussion: When positioned along the road shoulder, the right side crane outrigger floats rested on the paved portion of the shoulder. The left side floats were placed on the edge of a gravel undercourse which had been spread and compacted, by rolling, 2 weeks before the incident. To increase the bearing area for the 16- by 16-inch outrigger floats, the left side floats had been positioned on wooden blocks, stacked three blocks high, which were resting on the sloped edge of the gravel undercourse. The set-up also tilted the crane toward the highway, presumably to provide additional resistance to tipping toward the ditch, as had occurred 3 weeks earlier. This set-up could have affected the crane's stability in several ways.

- Normal operating movement of the crane may have further compacted the new fill under the left side outrigger floats, allowing the blocks to sink to the extent that the outrigger floats slipped off them.
- Since the blocks were set on the slope of the fill, normal operating movement may have caused the blocks to slide down-slope and out from under the outrigger floats.
- Since the blocks were stacked three high and the crane set-up was not level, normal operating movement may have dislodged the blocks from under the outrigger floats.

The manufacturer's operating manual for the crane specifies that the crane should be leveled on a firm supporting surface and that it may be necessary to add supports under the outrigger floats or tires to spread the load to a larger bearing surface. When necessary to perform lifts near edges of slopes, consideration should be given to positioning the crane a sufficient distance away from the slope so that the outrigger floats will be resting on firm, level ground. When this is not possible, blocking used to increase bearing surface should be secured to prevent dislodgement. It may have been possible for example, to secure the blocks by pinning them to the ground with steel rods.
