Asphalt Milling Superintendent Crushed Under Asphalt Milling Machine, Virginia

FACE 9418

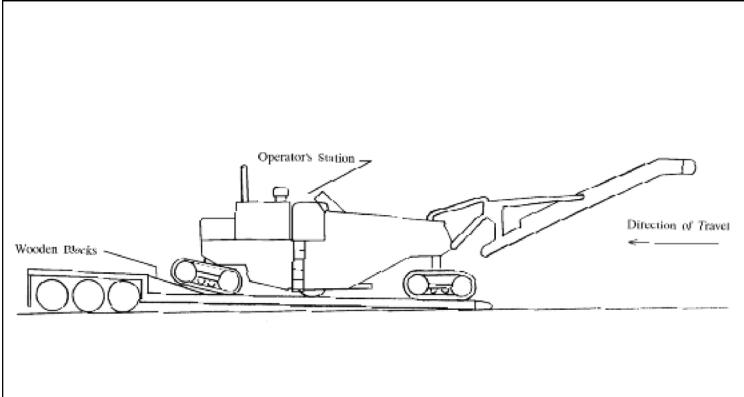
Figure 1. Asphalt Milling Machine and Transporter

Shortly before 2:45 a.m. the crew began to load the milling machine onto a transporter (lo-boy) for removal from the jobsite. The transporter had been parked on the asphalt shoulder of the highway between the edge of the roadway and a culvert. Because of the length of the milling machine, the rear tracks are normally positioned over the axles of the transporter for transport while the discharge conveyor is over the cab of the transporter's tractor. Positioning the milling machine in this manner requires that ramps be used to enable the machine to negotiate the transition from the transporter's deck in front of its wheels to the deck over the transporter wheels. To accomplish this, the crew placed two wedge-shaped wooden blocks (12- by 12- by 52-inch) in front of the deck transition ([Figure 1](#)). The victim began to tram the machine in reverse onto the transporter with the assistance of his co-workers, one positioned on the ground between the transporter and the edge of the roadway and the other positioned behind and to the culvert side of the trailer. The victim had moved the machine onto the transporter and the rear tracks were partially up on the wooden ramps. At that time, the co-worker standing between the transporter and the edge of the highway signaled to the victim that the machine was too high and that it should be lowered closer to the tracks. The other co-worker observed that the rear tracks were too far to the right, moved forward to notify the victim, and then returned to the rear of the transporter. At that time, either the rear of the milling machine slipped off the ramps, or the ramps themselves dislodged from under the tracks, and the machine overturned off the transporter. The co-workers immediately began searching the area for the victim and found him pinned under the milling machine at the operator's station. One co-worker left the scene and notified the local EMS by mobile telephone while the other checked the victim's pulse, finding none. The EMS responded approximately 15 minutes after notification, followed by the medical examiner, who pronounced the victim dead at the site.
