# Carpenter Dies After Falling 17 Feet From A Scaffold– South Carolina

FACE 9415

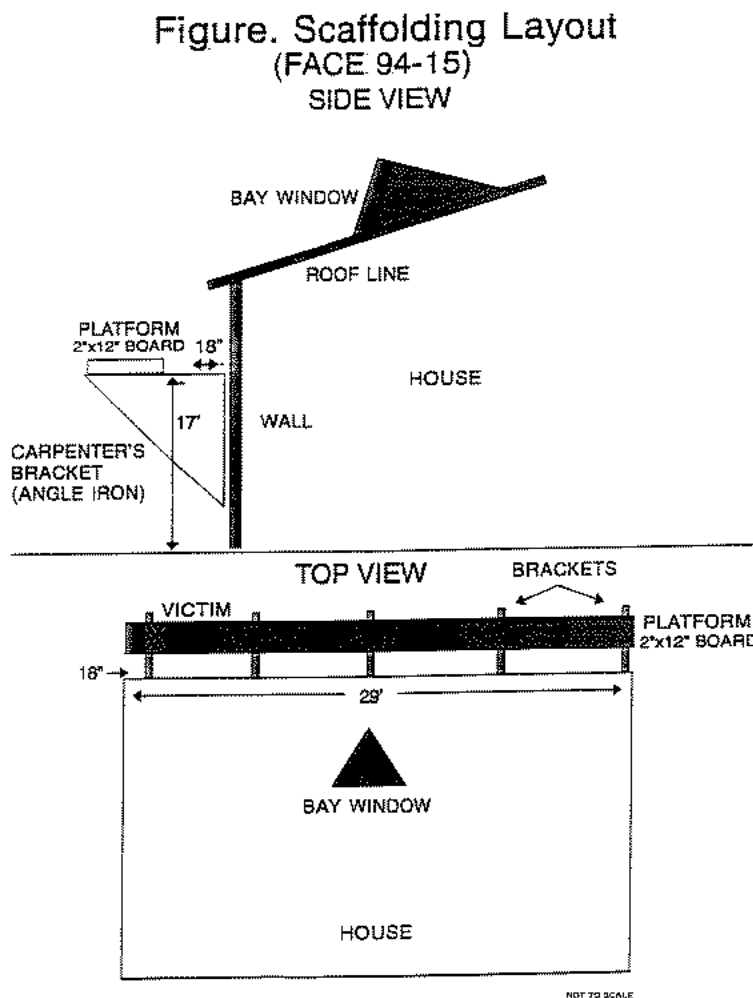
Figure.

Discussion: The victim was nailing soffit boards to a roof overhang while standing on an unguarded scaffold platform. Guarding of the scaffold platform, as required by CFR 1926.451 (a)(4), which states "Guardrails and toeboards shall be installed on all open sides and ends of platforms more than 10 feet above the ground or floor," was not present.

### **Recommendation #1: Employers should provide adequate guarding on scaffolding.**
