# Construction Foreman Dies After Falling From Aerial Lift Bucket Truck—South Carolina

FACE 9414

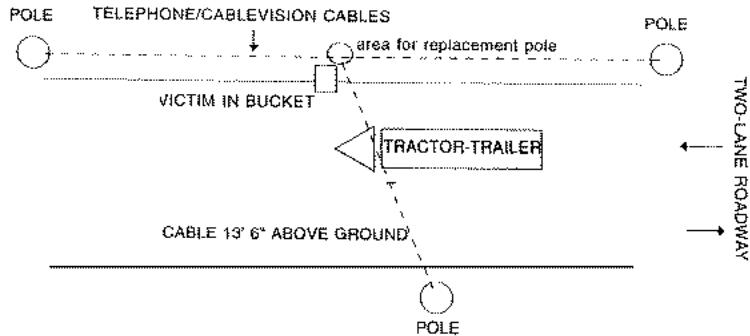
**FIGURE. INCIDENT SITE LAYOUT  
(FACE 94-14)**  
**TOP VIEW**

The victim and four crew members had been assigned to replace a cracked wooden utility pole located alongside a two-lane roadway. The top of the pole was about 20 feet above ground. The pole supported two sets of telephone and television cables which were strung 16 feet above the roadway. One set of cables ran parallel with the roadway; the other set ran across the roadway to a pole on the opposite side ([Figure](#)).
