# Department of Transportation Maintenance Foreman is Electrocuted and a Highway Maintenance Worker Severely Burned When Truck Bed Contacts Overhead 7,200-volt Powerline—South Carolina

FACE 94-08

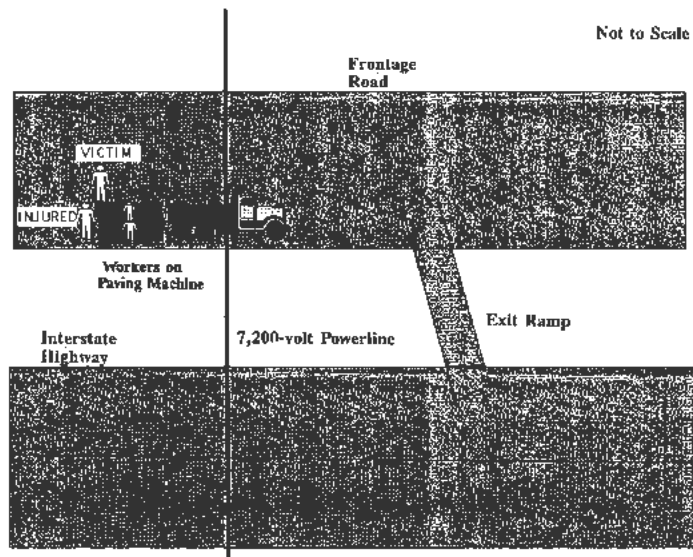
Figure.

On the day of the incident, the crew was repaving a section of the frontage road. By 2:30 p.m., one lane of the section of frontage had been repaved and the crew had begun repaving the second lane. The foreman was leaning against the paving machine, one road worker was operating the asphalt depth screw regulator while standing on the ground at the rear of the paving machine, and two workers were seated at the operator's station on the paving machine. The crew foreman directed the truck as it backed against the paving machine. When the truck was against the paving machine, the foreman directed the truck driver to raise the bed to allow the asphalt to flow into the paving machine. As the bed was raised, the proximity warning flasher at the top left corner of the truck bed sounded and flashed. The truck bed then contacted the 7,200-volt powerline. The current traveled through the truck bed and paving machine to ground through the foreman and the road worker at the rear of the machine. The road worker's clothes ignited. The truck driver heard the arc when the truck bed contacted the powerline and immediately lowered the bed. Neither he nor the two workers on the paving machine was injured. The driver radioed the office and requested the emergency medical service (EMS). The crew members immediately initiated cardiopulmonary resuscitation (CPR) on the foreman. Although the road worker at the rear of the machine had received severe burns to 35% of his body, he was breathing and conscious. The men were life flighted to the hospital, where the foreman was pronounced dead by the attending physician.

Measurements taken at the site revealed that the powerline was located 15 feet, 10 inches above the roadway. The truck bed could be raised to a maximum height of 17 feet, 3 inches. Since the incident, the utility company raised the powerline to a height of 20 feet.

**Discussion:** National Electrical Safety Code Rule 232B1 requires that for open supply conductors over 750 volts to 22 kilovolts, an 18½-foot clearance between the supply conductor and roads, streets, and other areas subject to truck traffic must be maintained. It is possible that the truck bed may have stretched the conductor slightly in this case; however, utility companies should ensure that required clearance distances are maintained.
