# Tree Trimmer Foreman Dies After Being Struck by a Pickup Truck – South Carolina

FACE 9407

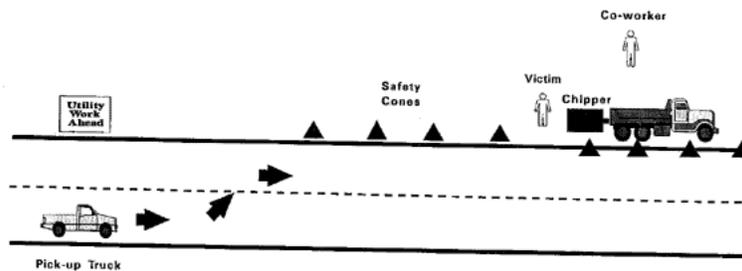
The company had been contracted by a local utility to clear a powerline right-of-way in a wooded area near a power plant. The two-man crew (a foreman [the victim] and a climber) had been at the site for 2 days. At 4:30 p.m. on the second day, as the job was nearing completion, the victim and the climber were cleaning up the remaining brush that had been cut in the woods and carrying it to the wood chipper located at the side of a two-way, two-lane State highway. The wood chipper and truck were located approximately 4 feet off the side of the highway. The wood chipper was attached to the company truck by a 2-inch trailer ball. The truck's wheels had been chocked. Orange safety cones, 28 inches high, were placed at the side of the highway in front of the truck, at the truck door, at the rear of the truck, and at the wheels of the chipper. Four cones were also placed at 15-foot intervals behind the chipper. A 48-inch-square "Utility Work Ahead" sign was placed on the same side of the highway as the truck, behind the chipper (Figure).

The workers were wearing their green work uniforms without orange vests. The utility company's right-of-way supervisor had inspected the worksite 12 hours prior to the incident and reported the job to be setup properly. At the time of the incident, the climber had just finished feeding a load of brush into the chipper and was walking into the woods to gather another load. He passed the victim walking toward him with a load of brush. When he arrived at the chipper, the victim dropped the load of brush on the ground at the chipper and began to feed the brush a little at a time into the chipper. As the climber was gathering brush, he heard a loud crash and turned to see the victim lying in the highway and a pickup truck against the chipper with the driver's head resting against the steering wheel. The climber immediately ran to the company truck and pressed the emergency button on the radio, which alerted the utility company to dispatch an emergency medical squad (EMS) to the scene. He then ran to the victim. Although he could not detect any vital signs, he did not begin cardiopulmonary resuscitation (CPR) because of the extent of the victim's injuries. He then provided basic first aid to the truck driver, who was unconscious, but breathing. When the EMS arrived they summoned the county coroner and the lifeflight helicopter. The county coroner pronounced the victim dead at the scene, and the truck driver was lifeflighted to the hospital where he was listed in critical condition.

The investigating highway patrol officer's report stated that all the safety cones had been run over and that no braking skid marks were present on the dry road. The wood chipper had been torn away from the truck and was destroyed and the company truck had moved forward 8 feet. The officer estimated the speed of the pickup truck at the time of impact, was between 50 and 55 miles per hour. The posted speed limit was 55 miles per hour. The pickup truck driver stated to physicians at the hospital that he had no memory of the incident.

**Recommendation #1: Employers should ensure that a flagman or lookout is present while work is being performed on the sides of roadways normally open to the public.**

Discussion: In this incident, both workers alternately fed brush into the chipper while the other gathered brush in the woods. It would have been possible for both workers to gather a quantity of brush, then alternate feeding brush into the chipper while the other acted as a lookout for oncoming traffic. The lookout could issue a warning if oncoming traffic approached in a manner that would pose a threat to the safety of the workers.

**Recommendation #2: Employers should ensure that employees wear high visibility clothing while performing operations on the sides of roadways normally open to the public.**

Discussion: Although the highway patrol and the utility company found no violations in the setup of the tree-trimming equipment at the jobsite, the use of high visibility clothing may have alerted the driver of the pickup truck of the foreman's position after the pickup began to hit the safety cones. The National Safety Council's Accident Prevention Manual for Industrial Operations in its classification of PPE (subheading-special clothing) recommends the use of high visibility and night hazard clothing for construction, utility, and maintenance workers; and police officers and firefighters whose work exposes them to traffic hazards. Additionally, ANSI D6.1-1971 requires that in positioning flagmen, consideration must be given to maintaining color contrast between the flagman's protective garments and his/her background.
