# Pipefitter Crushed by 5,000-Pound Shoring Plate—South Carolina

FACE 9403

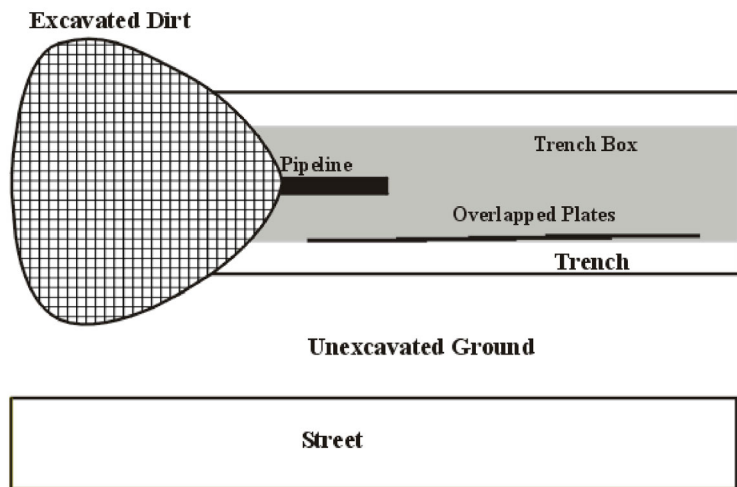
Figure 1

The employer had been contracted to install an 8-inch ductile iron sewer pipeline at a new residential subdivision and was 3 weeks into the job. The pipe was being installed in a 14-foot-deep by 5-foot-wide trench by a seven-man crew. The trench had been excavated in type "C" (sandy) soil that was water-saturated (water was constantly being pumped from the trench). A 28-foot-long by 10-foot-high trench box had been installed in the trench from which the men could work. Six shoring plates, measuring 7-feet, 5 inches wide by 16-foot high, and weighing 5,000 pounds apiece, were installed inside the trench on the street side of the excavation (Figure 1). These plates were overlapped over each adjacent plate and were installed to prevent ground water from accumulating in the trench and to provide additional protection from the saturated street sidewalk. The plates were lifted by a hook placed in a 3¼-inch by 6-inch hole cut into the top midpoint on the short side of each plate. The hook was attached to three cables leading to three shackles connected to an eyelet on the backhoe bucket.

Each day the crew performed the following sequence approximately seven times. The ground was excavated for the next length of pipe. A backhoe (#1) located on the side trench and in front of the trench box pulled the trench box forward while the backhoe (#2) at the rear of the trench box backfilled the previous length of pipe. The trench box was then pounded down into position by the two backhoe buckets. The six shoring plates were then set inside the trench box on the street side of the excavation. The first plate was guided into place by a pipefitter (the victim) who entered the rear of the trench box over the excavated dirt that covered the previous length of installed pipe. After the plate was guided into position by the pipefitter, the backhoe (#1) operator would push it down into the ground using the backhoe bucket. The next five plates would then be placed in the trench box in an overlapped fashion. The pipefitter guided only the first plate into position.

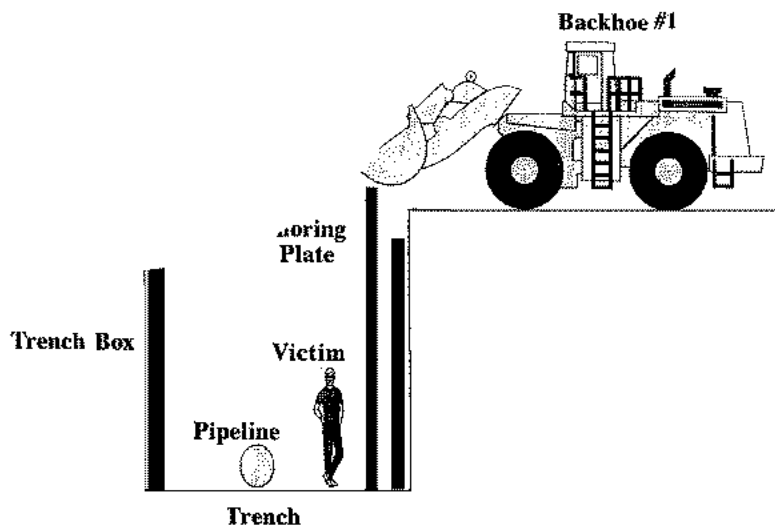
Figure 1.

At 2 p.m. on the day of the incident, the crew had just moved the trench box forward and the first plate was being positioned at the rear of the trench box (Figure 2). As backhoe (#1) began to push the plate down, the victim began to walk up the excavated dirt out of the trench box. As the bucket pushed down on the plate, it slipped off the plate and the plate began to fall toward the victim. The hook, missing a safety latch, slipped out of the hole in the plate. The foreman yelled to the victim, and the backhoe operator at the front of the trench box, seeing the plate free-falling toward the victim, blew his machine's horn. As the victim turned, the plate struck his chest and fell on top of him, crushing him.

The operator of the backhoe (#1) lifting the plate stated during OSHA interviews that the safety latch had broken off a day or so before the incident. Replacement hooks were available in the company parts truck.

Discussion: OSHA regulation 29 CFR 1926.651 (e) requires that no employee shall be permitted underneath loads handled by lifting or digging equipment, and that employees stand away from any vehicle being loaded or unloaded to avoid being struck by any spillage or falling materials. Alternate means of setting the shoring plates should be evaluated in order to eliminate worker exposure to suspended loads.

Discussion: Prior to any work being performed, a jobsite evaluation should be performed by a competent person, as defined by OSHA, to identify potential hazards (e.g., the pipefitter needing to enter the trench in proximity to a suspended load, the missing safety latch on the hook) and develop control measures that would lessen or eliminate worker exposure to these hazards. Any faulty equipment should be repaired immediately or tagged and removed from service. An inspection might have identified the faulty hook. This hook could have been replaced with a new hook from the supply truck.
