Sanitation Worker Runover After Falling From Trash Collection Vehicle–Virginia

FACE 9411

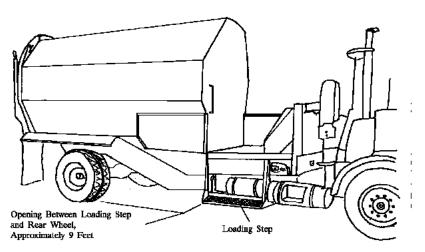
Discussion: An open space of approximately 9 feet existed between the loading step and the rear wheels of the vehicle, (Figure 1). This space between the wheels and the step was devoid of body work or fenders. Consideration should be given to covering this space with an extension of the truck body (Figure 2). Extended fenders or additional body panels would not prohibit a fall from the step, but could be installed in such a way that anyone falling off of the step would be deflected from the path of the wheels.

Figure 1. Configuration of Truck at Time of Incident

Recommendation #3: Employers should consider equipping vehicles with extended fenders or additional body panels to eliminate or reduce the likelihood of workers landing in the path of the vehicle's wheels in the event of a fall.

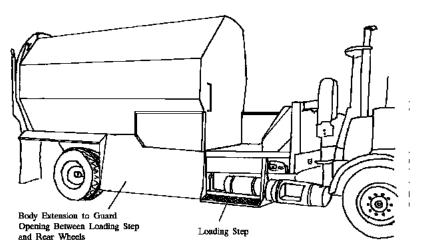
Figure 2. Possible Configuration of Extended Body
