# Timber Cutter/Skidder Operator Killed by Falling Tree – West Virginia

FACE 9405

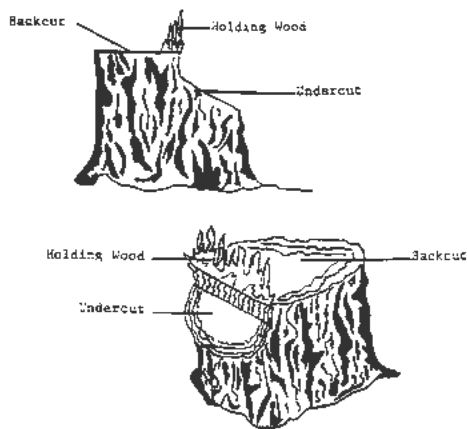
Figure 1.

Discussion: The victim was struck and killed by a falling tree as he was felling another tree about 60 feet away. The tree that struck him had been undercut in such a manner that it was supposed to have fallen away from the victim. However, when the backcut was made, the holding wood was cut through, causing the tree to twist on its stump and fall in the direction of the victim, approximately 90 degrees away from the intended direction of fall.

Figure. 1 Depiction of an appropriate backcut,  
holding wood, and undercut

**Recommendation #2: Employers should develop, implement and enforce a written safety program which includes worker training in proper tree-felling techniques.**

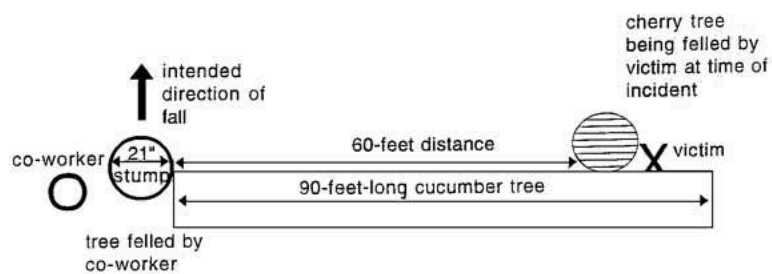
Discussion: Two workers, a timber cutter and the victim, were working within 60 feet of one another when the incident occurred. 29 CFR 1910.266(e)(1)(i) states "Work areas shall be assigned such that a tree cannot fall into an adjacent work area. The recommended distance between workers is twice the height of trees being felled."

Figure 2. Tree-felling incident site  
Top View

**Recommendation #1: Employers should ensure that workers are assigned to separate work areas.**
