# Fatal Incident Summary Report: Conductor Pipe Falls onto Helper While Drilling a Well

FACE 8415

On June 5, 1984, a 29-year-old oil/gas well drilling helper was fatally injured due to a crushed mediastinum when a suspended conductor pipe slipped from its rigging and struck the employee.

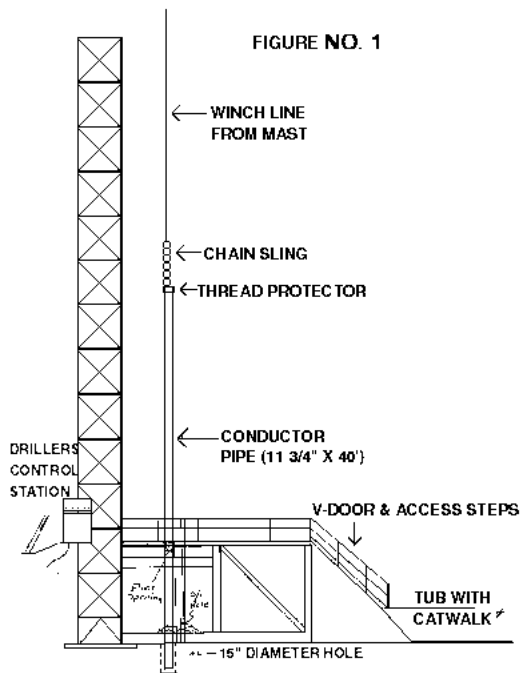
At approximately 5:00 a.m. on June 5, the driller estimated the conductor hole to be at its required depth. He pulled the drill bit from the hole and had a helper hook a winch line and chain sling to the 11 and 3/4-inch by 40-foot conductor pipe (refer to Figure 1). He lowered the pipe into the hole and realized the hole lacked two feet of being at proper depth. He then pulled the pipe from the hole. The derrickman and two helpers were maneuvering the conductor pipe over to the V-door in order to place it back on the supply tub (refer to Figure 2). This process required (a) the workers to push the pipe end beyond the upper edge of the V-door and (b) the driller to lower the winch line at the moment the pipe end cleared the V-door edge. It was during this process that the conductor pipe slipped from the chain sling and fell. (The driller stated that in his 7 years of working on a rig, this was the first time he had experienced a pipe slip from its chain choker. The grab hook was still attached to the chain forming a loop after the pipe slipped out.) The four workers, including the driller, scrambled to avoid being struck by the falling pipe. Figure 3 shows the approximate locations of individual crew members at the time the pipe began to fall and their paths of movement during the fall. The upper end of the pipe struck the derrick mast and fell onto the work deck, narrowly missing the driller and striking the deceased in the upper right torso area. The momentum of the pipe caused it to totally leave the work deck and come to rest on the supply tub. This incident occurred between 5:30-5:45 a.m.

The major contributing factor for this fatal incident was that the chain sling, which utilized a chain grab hook for making the connection, was not wrapped tightly enough around the pipe. This situation, combined with the pipe being damp from the heavy dew, created enough loss of frictional forces to allow the pipe to slip from the sling. This method of handling pipe was stated as being common industry practice and was verbally verified by a representative of the Independent Association of Drilling Contractors. This practice might be improved via use of a thread protector lifting attachment or a thread protector with a flanged lip and wire rope choker. A combination thread protector lifting attachment would allow use of a winch line cable lifting hook or chain sling with lifting hook. It would also allow for protection of the pipe threads. The flanged thread protector would keep the pipe from sliding through the chain sling. However, if the chain grab hook is not fastened properly (e.g., back of hook next to pipe) it could become unfastened and still allow the pipe to fall. For this reason, a wire rope choker sling would seem more appropriate for use with the flanged thread protector.
