Two Confined Space Fatalities During Construction of a Sewer Line

Death in the Line of Duty...A summary of a NIOSH fire fighter fatality investigation

F84-13 Date Released: NA

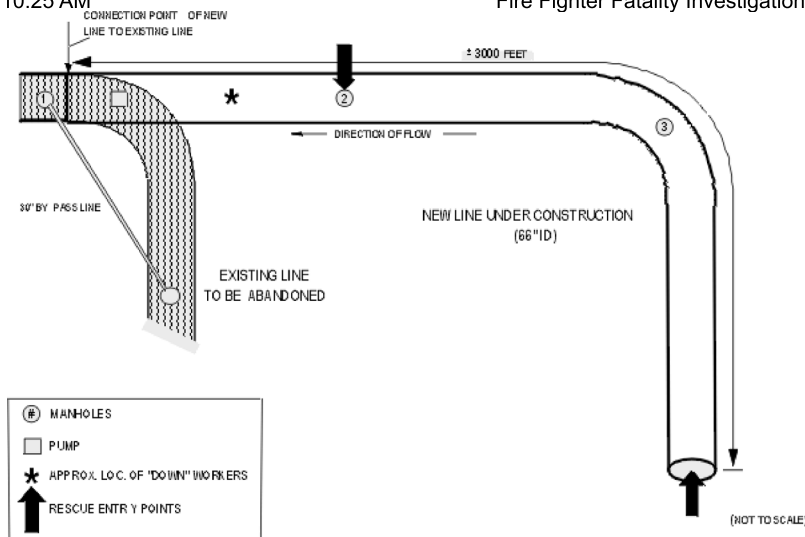
Figure.

In the process of constructing the interstate highway, the contractor had to construct several thousand feet of sanitary sewer line composed of 66 inch ID by 16 feet long sections of concrete pipe. This new line had to tie into an existing line. The upstream portion of the existing line would be abandoned after completion of the new line. (Figure)

The existing line had to be kept in service during construction. A by-pass line had to be built around the connection point of the new and existing lines. This was done by tapping a 30 inch by-pass line into the existing line, upstream of the connection point, and tying the by-pass line into a newly constructed manhole (No. 1) at the connection point. In order to keep sewage from entering the construction area of the connection point, the pipe was diked by sand bags several feet upstream of Manhole No. 1. The dike was left in place for approximately 1 month while the contractor continued to lay pipe.

During this time, sewage seeped/flowed past the dike and extended approximately 480 feet (30 sections) into the newly constructed line. This sewage had to be removed before the contractor could proceed with grouting the pipe joints.
