# Supply Motorman Killed by Load Falling from a Forklift

FACE 8412

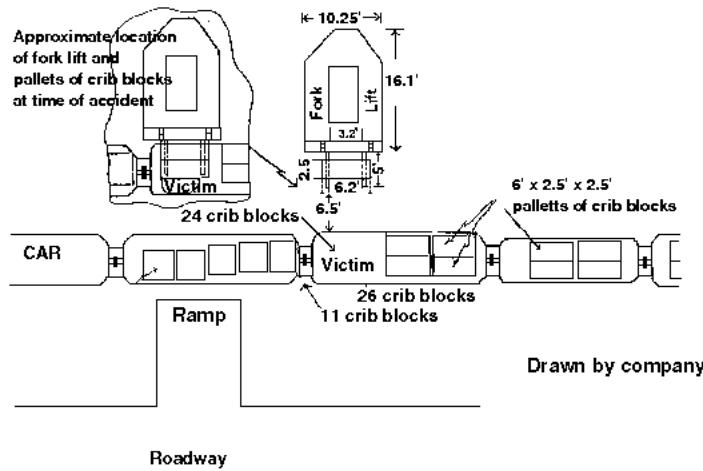
It is believed that either the 1/2-inch steel bands broke or the load slipped and fell crushing the motorman. The forklift operator stated that he had the load all the way on his forks, had his forks tipped slightly to the rear, had his forklift in neutral, had his feet on the clutch and the brake, and had set the handbrake. The forklift operator did not see the load fall, but heard it fall. He then backed away about 6-1/2 feet and lowered the load. Three of the four 1/2 inch steel bands were broken and the cribbing was scattered on the car and ground.

The victim was doubled over with one foot on the flatcar and the other on the ground ([see diagram](#)). The victim was uncovered by the forklift operator and fellow workers and transported at 1:30 p.m. to the hospital by the emergency medical squad. The victim was alert and cooperative when he arrived at the hospital, but subsequently turned blue. After open cardiac massage and external pacing proved unsuccessful, the victim was pronounced dead at 3:40 p.m.
