# FATAL INCIDENT SUMMARY REPORT: FIRE AT A WASTEWATER TREATMENT PLANT

FACE 8411

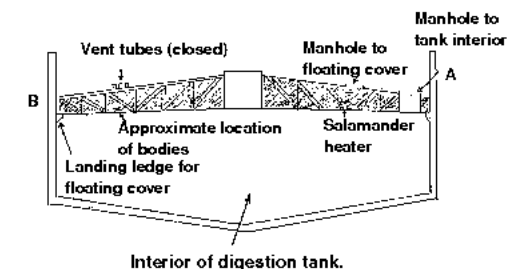
**Figure 1.** Side view of digestion tank with flashing cover

The floating circular cover consisted of a confined space of approximately 6400 cubic feet with a five foot ceiling height at the apex ([see figure 1](#)). The only entry into the cover was through a 30" diameter manhole located approximately ten feet from the apex. Due to the cold and windy winter weather, the carpenters built a temporary roof (2" x 4" studs covered with 8-10 mil. plastic sheeting) over the floating cover.

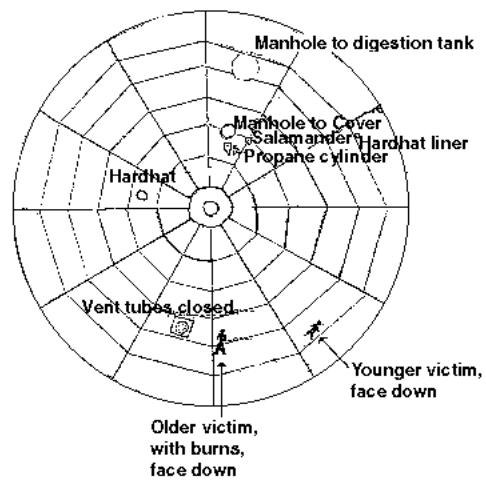
**Figure 2.** Top view of digestion tank showing location of victims

After entering the cover, the two firefighters made a counterclockwise sweep close to the center of the tank. One hard hat was found approximately 201 from the manhole. During a second sweep more towards the outside of the cover, a helmet liner was found and then the two bodies. Both victims were found lying face down and no vital signs were present ([see](#)

Figure 2). The older victim had overalls which were singed and a cigarette lighter was found near his body. The two victims were pronounced dead on the scene by the attending medical examiner and were transported to the morgue at a local hospital.
