Cement Finisher Dies After 17-Foot Fall Through Unguarded Floor Opening—North Carolina

FACE 9321

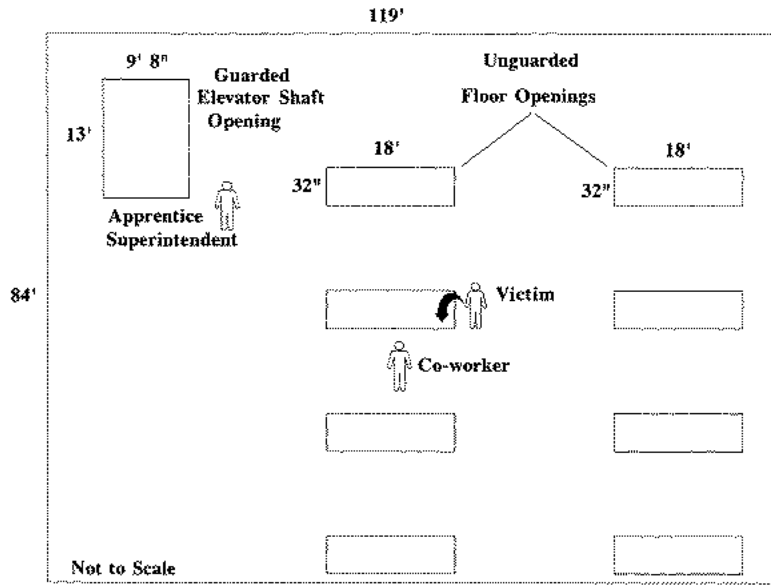
Figure.

Eight unguarded floor openings, each measuring 32 inches wide by 18 feet long, had been formed into the floor. These openings would be used as vents and ducts for service cables. A ninth floor opening measuring 13 feet long by 9 feet 8 inches wide, marked the location of the elevator shaft and was guarded by a steel rope barrier (Figure).

As the victim was walking backward floating the concrete, he stepped into the unguarded opening and fell approximately 17 feet to the concrete floor below, striking his head. The co-worker did not see the victim fall, but heard him yell. The apprentice superintendent saw a portion of the victim's body fall through the opening.

Recommendation #1: Employers should implement 29 CFR 1926.500 (b)(1) and (8), which requires that all floor and platform openings be protected with a standard railing or a floor opening cover secured against displacement.

Discussion: Prior to the start of work, floor openings should be protected with a standard railing, or covered or guarded with materials that are installed so as to prevent displacement. After the incident, the openings were properly fitted with secured plywood covers by the prime contractor.
