The National Institute for Occupational Safety and Health (NIOSH)

Electrician Apprentice Dies Following a 33-foot Fall Through a Roof—South Carolina

FACE 9319

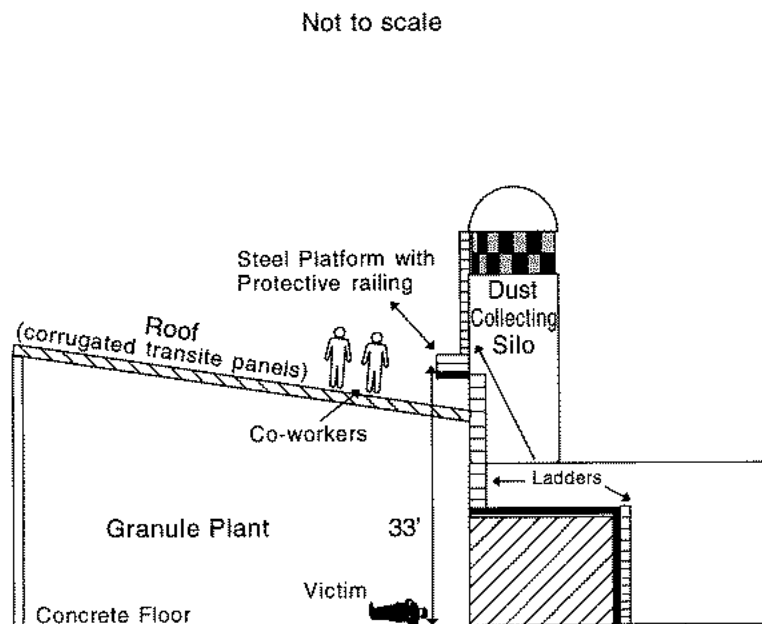
Figure.

The employer had been contracted by a roofing products manufacturer to install electrical conduit, wiring, and related components at the dust-collecting silo located in the granule plant. The silo was situated adjacent to and partially above the roof of the 29-year-old granule plant. The plant walls and roof were constructed of corrugated transite panels, a fire-proofing material used in walls and roofs and for lining ovens. The panels were composed of asbestos and cement molded under high pressure, and they had a load rating of 200 pounds per square foot. The panels were set in place on steel girders approximately 30-inches apart. Work on the dust-collecting silo had been in progress for 3 days before the incident.

On the day of the incident, the victim and four co-workers (one foreman, and three other electrician apprentices), arrived at the plant and started work at 7 a.m. The workers had spent the morning installing the necessary conduit and pulling electrical wire through it. At approximately 11:35 a.m., the workers were getting ready to break for lunch. The victim had just completed pulling electrical wire through a conduit while standing on a steel platform attached to the side of the silo. The platform was equipped with a standard protective steel railing which consisted of a top rail, mid rail, and toe board. The granule plant roof was directly below the platform, approximately 34 inches from the mid rail (Figure). The foreman and another worker were standing on the granule plant roof about 10 feet from the edge of the platform, waiting for the victim to finish his task and go to lunch. Plant personnel had seen the workers using the roof as a route of access to the ladder leading to the ground. His back toward the other workers, the victim climbed over the top rail, and with his feet resting on the mid rail, jumped to the granule plant roof. The victim, who weighed 235 pounds, broke through the corrugated transite panels and fell to the concrete floor 33 feet below. An employee working in the granule plant saw the victim fall and strike the concrete floor. The employee and the workers from the roof ran to aid the victim, who suffered a severe head injury. The victim was unconscious and was not breathing. Cardio Pulmonary Resuscitation (CPR) was started and the EMS was called. The Emergency Medical Squad (EMS) arrived in less than 15 minutes and pronounced the victim dead at 11:50 a.m. The medical examiner arrived on the scene shortly thereafter and had the victim transported to the morgue at the local hospital.

Recommendation #1: Employers should evaluate their current safety program and incorporate specific training procedures emphasizing the importance of recognizing and controlling hazards in the workplace. These procedures should include, but not be limited to, conducting hazard evaluations before initiating work at a job site, and implementing appropriate controls.

Recommendation #2: Employers should designate a competent person to conduct scheduled and unscheduled site visits to evaluate field compliance with company safety rules and procedures.

Recommendation #3: Plant/facility owners should identify areas that may be hazardous to all personnel, including contractors, and restrict or prohibit the use of or access to these areas.
