The National Institute for Occupational Safety and Health (NIOSH)

Electrician Apprentice Electrocuted after Contacting a 480-volt Conductor in South Carolina

FACE 93-18

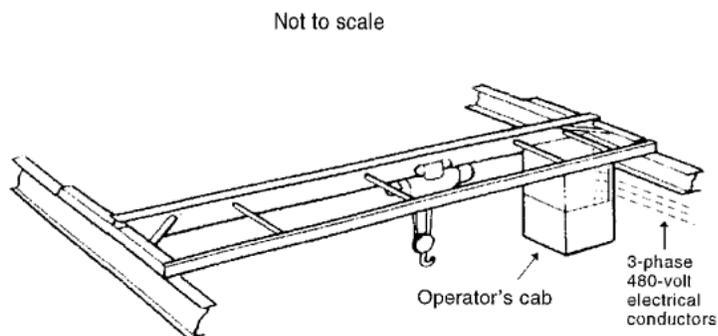
Figure. Overhead Cab-operated Crane

A 42-year-old male electrician apprentice (the victim) was electrocuted when he contacted an unguarded energized 480-volt overhead crane contact conductor. The victim and two co-workers had just performed electrical maintenance on the hoisting motor of the overhead crane, and the crane was moved approximately 200 feet in order to access another overhead crane. The two co-workers were positioned on top of the bridge of the crane, while the victim operated the controls inside the operator's cab to move the crane. After the crane was stopped alongside the second overhead crane, the victim exited the cab and proceeded to climb a metal ladder attached to the cab, which led to the top of the bridge where the other workers were located. Approximately halfway up the 7-foot metal ladder, the victim apparently partially lost his footing and grip on the ladder. As he began to fall, he extended his left arm to catch himself and his left hand contacted one conductor of the energized, three-phase, 480-volt overhead crane contact conductors. The electrical current passed through the victim's body to ground through his right hand, which was grasping the metal ladder. When the victim's hard hat fell to the ground, another worker located on the ground beneath the crane looked up and saw the victim dangling from the ladder. He alerted the workers on the bridge, and they moved to assist the victim. One of the workers administered cardiopulmonary resuscitation (CPR), while another worker ran to call for medical assistance. An ambulance arrived in about 15 minutes and paramedics continued CPR and transported the victim to a local hospital where he was pronounced dead on arrival. NIOSH investigators concluded that, in order to prevent similar occurrences, employers should:

Power for the cranes was provided, via collector leads, by a three-phase, 480-volt circuit composed of three bare steel contact conductors which ran adjacent to the operator's cab/crane bridge (Figure) for the entire length of the building.

Recommendation #1: Employers should implement Article 610-21(a) of the National Electrical Code, which is entitled "Locating or Guarding Contact Conductors."

Discussion: This article states that “Runway contact conductors shall be guarded, and bridge contact conductors shall be located or guarded in a manner that persons cannot inadvertently touch energized current-carrying parts.” The National Electrical Code defines guarded as “covered, shielded, fenced, enclosed, or otherwise protected by means of suitable covers, casings, barriers, rails, screens, mats, or platforms to remove the likelihood of approach or contact by persons or objects to a point of danger.” The crane runway conductors were not guarded when this incident occurred. [Note: Subsequent to the incident, metal screen guards were welded around the operator’s cab/bridge area that is in proximity to the contact conductors.]
