# Truck Driver and Company President Electrocuted After Crane Boom Contacts Powerline—West Virginia

FACE 93-14

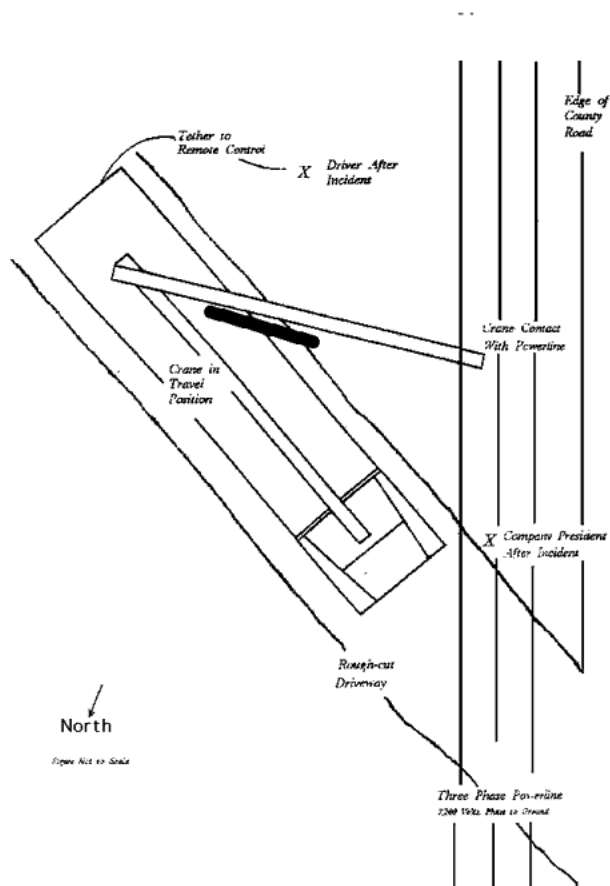
**Figure.** Location of Truck Relative to Powerline

The residential building site in this incident, located on a hillside, was accessed from a state road by a steeply pitched (15% grade) rough-cut driveway. The state road was 17½ feet wide and protected by a guardrail about 5 feet from the road edge opposite the entrance to the driveway. The energized overhead powerlines were located 25 feet above ground and 6 to 8 feet from the edge of the state road. Several days before the incident, the plant manager had examined the site because the company was aware of the limited operating space available for delivery trucks. The plant manager cautioned drivers, who were assigned to deliver to the site, including victim #1, about the limited space available for parking delivery trucks, the steep grade of the driveway, and the proximity to the overhead powerlines.
