# Commercial Fisherman Drowned After Fishing Vessel Capsized – Alaska

FACE 9232

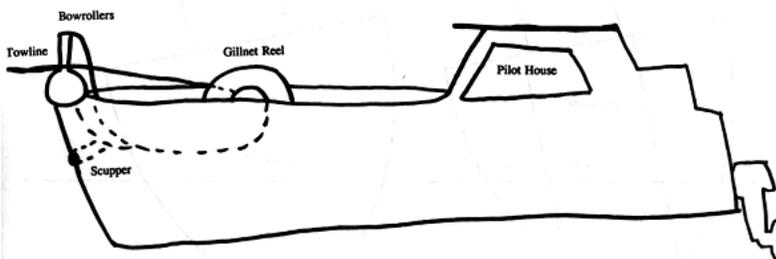
Figure 1. Bowpicker with Towline Attached (Port View)

The tender passed approximately 200 feet of 1-inch-diameter nylon mooring rope to the bowpicker to serve as a towing line. The skippers discussed how to secure the tow line to the bow- picker. Both rejected the option of running the line through the scuppers (a drainage opening cut through the side of a ship, usually flush with the deck) and securing the end of the tow line to the deck cleats, because the deck cleats were deteriorating and the scuppers were raw fiberglass which could abrade the tow line. They decided to connect the line to the gillnet reel and then feed it over the bow rollers of the bowpicker (Figure 1).

Another factor affecting vessel stability in this incident was the point at which the tow line was attached to the bowpicker. A bowpicker is built in such a way that when it is in transit the bow is positioned several feet higher than the stern. However, when it is in a resting position, the bow is positioned lower, with only 4 feet of freeboard. It is, therefore, imperative when the vessel is being towed, that the attachment point be as low and as close to the centerline of the towed vessel as possible, to approximate the normal running presentation of the bow to the water. The tow line, in this instance, was attached to the gillnet reel and then lead over the bow rollers (Figure 1). This attachment point was too high and too far back for this type of vessel. A more appropriate way of securing the tow line would have involved threading the line through the scuppers and then attaching it to the deck cleats. However, the skippers on both vessels were not comfortable with this arrangement because of the condition of the deck cleats and scuppers. The cleats were very worn and weathered and the scuppers were raw fiberglass, which they felt would cut the tow line. Bowpickers now being built are equipped with an eyelet low on the bow for towing purposes.

Individuals on both vessels were unaware of the possible stability problems of attaching the tow line too high and too far back on the bowpicker. Other instances of near capsizings of bowpickers under tow have been reported to the USCG, although none have resulted in a fatality.

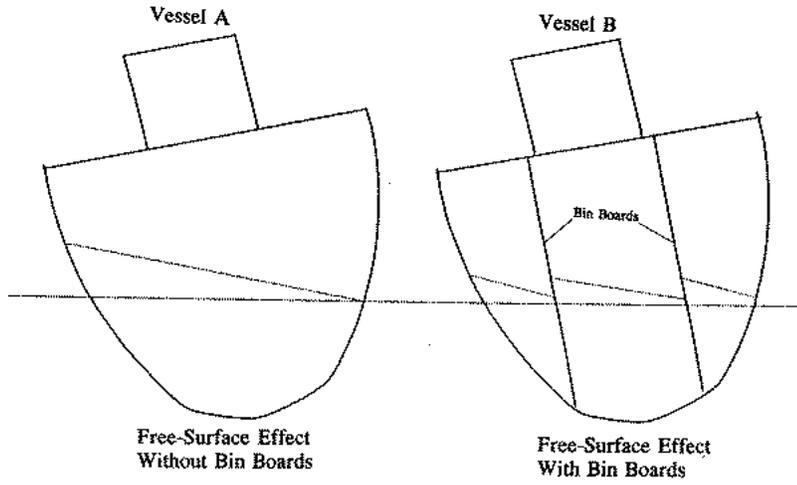
Figure 2. Use of Bin Boards to Decrease Free-Surface Effect

The bowpicker (a gillnetter that retrieves nets from the bow as opposed to the stern of a vessel) was carrying a partial load, of salmon and slush ice, weighing an estimated 1,000 pounds. The fish hold was not "topped off" with water; this results in a condition known as a "free-surface effect." A free-surface effect describes the motion of a liquid in a partially filled tank or compartment. As a vessel rolls to one side, the liquid's center of gravity shifts toward the low side. Consequently the vessel's center of gravity rises on the high side and adds to the transverse heeling moment (the amount of time it takes the vessel to sway back into an upright position after being affected by a wave), which tends to roll the vessel further than if the tank or compartment had no free-surface (National Transportation Safety Board, 1991).

Discussion: One stability factor in this incident was that the fish hold of the bowpicker was partially loaded with an estimated 1,000 pounds of salmon and slush ice. However, this hold was not "topped off," causing a free-surface effect that may have contributed to the capsizing of the bowpicker. As defined earlier, free-surface effect describes the motion of a liquid in a partially filled tank or compartment.

One potential solution to the problem of the free-surface effect would be to insert bin boards into fish holds. Bin boards limit both the mass of water and the distance of movement of liquid, thereby decreasing the free-surface effect. Free surface effect is measured by cubing the width of a container or hold. For example, in [Figure 2](#), if vessel A's fish hold width is 9 feet, then the free-surface effect is 729 cubic feet (9 by 9 by 9). But when two bin boards are inserted in vessel B to create three separate fish holds, the free-surface effect for each hold is 27 cubic feet (3 by 3 by 3) and a total of 81 cubic feet for the three holds. The addition of the bin boards reduces the free-surface effect by 89% (Alaska Marine Safety Education Association [1993]).
