Line Mechanic Dies After Falling From Aerial Bucket Truck – Virginia

FACE 9235

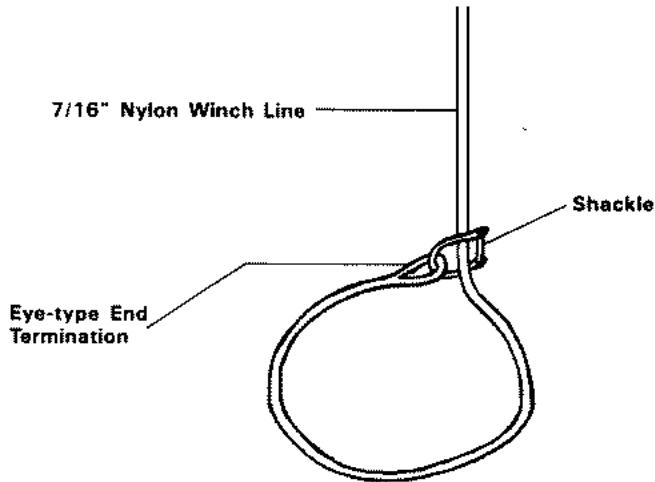
Figure: Choker Hitch

The victim, without wearing the fall protection equipment provided (a safety belt and lanyard secured to a boom anchor point adjacent to the man-bucket), entered the bucket and positioned the end of the truck boom next to the tree limb. Instead of following company procedure and using a sling, he passed the end of the 7/16-inch woven nylon winch line around the limb and formed a choker hitch by attaching the line's eye-type end termination to the line with a shackle ([Figure](#)), and attempted to lift the partially split limb (using the winch).

Discussion: The winch line, a 7/16-inch woven nylon rope, had been attached to the tree limb as a choker by looping the line around the limb. The loop was closed by connecting the eye of the end termination to the line with a shackle. This method of rigging may have jeopardized the strength of the rope by concentrating excessive rope stresses at the point where the end termination was connected to the line, or by severing the rope fibers through contact with metal fittings (shackles). Either of these conditions could effectively decrease the working capacity of the rope and cause it to fail suddenly. The rope had a manufacturer's rated working capacity of 1,500 pounds and a breaking strength of 7,500 pounds. However, because of the sharp bends in a rope rigged in a choker hitch, the working capacity of a rope can be reduced by 30%. After the incident, the employer load tested the remaining line to 3,000 pounds without damage. The employer's standard operating procedures prohibit the use of winch lines for loads over 1,000 pounds, and require the use of separate slings appropriate for the type of lift being performed. Use of fabricated slings allows the selection of rope sizes larger than the winch line, thereby compensating for the decrease in effective strength from rigging in a choker hitch. Larger size ropes also decrease the severity of the rope bends used in fashioning a choker hitch, further protecting the integrity of the rope. It is not known what load the rope experienced on the day of the incident. The tree limb was 9 inches in diameter at the base, tapering to 6 inches in diameter at the end of its 15 foot length not including the minor branches. It is estimated that the limb weighed 200 pounds. Since the tree limb was only partially split from the tree trunk, it is possible that, because of the location of the winch line attachment to the limb and the angle of the pull, the victim was unintentionally attempting to lift the entire tree, not just the limb. If this was the case, then the winch line would have been subjected not only to the weight of the tree, but also to the resistance of the tree roots. This could have significantly overloaded the winch line, resulting in failure.

Recommendation #3: Employers should ensure that safe work procedures address the manner in which load lines of hoisting equipment are attached to the load so that the full strength of the load line is available and the lifting capacity of the equipment is not exceeded.
