Warehouse Supervisor Dies After Being Caught Between a Pallet Stacking Machine and a Storage Rack Support—Virginia

FACE 9226

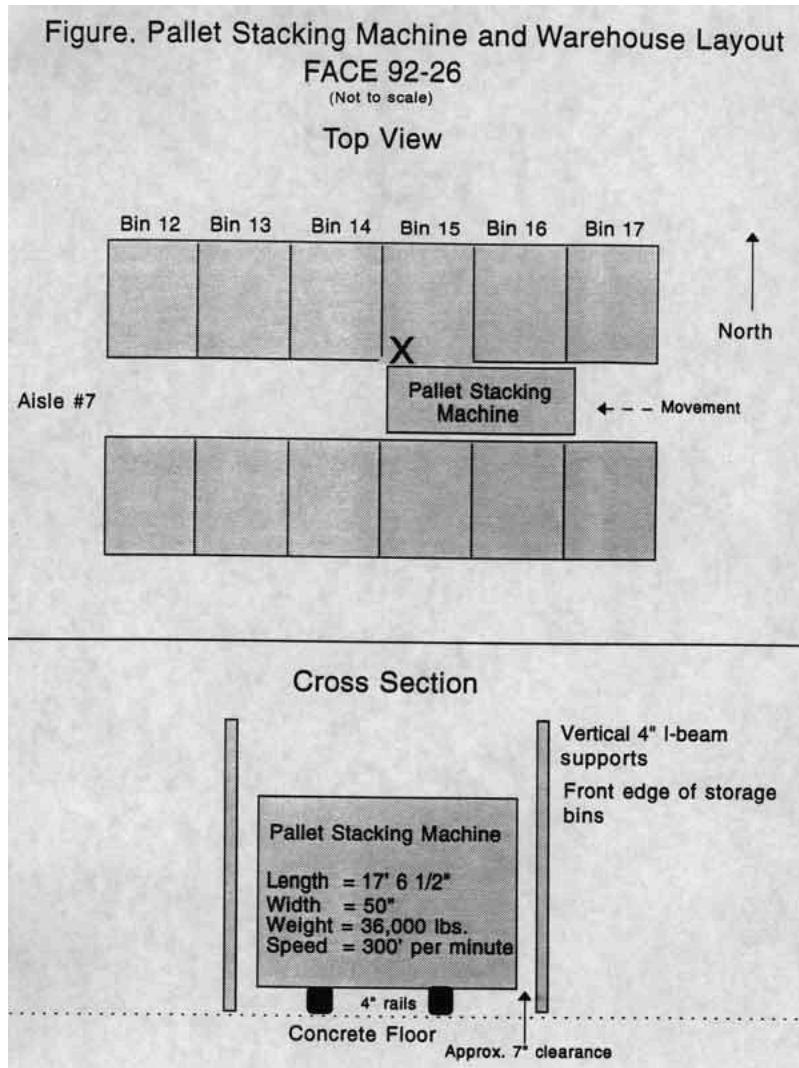
Although the incident was unwitnessed, evidence suggests that the victim had proceeded down aisle number 7 to an area around bin number 15 (Figure). At that area, the bin was arranged such that a person could stand in the bin area while the stacking machine passed by. The victim may have noticed that cigarettes had spilled out onto the floor and had stopped to pick them up; alternatively, he may have been in the area checking product inventory. At about 11:30 a.m., the victim apparently had his back turned toward the approaching stacking machine when it struck and crushed him between the stacking machine's frame and a vertical 4-inch I-beam storage rack support. The body was dragged several feet until some part of the victim's body contacted the bumper, causing the machine to stop. A co-worker traveling through the area noticed the body around 12:05 p.m. and activated the plant's internal emergency response system. When emergency service personnel arrived, they determined that nothing could be done for the victim and contacted the medical examiner. The medical examiner arrived about 70 minutes after the incident and pronounced the victim dead at the scene.

Recommendation #2: Employers should consider the installation of stationary travel warning lights and redesign of the stacking machine pressure-sensitive stop bumpers.

Discussion: Although the pallet stacking machine was equipped with green travel warning lights and pressure-sensitive stop bumpers located on the front and rear ends of the machine, the incident still occurred. The warning lights may be effective when an employee is facing the machine, but in this incident the victim had his back turned toward the machine, apparently did not hear its approach and was struck and killed. Engineers should consider the installation of stationary travel warning lights at conspicuous areas within the aisles, and analyze their effectiveness. Any time the machine is in operation, the stationary travel warning lights would illuminate to warn any worker in the area that the machine is in operation and to be alert to its location and movement. Further, the pressure-sensitive stop bumpers located on the front and rear ends of the machine, could only be activated by direct forward or rearward pressure on the bumpers. An object which was positioned laterally, or adjacent to the direct line of travel of the machine, would not engage the bumpers and stop the machine. Various sets of circumstances would allow the bumpers to miss contact with an object, yet still allow the moving machinery to crush an object or person positioned adjacent to the direct line of travel. In this incident, the victim was in such a position and at a location within the aisles (bin number 15), that the bumper missed the victim. The machine continued its travel, struck the victim, causing his death. Engineers should consider redesigning the pressure-sensitive stop bumpers to such a degree that an object located laterally, or adjacent to the machine, would contact the bumper causing it to stop.
