Electrician Electrocuted After Contacting Energized Conductor While Working From the Bucket of an Aerial Lift Truck—Virginia

FACE 92-25

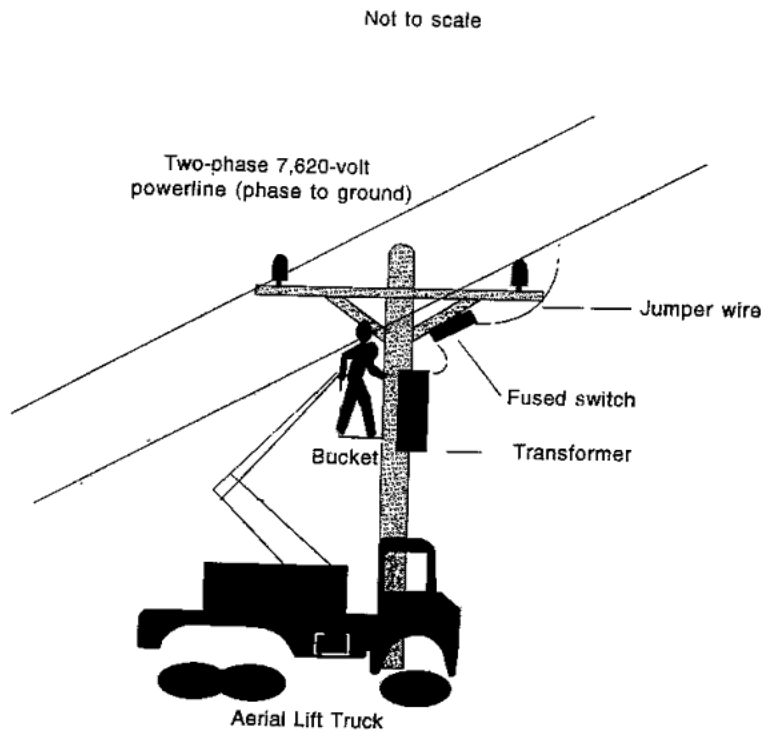
On the morning of the incident, two workers (the victim and his co-worker), arrived at the work site to continue replacing switches. Five switches had been replaced the day before and work was to be performed on the sixth switch. It was determined that the victim would work from the bucket of the aerial lift truck (a double bucket Pitman Uni/dyne aerial lift mounted on a 1982 GMC Truck) while he replaced the switches and the co-worker would remain on the ground performing other tasks. The victim positioned himself in the bucket and maneuvered the bucket adjacent to the powerline in proximity to the switch. He used a "hot stick" to disconnect the jumper wire from the switch to the powerline, stopping the flow of electricity from the powerline to the switch and transformer. Without donning personal protective equipment (PPE) or covering the powerlines with insulating line sleeves or blankets, he removed one of the bolts securing the switch to the crossarm as the co-worker watched from the ground. At that time the company owner arrived and began a conversation with the co-worker. As the victim either began to remove another bolt or tried to reposition the bucket, he contacted the powerline (Figure). While the owner and co-worker were talking, they heard an arcing and popping sound, and looked up to see the victim slump down into the bucket. The company owner immediately jumped onto the truck and used the controls mounted on the pedestal to lower the bucket while the co-worker called 911 for assistance. The paramedics arrived within 6 minutes and determined the victim had died. The medical examiner was notified and he directed the paramedics to transport the body to a local mortuary.

Figure. Worker Contacting Overhead Powerline

Recommendation #1: Employers should require that workers wear appropriate personal protective equipment when they are exposed to hazardous conditions and ensure that energized powerlines are insulated or guarded before work is performed on or near them.

Discussion: 29 CFR 1926.28 (a) states "The employer is responsible for requiring the wearing of appropriate personal protective equipment in all operations where there is an exposure to hazardous conditions or where this part indicates the need for using such equipment to reduce the hazards to the employees." Also, 29 CFR 1926.950 (c)(1)(ii) states "The energized part is insulated or guarded from him and any other conductive object at a different potential." Work was being performed from an aerial lift truck bucket near energized, unguarded or insulated powerlines and appropriate PPE was not being worn. The rubber gloves, sleeves, and line hoses used for this type of work were later found in the aerial bucket and bins of the truck.
