Electrical Contracting Company Line Mechanic Electrocuted After Contacting Energized Conductor While Working From an Aerial Bucket—Virginia

FACE 92-01

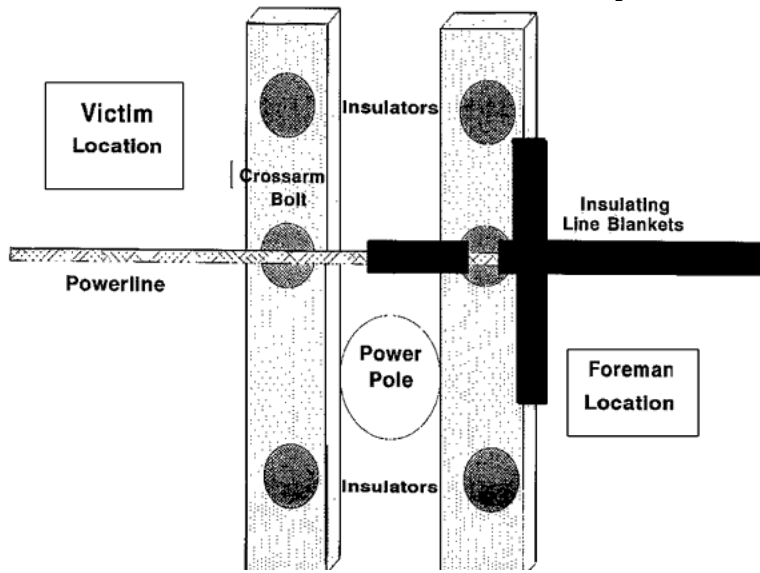
Figure.

The trucks were positioned in a manner that would allow work to be performed on both sides of the crossarm. The victim and foreman could then attach the energized conductors to the insulators on their respective sides of the crossarm (Figure).
