Electrical Technician Electrocuted after Contacting a 800-volt Conductor in South Carolina

FACE 92-07

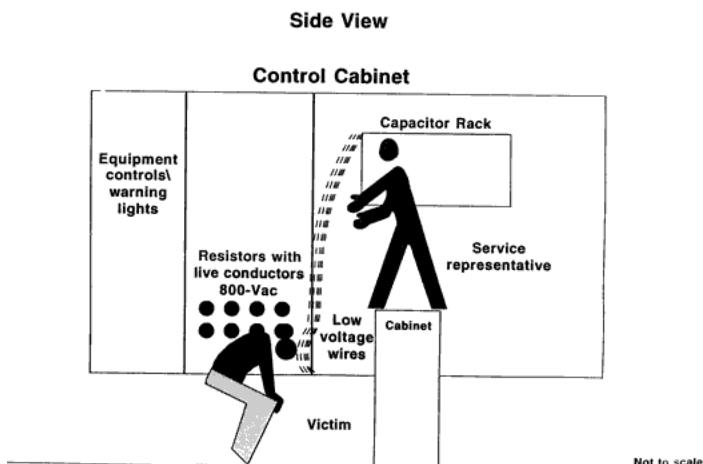
Figure. Mini-Comp System

The high-temperature, steel-alloy rolling mill was in the start-up mode at the time of the incident. The plant's buildings had been erected, rolling machines and all related equipment had been installed, and the employees were in the process of testing all equipment prior to the actual start-up of the rolling mill. On the day of the incident, the victim had been instructed to meet with and assist a service representative from the company that manufactured a piece of voltage regulating equipment. The equipment (a Mini-Comp system) was being used to control voltage surges and regulate voltages to different pieces of equipment throughout the plant (Figure).

On the day of the incident, the victim met the service representative and proceeded to the building within the plant that contained the Mini-Comp system. The two men discussed what had to be done, then began checking the voltages on the low-voltage (15-volts) wiring from the Mini-Comp system. They determined a problem existed within the equipment, as the correct amount of voltage was not being detected. The victim left the area to get the service manual for the equipment. Without de-energizing the Mini-Comp system, the service representative opened the panel cover on the system's control cabinet in preparation to trace out the low-voltage wires in question. The wires were not color-coded. He then climbed onto the compartment adjacent to the capacitor rack in order to view the wiring.

At that time the victim returned, kneeled in front of the opened control cabinet, and positioned his head and shoulders inside the 800-volt resistor compartment. As he began tugging on the wires inside the compartment, he was told by the service representative to be careful around the conductors. The service representative was watching to see which wire moved when he heard the victim making a gurgling noise. When he looked down he saw the victim shaking as though he were being shocked. He jumped down from the cabinet and although receiving a shock himself, knocked the victim away from contact with the energized conductor.

Recommendation #3: Voltage regulating equipment should be wired with color-coded conductors.

Discussion: The victim was in the process of trying to identify non-color-coded wiring in the regulating unit when he contacted an energized conductor and was electrocuted. Color-coded insulation covering the wiring is unique to specific conductors, and can be readily identified and separated from all others in the same wiring harness or conduit. Voltage regulating equipment should be designed and manufactured with unique color-coded conductors for each separate circuit in the cabinet or compartment of electrical equipment. Also, electrical equipment purchase orders should require voltage regulating equipment conductors be color-coded, and electrical equipment deliveries should be inspected for compliance before delivery acceptance and before equipment installation.
