# Rofer Helper Dies Following a 22-foot Fall Through a Roof Opening in Virginia

FACE 9203

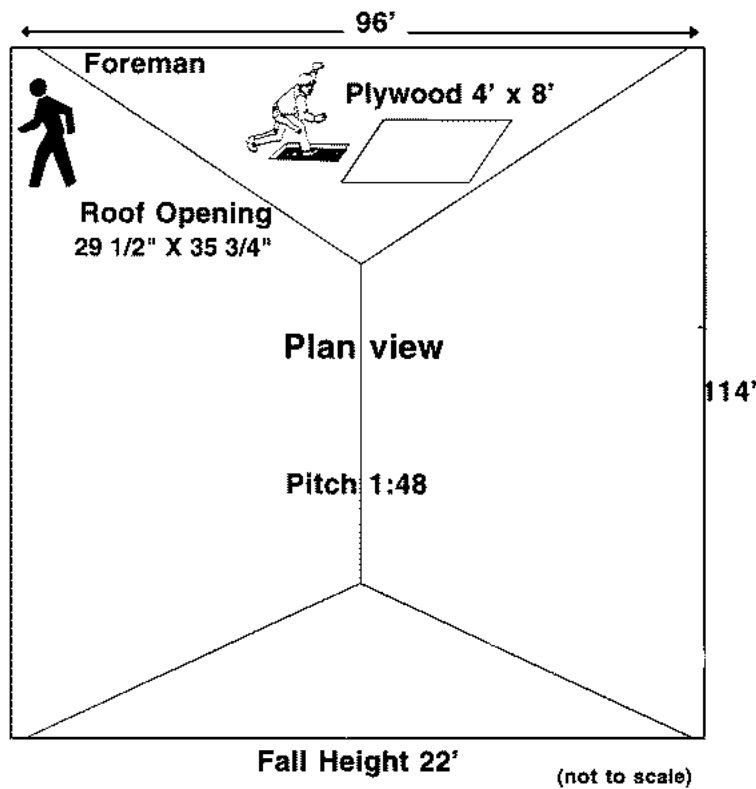
### Figure. Roof Opening (FACE 92-03)

A roofing and sheet metal contractor had been subcontracted to provide and install roofing materials on an addition to the gymnasium at a middle school. Work had been intermittent for about 1 year prior to the incident. At the time of the incident, corrugated roofing panels had been secured to the roof deck, and weather insulating strips were being applied over the panels. The roof area was approximately 114 feet long by 96 feet wide, and contained one roof hatch opening 292-inches wide by 35-inches long. The opening was covered by a 4-foot-wide by 8-foot-long sheet of e-inch-thick plywood. The roof had a 1:48 pitch (i.e., the roof rose 1 foot for every 48 feet) (Figure).

Discussion: Although the one remaining roof opening was covered with a 4-foot-wide by 8-foot-long by e-inch-thick piece of plywood, the plywood was not secured to prevent inadvertent displacement. Since the incident was unwitnessed, a determination could not be made as to whether the victim intentionally or unintentionally moved the plywood. Securing the plywood properly would have eliminated any unintentional movement. Employers should ensure that all roof openings which have the potential of becoming hazards during construction, be safeguarded in one of the following manners: The roof opening should be secured with a standard railing and toe-boards on all exposed sides, or with a cover capable of supporting a worker’s weight without danger of displacement.

**Recommendation #1: Employers should implement 29 CFR 1926.500 (b) and 1926.500 (f)(5)(ii), which require that floor openings be guarded by a standard railing and toe-boards, or a cover capable of supporting the maximum intended load, and so installed as to prevent accidental displacement.<sup>(1)</sup>**
