# Assistant Manager at Ice Rink Asphyxiated by an Oxygen-Deficient Atmosphere – Alaska

FACE 9113

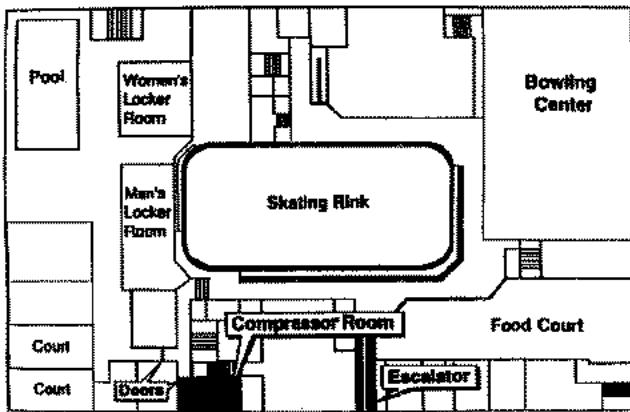
**FACE 91-13**  
**Figure**

There were no eyewitnesses to several contributory events preceding the incident; however, evidence, calculations, and investigative examination suggest the following sequence of events ([Figure](#)).

Sometime during the 2 days before the incident, someone had attempted to stop a pinhole-sized leak in the filter flange pipe by tightening the pipe with a wrench. This caused a section of pipe to break off, and produced a much larger leak. Someone then plugged this leak by driving a makeshift plastic plug into the flange hole and sealing it with a putty-like material.
