**SUBJECT:** A crane oiler dies when crushed between the counterweights and the rotating superstructure of a mobile crane.

**SUMMARY**  
**California FACE Report #04CA003**

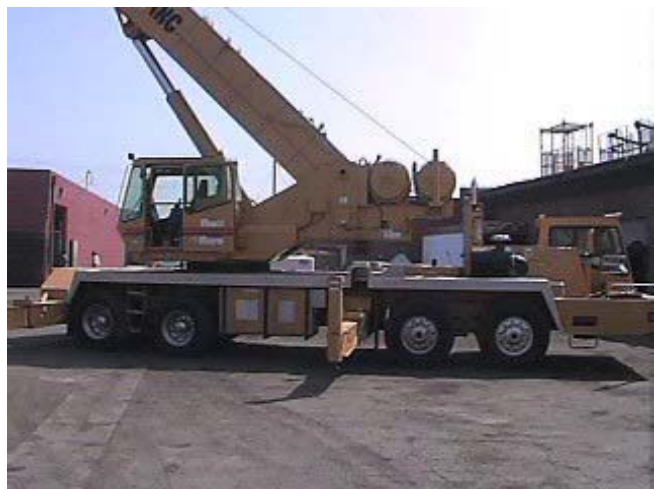
Exhibit 1. The mobile crane involved in the incident.

The site of the incident was a construction site of a commercial business. The machine involved in the incident was a mobile crane (**Exhibit 1**) that was hired to move concrete blocks at the construction site. After the crane arrived at the job site, the crane operator and victim did a job site evaluation to determine the amount of counterweights needed to perform the lifts. The adjustments to the counterweights were made using the crane hook. After the proper amount of counterweights were in place, the crane needed to turn around to attach the counterweights to the crane base. The operator and victim made eye contact as they did many times in the past, then the operator turned his attention to the controls of the crane as he began rotating the crane around. The victim, according to the crane operator, would then sit on or stand next to the crane's right front outrigger and signal the operator once the crane and the counterweights were aligned. As the crane operator swung the crane around, he heard an unfamiliar noise and when he looked to the rear he saw the victim caught between the counterweights and the base of the crane. The operator got out of his cab to check on the victim, then went back to the cab to move the crane off of him. He lifted and carried the victim from the crane and placed him on the ground, then ran to get help.

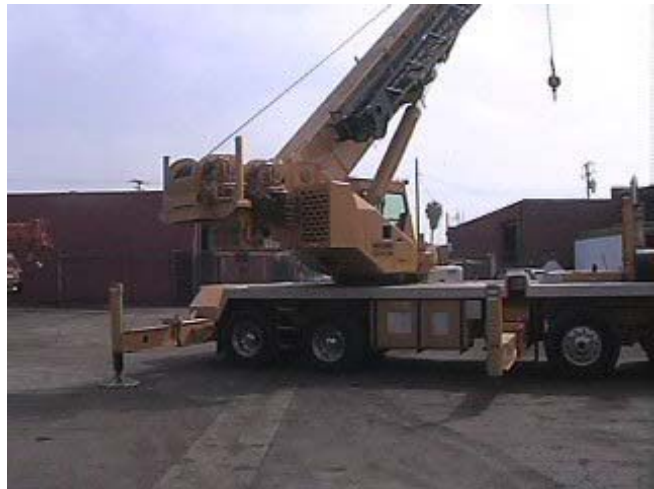
Exhibit 2. The truck-mounted crane rotating into position, depicting the blind spot for the operator.

After the proper amount of counterweights were in place, the crane needed to turn around to attach the counterweights to the crane base. The operator and victim made eye contact as they did many times in the past, then the operator turned his attention to the controls of the crane as he began rotating the crane around. The victim, according to the crane operator, would then sit on or stand next to the crane's right front outrigger and signal the operator once the crane and the counterweights were aligned. As the crane operator swung the crane around, he heard an unfamiliar noise and when he looked to the rear he saw the victim caught between the counterweights and the base of the crane. The operator got out of his cab to check on the victim, then went back to the cab to move the crane off of him. He lifted and carried the victim from the crane and placed him on the ground, then ran to get help.

Discussion: Most truck mounted cranes do not have mirrors on the crane’s operating cab because the operator’s attention is usually focused on the hook and boom which is always in front of or above the cab and never in the rear. However, when the focus of the operation is not on the hook and boom, then consideration should be given to where the operator’s attention is focused. When rotating the crane for counterweight alignment, it might be beneficial to have mirrors or other devices that allow the operator to see the rear of the crane. This would allow the operator to take immediate evasive action when necessary.

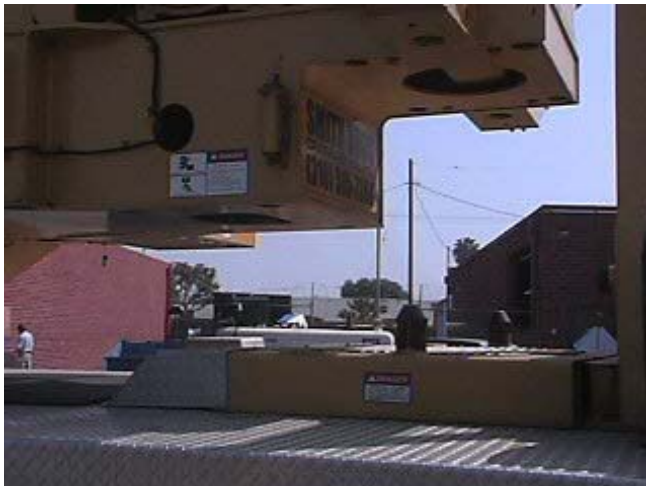
Exhibit 3. The base where counterweights are placed in order to be attached to the crane.

Paramedics were called and they transported the victim to the hospital where he died two days later as a result of his injuries sustained in this incident. Reconstruction of the incident suggested the victim climbed onto the crane to remove a shackle that was left on top of the counterweights. According to the crane operator the shackle would have interfered with the counterweights' connection to the superstructure.

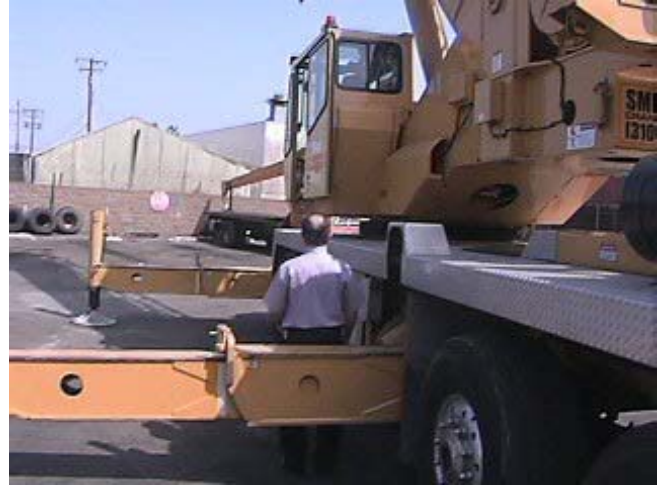
Discussion: The crane operator and victim had worked together for several years, and as a result of their working relationship they developed a habit of rotating the crane while the victim was not clear of the superstructure. As the crane rotates, the operator can not see all the action at the back of the crane because of the blind spots. The crane operator should not start rotating the crane without knowing all personnel are clear of the superstructure either by seeing or some other means. Employees also have a responsibility to stay clear of the crane while it is rotating. Safe work practices can be enhanced through programs of task-specific training, supervision, rewards, and progressive disciplinary measures.

Exhibit 4. A simulated picture depicting the victim's position while the crane rotated into position.

### **Recommendation #1: Ensure all personnel are clear from the counterweight and superstructure area before rotating the crane.**

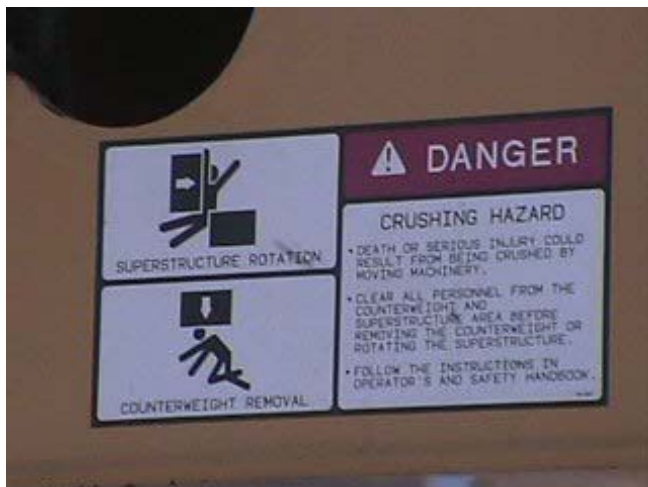
Discussion: The crane operator and victim had worked together on this crane since it was purchased over three years ago. According to the crane operator they always worked well together and did not have to verbally communicate with each other all the time because they just knew what to do at certain times during the crane operation by a simple nod or a glance. In this case, a nod between both parties meant that the crane was going to rotate into position to connect to the counterweights and the victim would assume his usual position as he had done numerous times in the past. This system of communication worked as long as the conditions did not change. When the victim left his usual position and climbed on top of the crane while it was rotating, he failed to communicate his action beforehand to the crane operator. Clear and constant communication could have been maintained through the use of two-way radios or other such devices that are used for signaling purposes.

Exhibit 5. A picture of the safety placard on the crane.

### **Recommendation #2: Ensure there is constant and clear communication between the crane oiler and the crane operator whenever the crane's superstructure is in motion.**
