SUBJECT: A saw operator dies when struck by an aluminum plate that fell from a vacuum crane.

SUMMARY
California FACE Report #04CA002

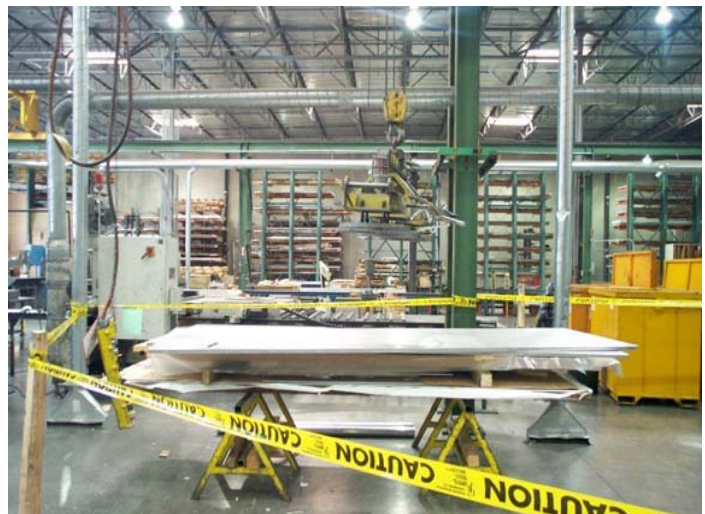
Exhibit 1. The work area where the incident took place.

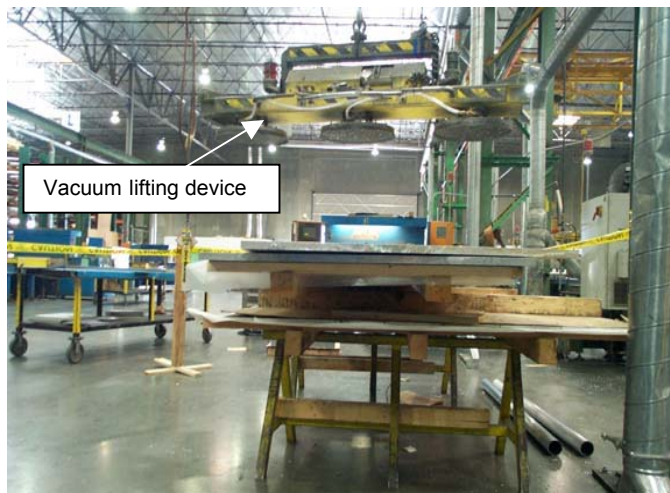
Exhibit 2. The three-cup vacuum lifting device suspended above the aluminum plates.

Discussion: In this particular case, the vacuum lift was wired directly to the crane's main power supply. This meant that every time the crane was shut off, the vacuum lift was also shut off. The crane can still be in use suspending a load with the power shut off, however, in order for the vacuum lift to work properly, it must have power supplied to it at all times during normal operation.

The power source for the vacuum lift attached to the hook of the crane should have had its own power supply.

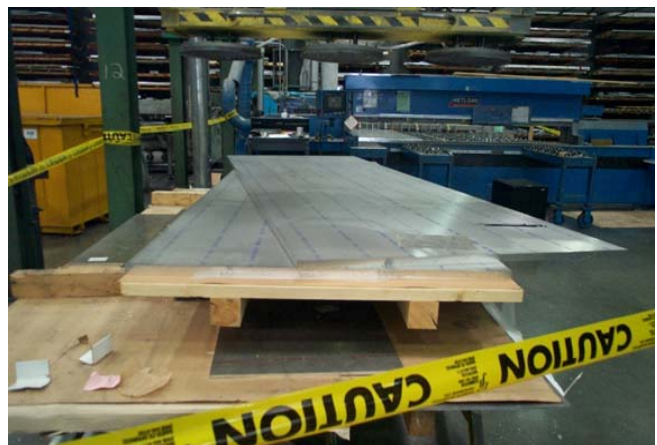
Exhibit 3. The aluminum plates involved in the incident.

The inspection of the incident scene showed two aluminum sheets on a wooden pallet on two metal saw horses directly below the crane hook holding the three-cup suction device. The top aluminum plate was not in line with the bottom plate and had markings on the top of it consistent with the suction cups. On the bottom of the top plate near the edge was a small amount of blood. Safety goggles were stuck between the two aluminum sheets. According to his co-workers, the victim always wore his safety goggles when he was working.

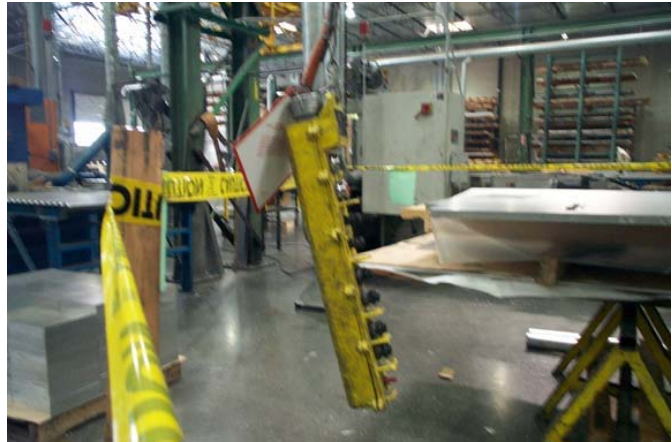
The controls to the crane were inspected and the stop button was depressed. The employer of the victim requested an independent company to test and inspect the overhead crane involved in this incident. A vacuum leak down test was performed to determine how long the suction cups could hold a load after the loss of power. Two tests were performed and the load was held for only 13 seconds and 7 seconds, respectively. Inspection of the crane discovered cracks in the rubber of the suction cups and one suction cup had a cut completely through it. One vacuum hose was found to be defective because of a cut and another one was loose. The inspection also noted the vacuum lift mechanism was tied into the main power cut-off to the crane instead of having a separate power supply. The manufacturers set-up instructions for the vacuum lifting device did not specify a separate power source for the lift. The evidence suggests that the victim was moving an aluminum plate to be cut by the saw. The victim was using the overhead crane with the three-cup suction device attached to the crane hook. When he raised the top aluminum plate the bottom plate shifted. The victim raised the top plate approximately 30 inches from the bottom plate, and then pushed the “off” button on the crane control. He then placed himself underneath the top plate for unknown reasons. With the crane power supply off, the hold on the top plate was lost more quickly than normal, due to the damaged suction cups and defective vacuum lines, and it dropped, striking the victim.

Exhibit 4. The crane controls.

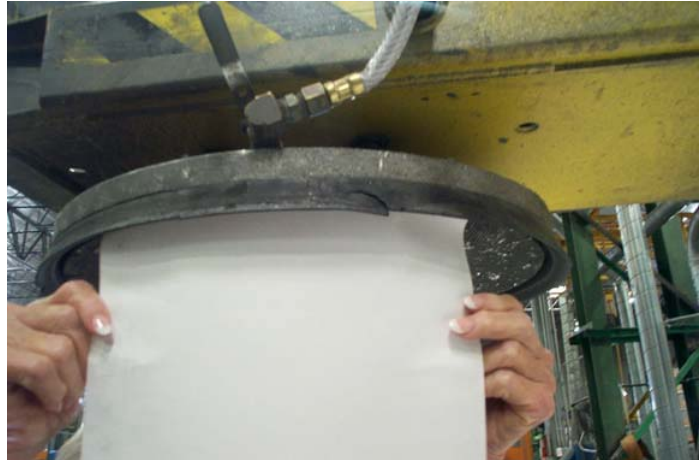
Discussion: The crane involved in this incident had numerous defects which should have rendered it unsafe to use. Scheduled documented maintenance and documented inspections must be performed on all cranes in order to prevent such oversights. When defective equipment is found during the inspection process, it should be removed from service until it can be repaired. Had this crane been properly inspected and maintained, this incident might have been prevented.

Exhibit 5. The damaged suction cup.
