SUBJECT: An automotive mechanic died when the vehicle he was working under slipped off a lift and fell on him.

SUMMARY
California FACE Report #03CA010

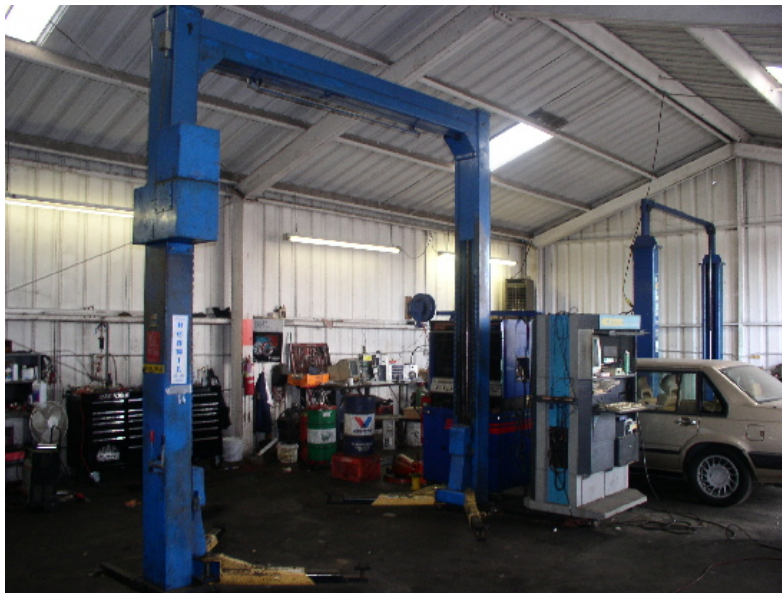
Exhibit #1

The site of the incident was an automotive repair shop which had eight bays and six lifts. The automotive lift involved in this incident was a 2-post, surface-mounted hydraulic lift with a capacity of 7,000 pounds that was manufactured around 1964 (**Exhibits #1, 2, & 3**). The vehicle involved in this incident weighed less than 7,000 pounds. The lifting arms on the lift were the outrigger type that were adjustable to accommodate the vehicle being lifted. The lifts were installed in the shop by the previous owner. The present owner had no manuals or books on the lift involved in this incident.

On the day of the incident, the victim was assigned to do repairs and maintenance on a crew cab pickup truck. The victim drove the vehicle into the bay and then adjusted the extension arms of the lift to accommodate the vehicle. The rear arms were unable to reach the spot where the vehicle manufacturer suggested they be placed in order to lift the vehicle safely. The victim placed the rear extension arms as far back as they could reach, then raised and lowered the vehicle many times throughout the work day depending on what procedure was being performed. As the victim raised the vehicle on the lift for the last time, the left-rear lift arm moved from its original position and was no longer positioned equally with the other arms to support the weight of the vehicle. The rear of the vehicle fell off the lift, and then the front of the vehicle came down, crushing the victim.

A picture of the automotive lift involved in this incident.

Recommendation #2: Ensure the automotive lifts used in the workplace are capable of raising the vehicle safely.

Discussion: The adjustable arms and pads on most automotive lifts are to accommodate the different designs of the many vehicles that might require lifting. The operator of the lift must set the arm in the specific spot under the vehicle, recommended by the vehicle manufacturer, in

order to lift it equally and safely. If the arms cannot be placed in the proper position, then the vehicle should not be lifted. The lift involved in this incident was manufactured around 1964. When it was designed and manufactured, it could accommodate most vehicles on the road at that time. Today manufacturers engineer and design their vehicles to specifications quite different than 40 years ago. In this incident, the manufacturer of the lift was no longer in business. The employer had no manuals to determine what the manufacturer's recommendations were for operation and maintenance. There may have been additional restrictions in the way this lift should have been used which a manual would contain. Although the weight capacity was within limits, in this particular case, the vehicle was too long for the lift to accommodate. Had the victim used a different lift with a longer reach, this incident might have been prevented.

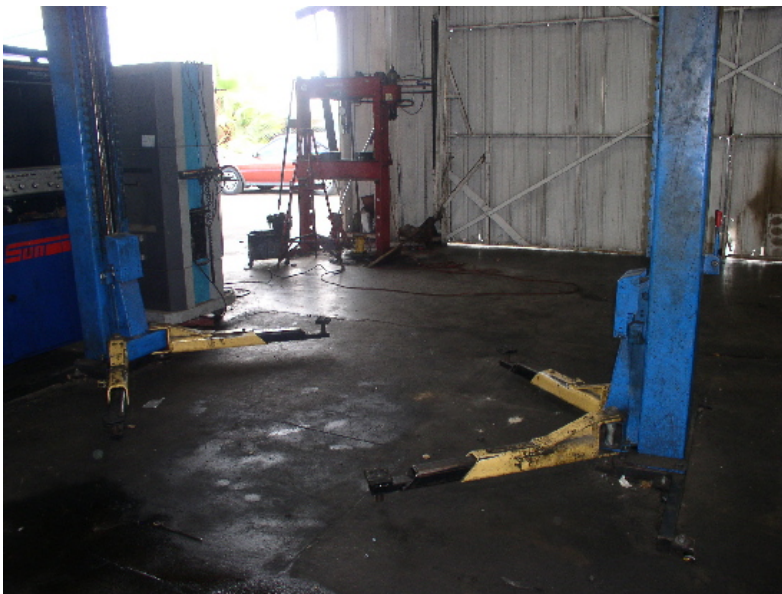
Exhibit #2

A picture of the automotive bay and lift with the adjustable lift arms.

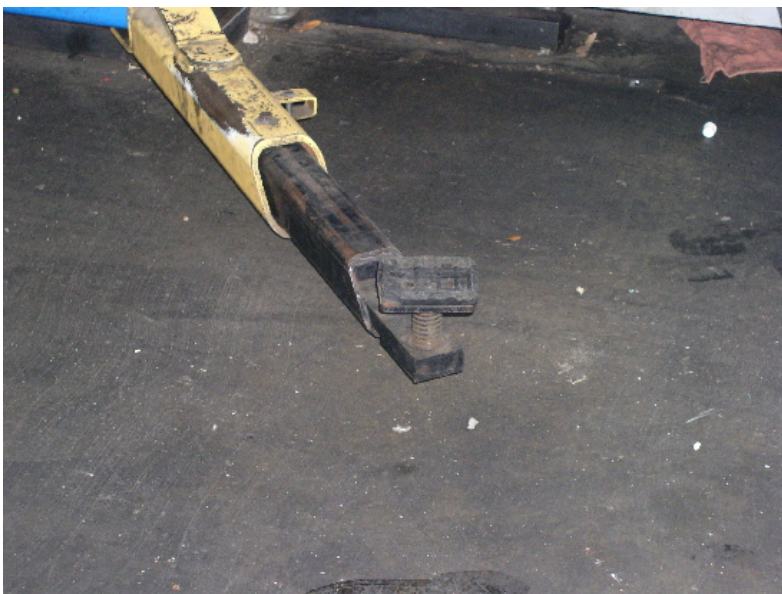
Exhibit #3

A picture of the automotive lift arm with the adjustable pad on the end.
