SUBJECT: A machine operator died when crushed in a plastic injection molding machine.

SUMMARY
California FACE Report #03CA006

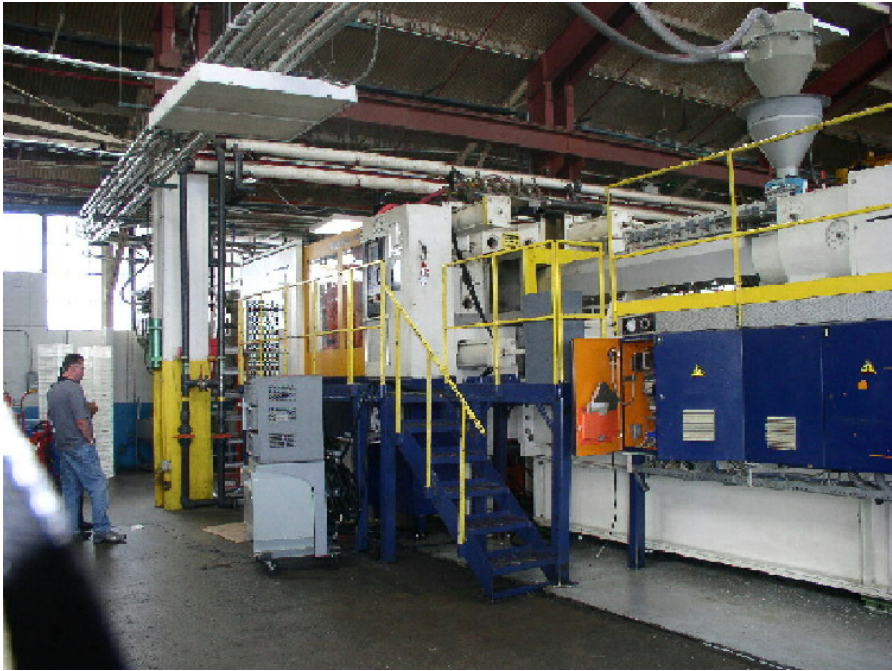
03CA006
Exhibit #1

View of the front side of the plastic injector mold involved in this incident.

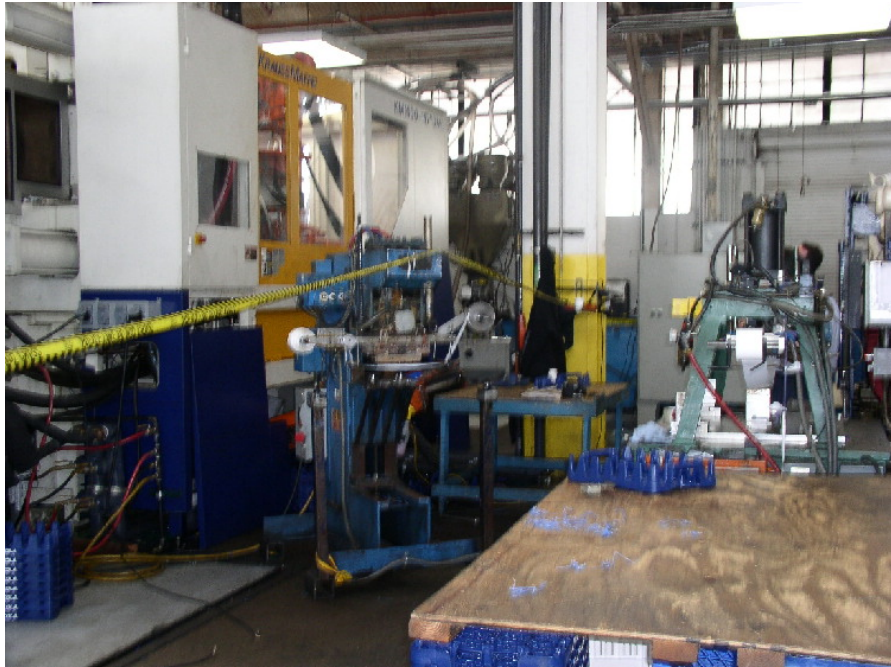
03CA006
Exhibit #2

View of the back side of the plastic injector mold involved in this incident.

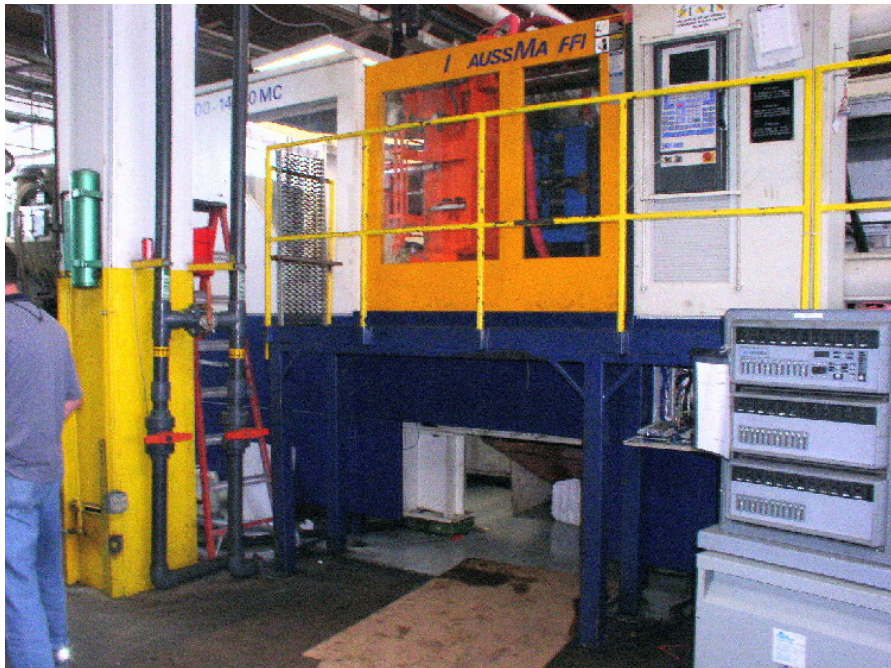
03CA006
Exhibit #3

View of the location where the victim entered inside the injector mold.

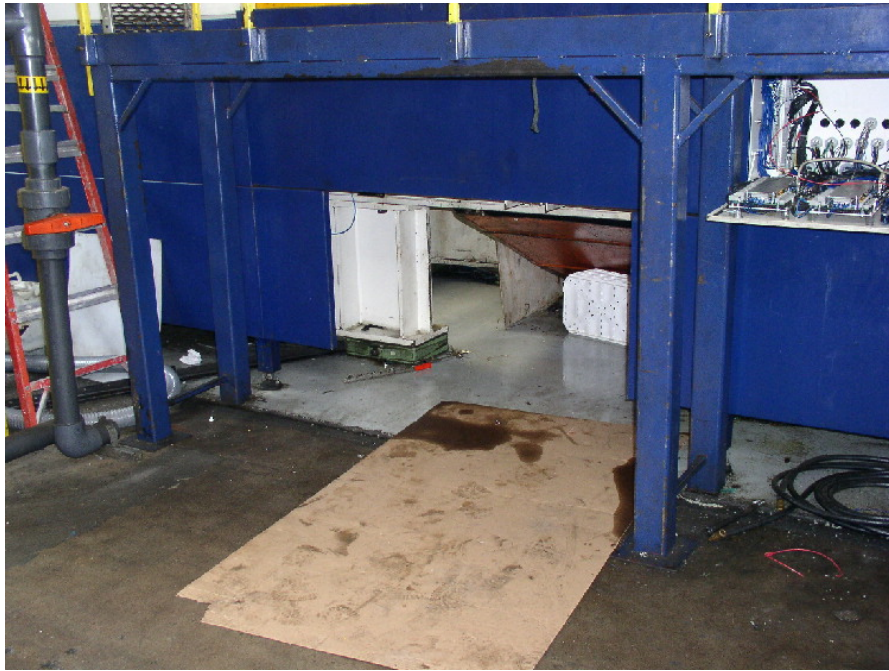
03CA006
Exhibit #4

Investigation of the incident site revealed the victim's tools lying next to the opening in the pedestal where the conveyor belt was located, and several pieces of the machine product laying scattered about the conveyor belt. The guard or shield on the side of the conveyor belt was unbolted on one side. These factors suggest that the victim crawled into the machine from the opening of the conveyor belt not being used. Once inside, he may have attempted to adjust the shield or guard to prevent the product from bouncing off the conveyor belt. Because the area he was in was extremely restrictive (approximately 51" long, 48" wide, and 58" high), he may have tried to stand up when the machine cycled, not realizing that the mobile portion of the mold would cycle backward again. When the machine cycled back, the victim may have been unable to move out of the way and his head got caught between the frame of the pedestal and the frame of the mold.

View of the area where the victim removed the conveyor belt to gain access to inside the injector mold.

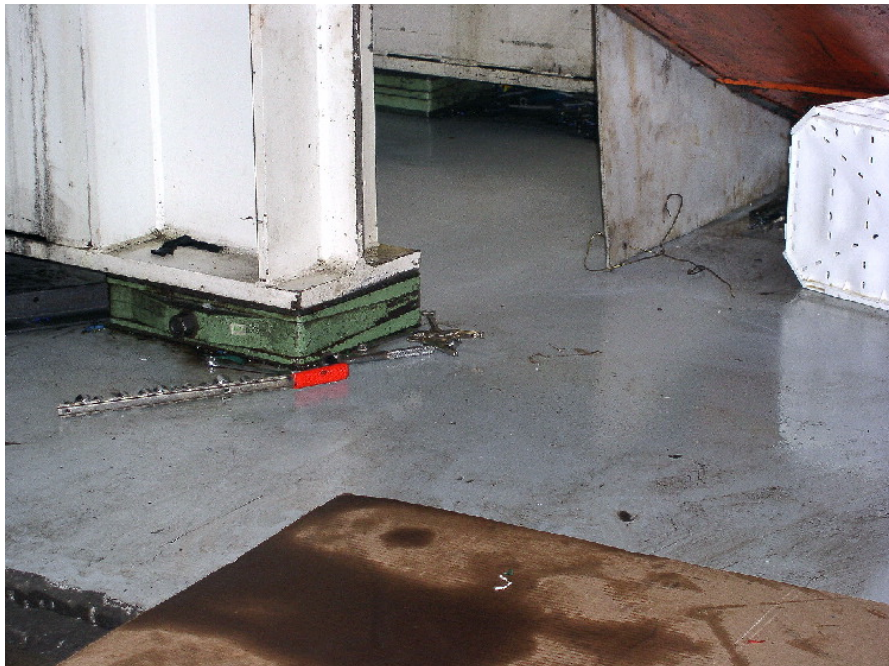
03CA006
Exhibit #5

This is a picture of the victim's tools at the point of entry.

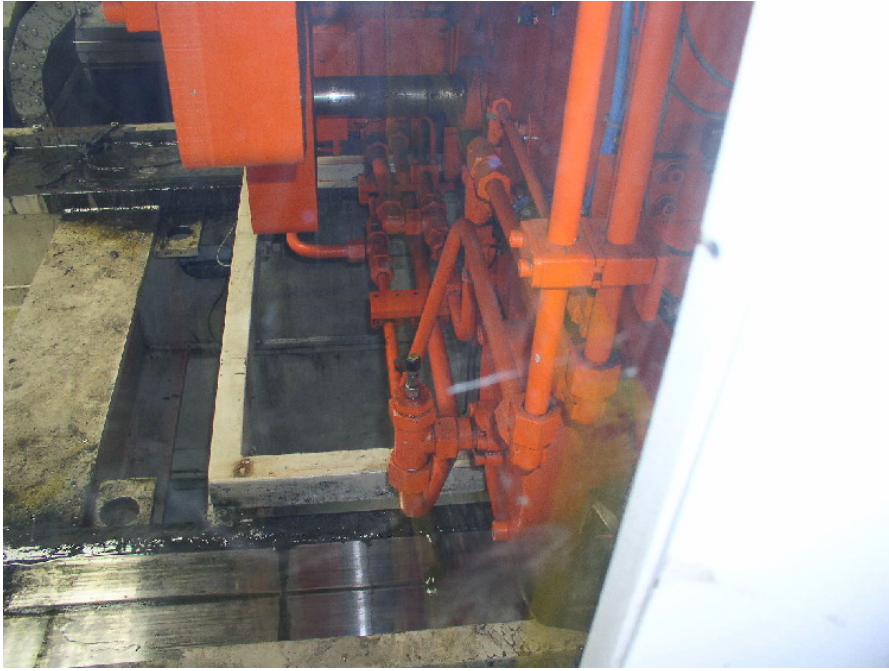
03CA006
Exhibit #6

View of the area where the victim was caught looking from the top down.

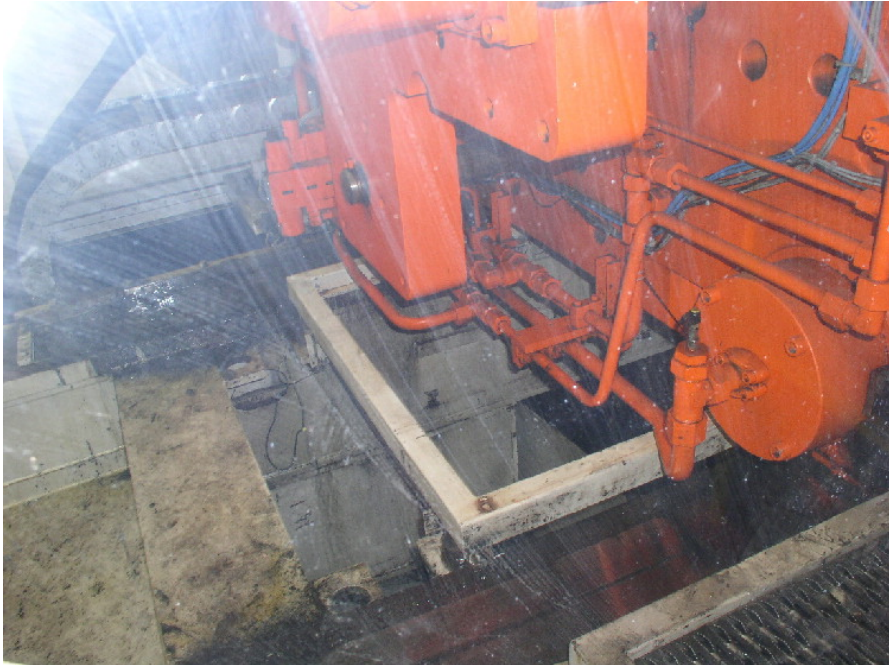
03CA006
Exhibit #7

Another view of the area where the victim was caught looking from the top.

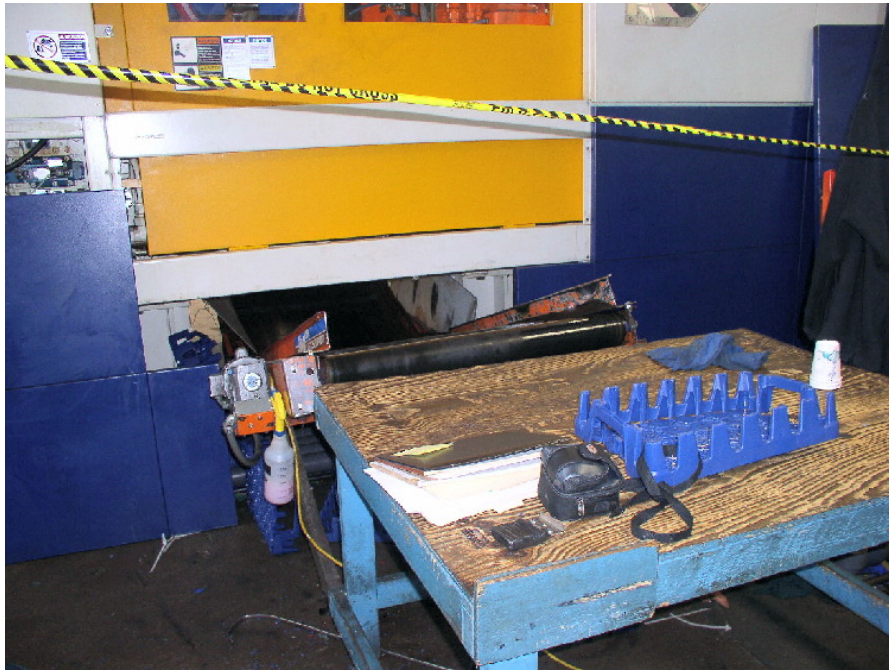
03CA006
Exhibit #8

View of the victim's work area on the back side of the injector mold.

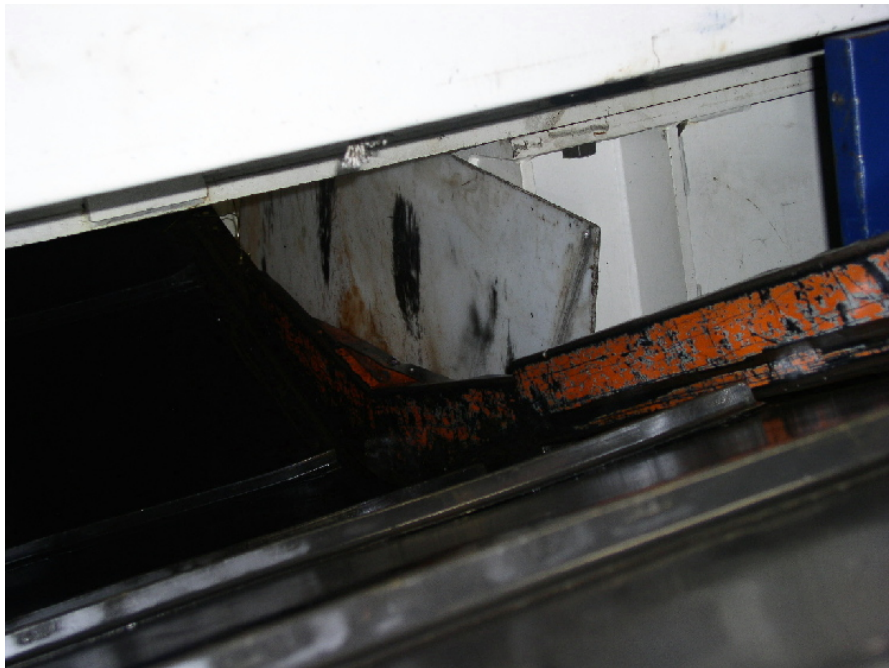
03CA006
Exhibit #9

View of the conveyor belt used to catch and transport freshly molded products.

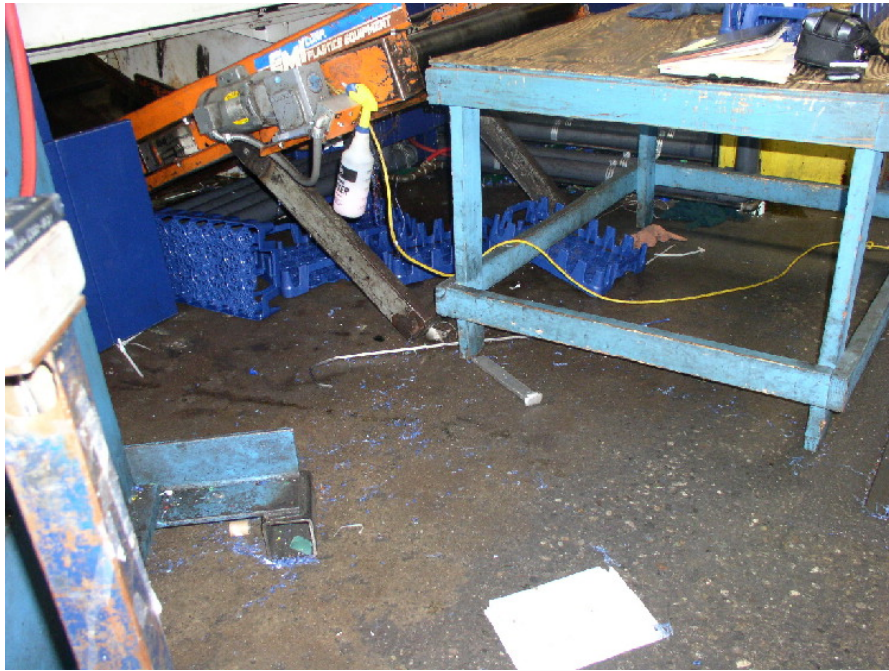
03CA006
Exhibit #10

View of the victim's work station with freshly molded products on floor.

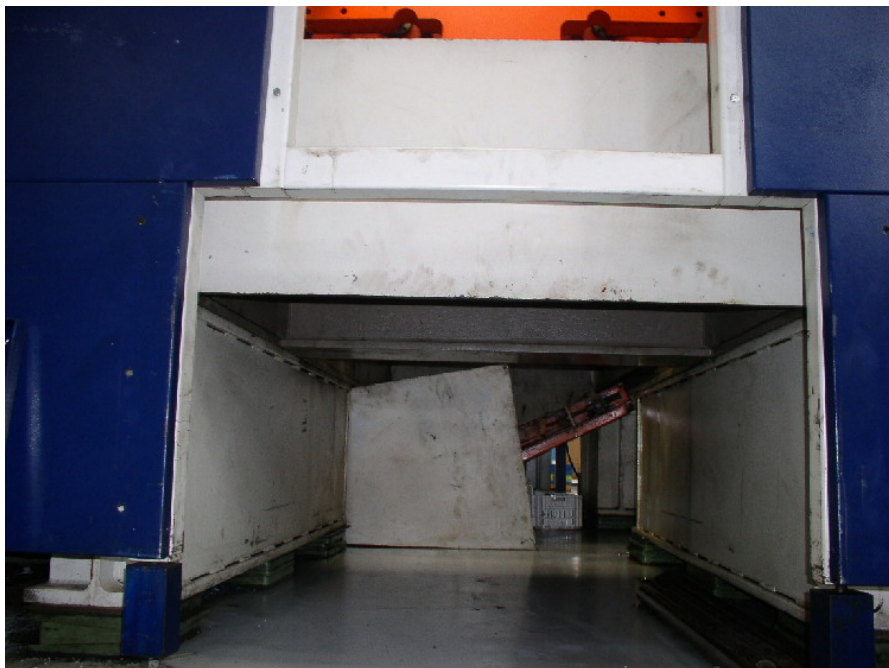
03CA006
Exhibit #11

View of the left side of the injector mold with a panel removed to show where the victim was caught.
