SUBJECT: A machine operator died when caught in a plastic injection molding machine.

SUMMARY
California FACE Report #03CA004

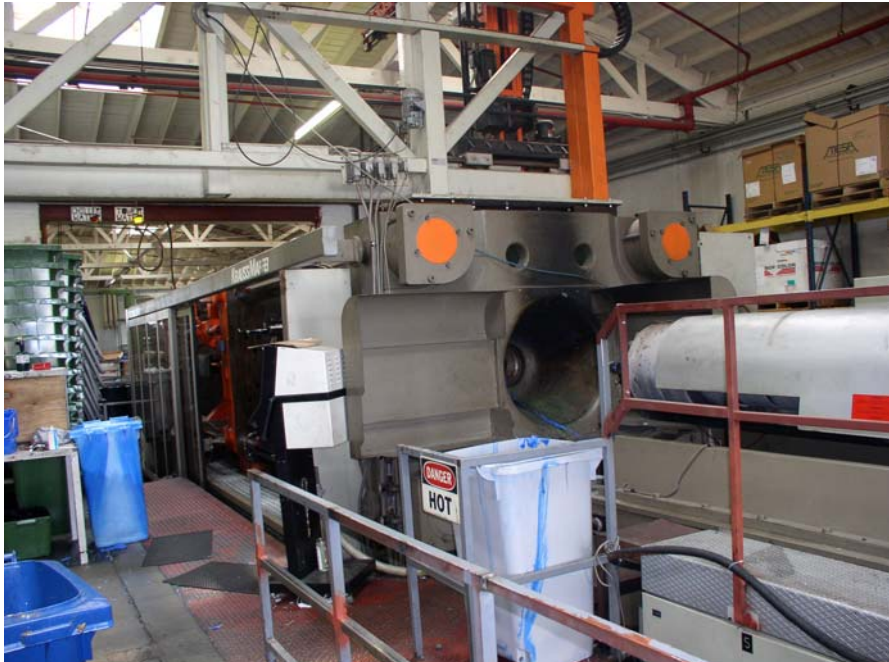
Exhibit #1

View of the plastic injector mold involved in this incident.

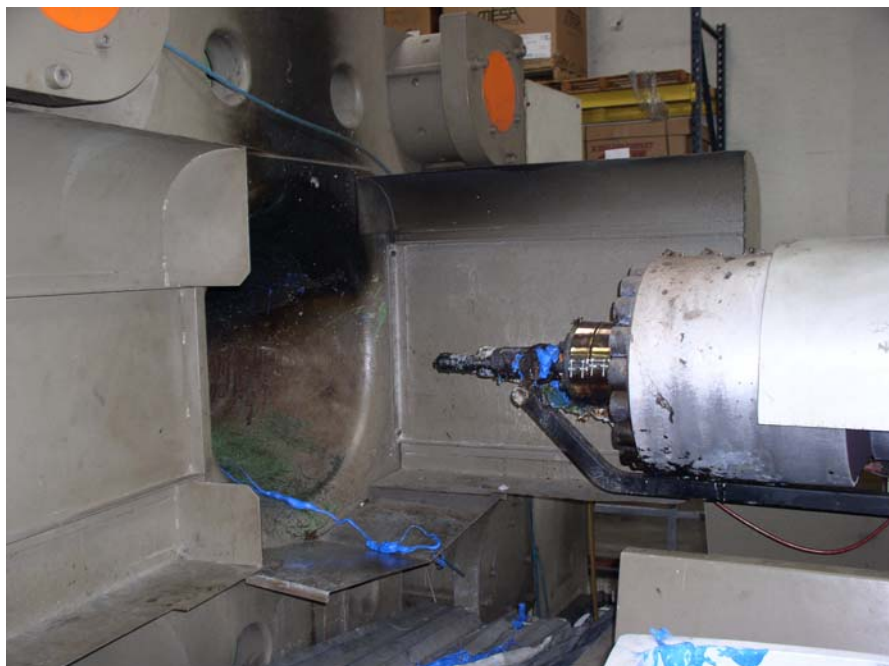
Exhibit #2

View of the area where the victim was caught.

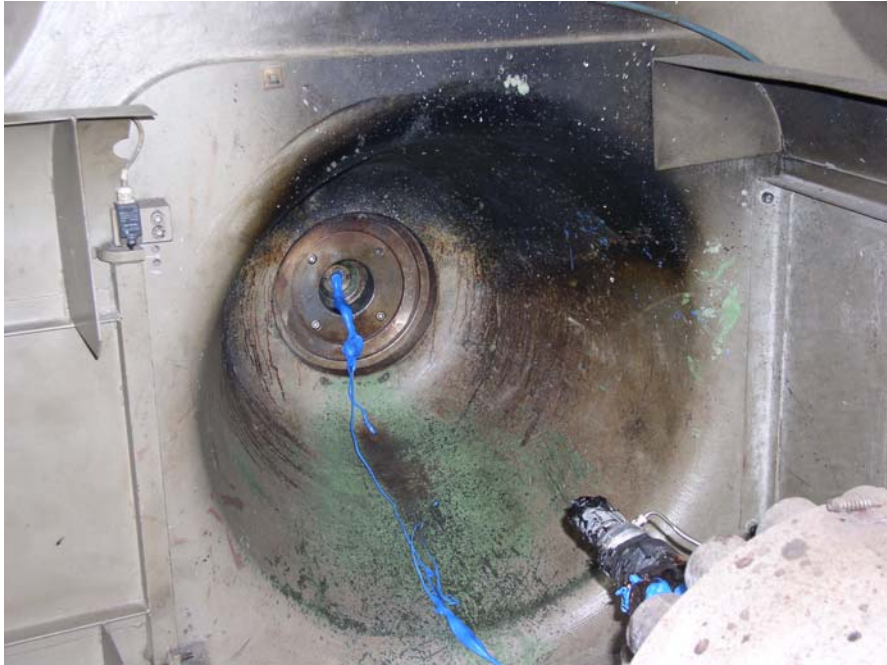
Exhibit #3

Closer view of the area where the victim was caught.

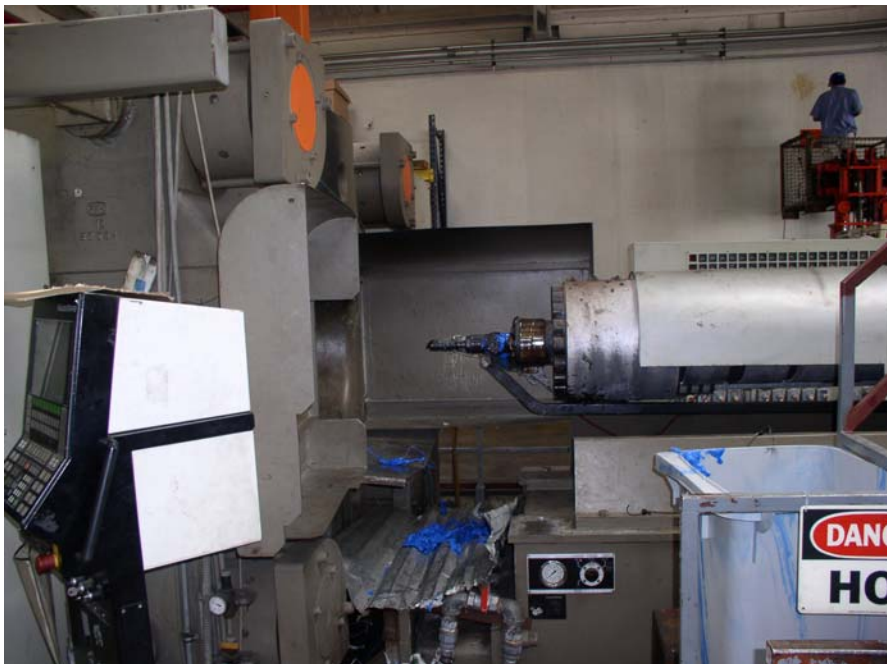
Exhibit #4

View of the injector with the protective shield open.

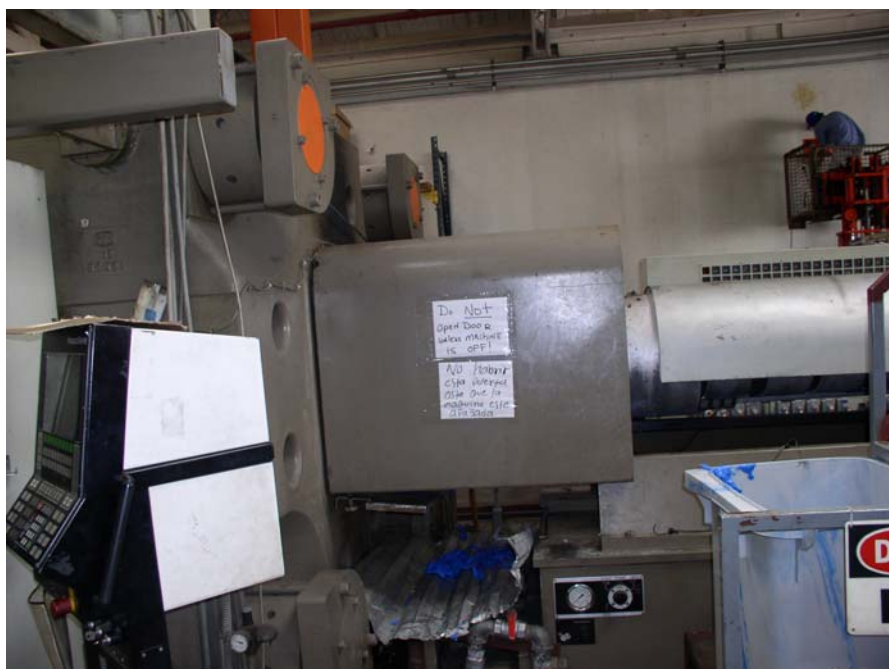
Exhibit #5

View of the injector mold with protective shield in place.

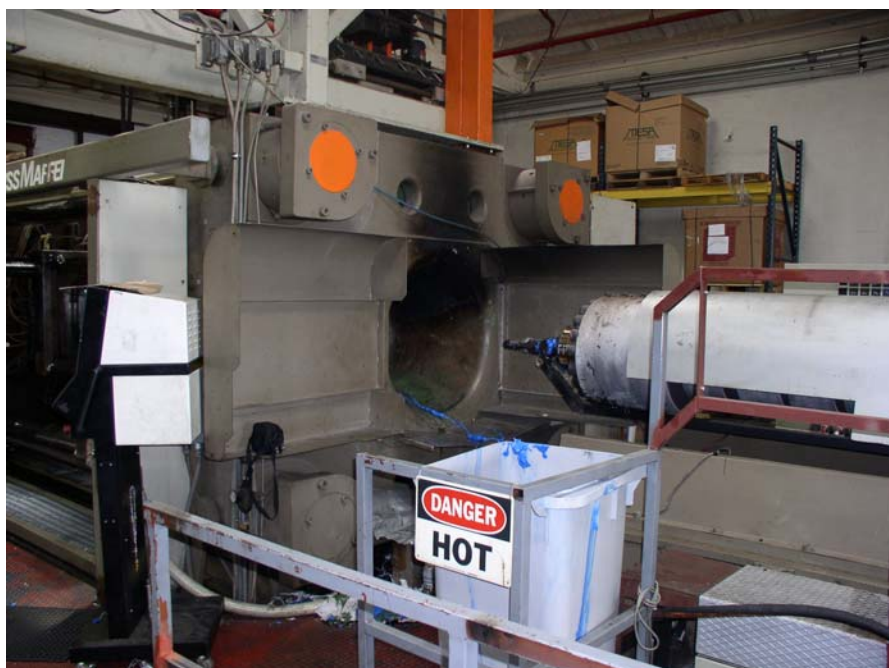
Exhibit #6

The site of the incident was a manufacturing plant of plastic products for home, office and industrial use. On the day of the incident, the victim was assigned to operate a plastic injection molding machine that was mostly automated. The machine involved in this incident covered an area approximately 80 feet long by 12 feet wide and 12 feet high (**exhibit #1**). The machine involved in the incident was molding high-density polyethylene plastic trash cans. The machine was made up of two components: an injector head and a mold frame. The end of the mold frame had a concave cone-shaped opening with a machined seat in the center (**exhibits #4 & 5**). The injector head end was round and mated with the mold seat. The area where these two sections met had a two-piece metal shield. The back portion of the shield was fixed parallel to the injector (**exhibit #3**). The front side of the shield was hinged to allow access to the junction between the mold and the injector for maintenance (**exhibit #2**). The hinged shield was equipped with an interlock safety switch which was supposed to shut down the machine when open (**exhibit #6**). The safety interlock was not working at the time of the incident.

View of the injector mold that injects the heated plastic into the mold.

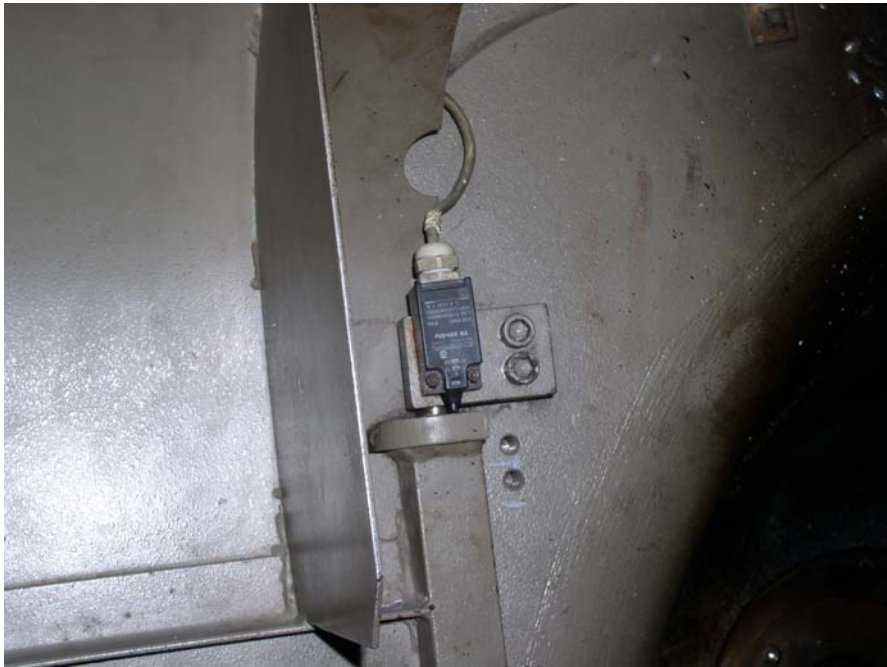
Exhibit #7

Discussion: The machine involved in this incident had a safety interlock device attached to the front side hinged metal shield. This device should have automatically shut off the machine when the victim opened the hinged shield to gain access to the injector. This device was non-operative. Safety devices should be checked daily to assure their working order. A log should also be kept documenting these daily checks. Workers should not be allowed to operate machines that have identified hazards such as disabled or inoperative safety interlock devices. Had this machine been properly maintained or removed from service until maintenance was completed, this incident might have been prevented.

View of the safety switch that cuts the power to the machine when the door is open.

Recommendation #2: Ensure all machine safety interlock devices are in working condition.

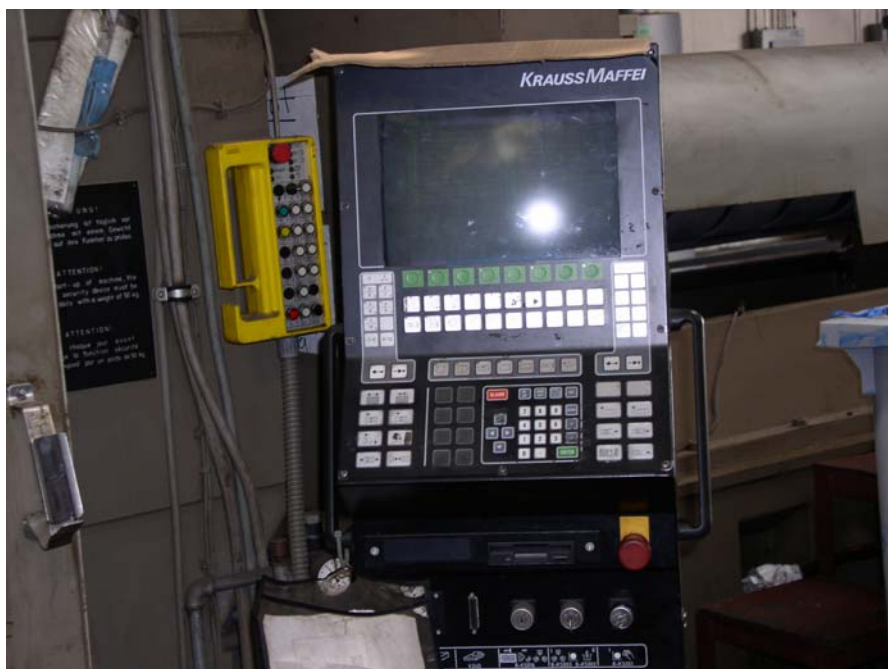
Exhibit #8

View of the control panel for the machine.
