FROM: California Fatality Assessment and Control Evaluation (FACE) Program

SUBJECT: A security guard is killed when he was run over by a heavy-duty industrial forklift while directing traffic in a cargo container storage yard.

SUMMARY
California FACE Report #02CA007

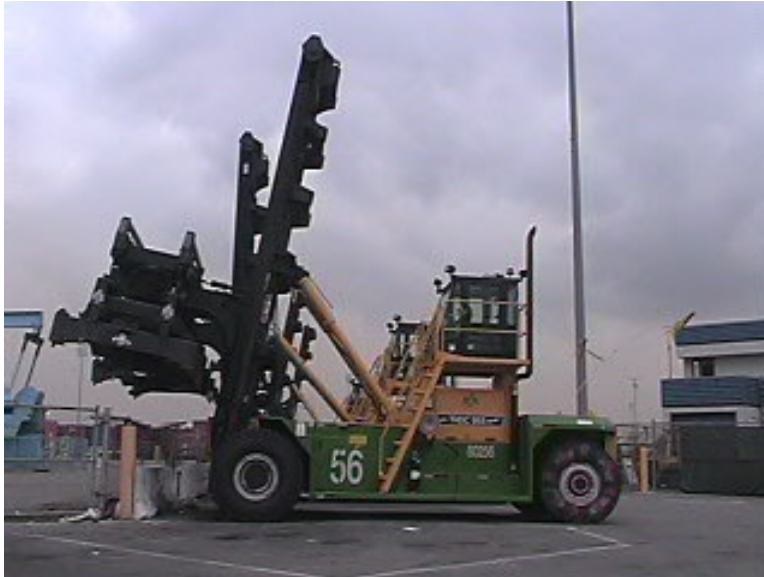
Exhibit #1

A side view of a forklift “top handler” similar to the one involved in the incident.

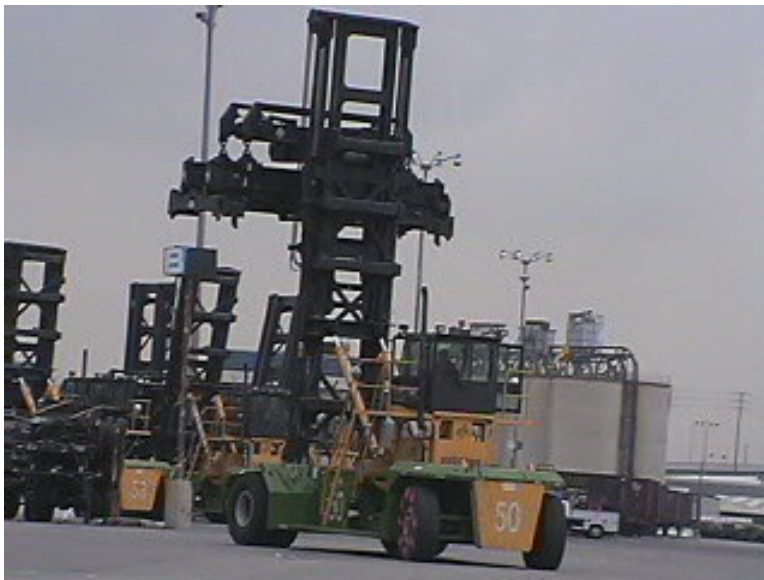
Exhibit #2

A rear view of a forklift “top handler” similar to the one involved in the incident.

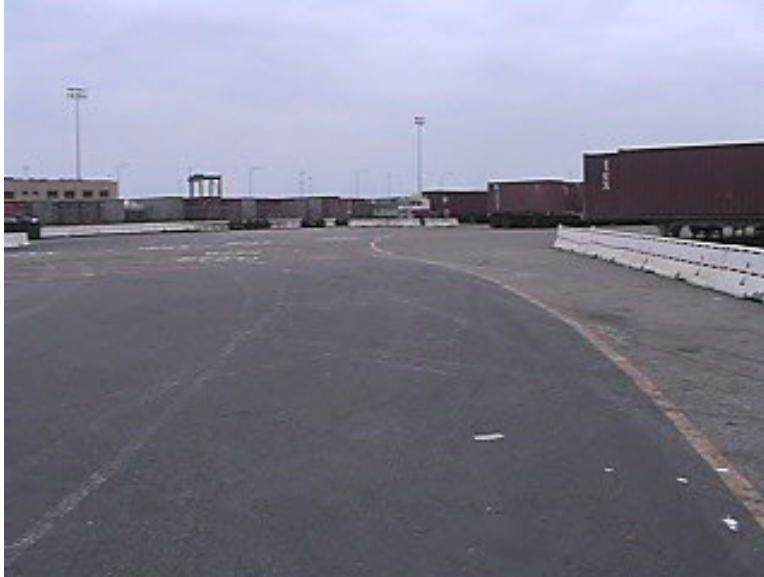
Exhibit #3

A picture of the incident scene looking west. The forklift came from the area to the right of the picture.

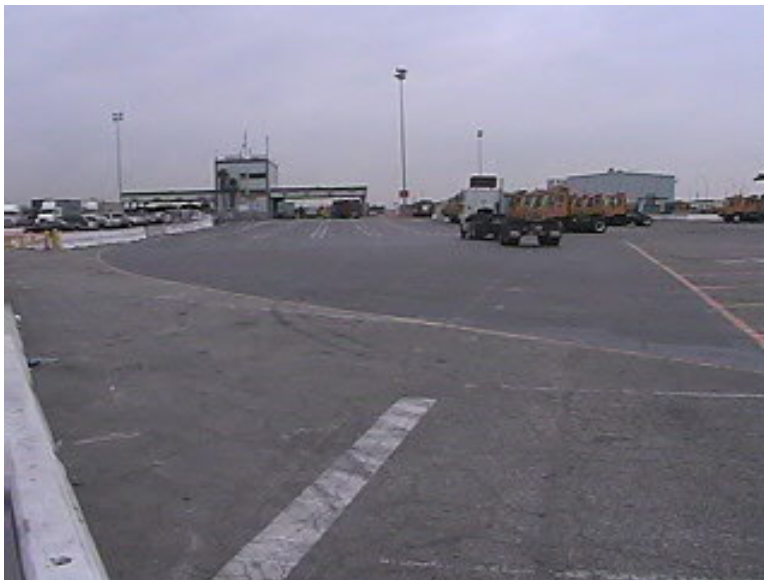
Exhibit #4

Discussion: Heavy equipment operators usually have designated areas where they can operate and park. In this case, the forklifts had a specific area assigned to them for parking when not in use. In this incident, the victim directed the forklift operator toward the forklift parking lot. The forklift operator instead turned the forklift in a different direction, toward the employees' parking lot. By not following the victim's directions, the operator changed the conditions under which the victim made his assumptions about safe areas to walk. As a trained and licensed operator, he should have followed the directions of those directing traffic. Employers can ensure safe work practices by establishing work procedures through programs of training, supervision, safe work recognition, and progressive disciplinary measures.

A picture of the incident scene looking east. The forklift parking area is on the right of the picture. The employee parking lot is on the left of the picture. The top handler was headed to the area on the left of the picture.

Recommendation #1: Ensure forklift operators follow the directions of workers directing traffic.
