A Service Writer for a Car Dealership Died When He Was Struck in the Head by an Alignment Rack that Rolled Off a Handcart

SUMMARY

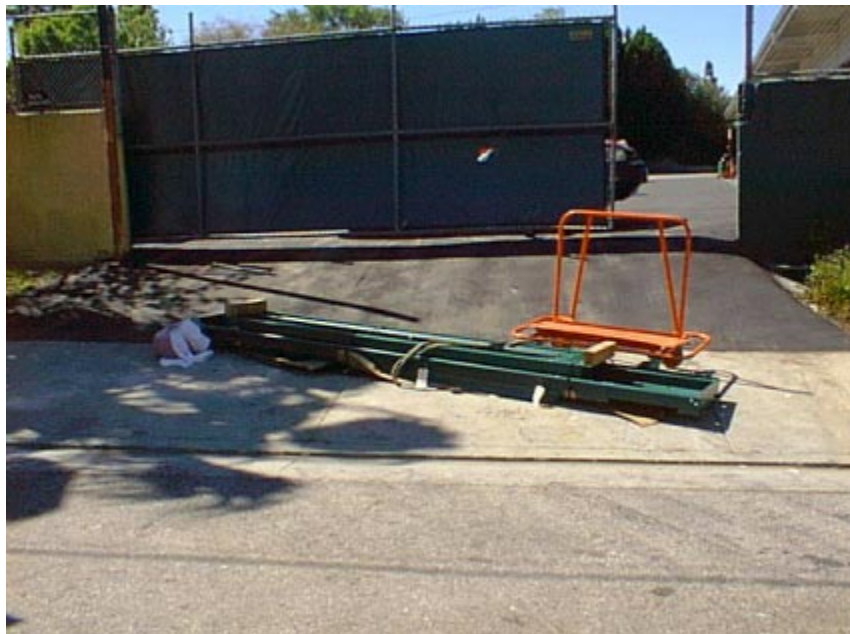
Exhibit #1

View of the incident scene showing the alignment rack, handcart, and the driveway incline.

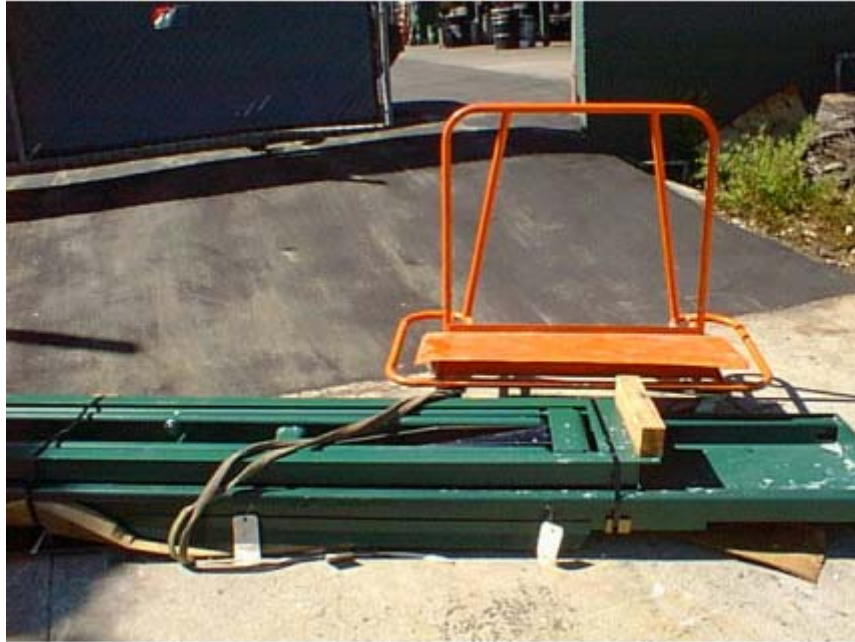
Exhibit #2

A closer view of the alignment rack, handcart, and driveway incline.

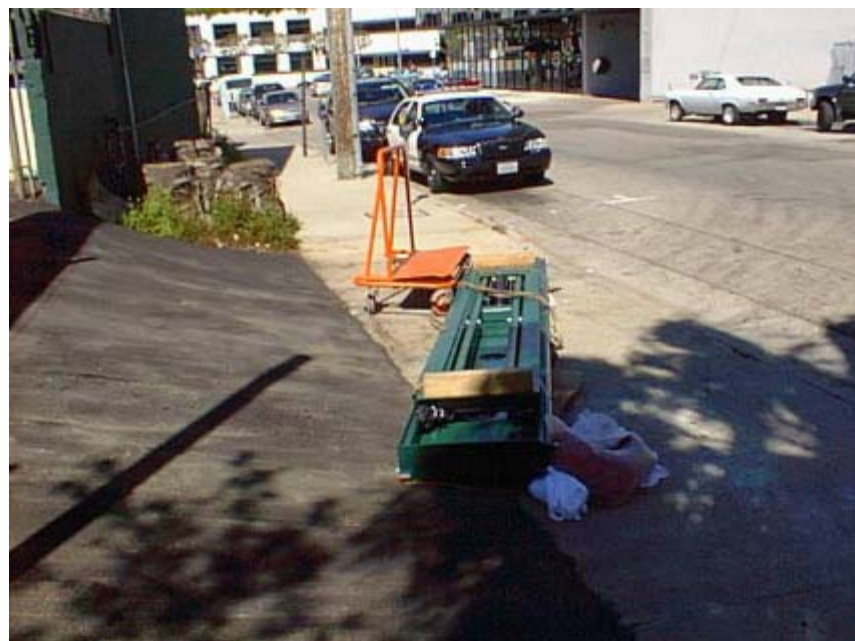
Exhibit #3

View of the incident scene looking south and depicting the pitch of the driveway ramp.

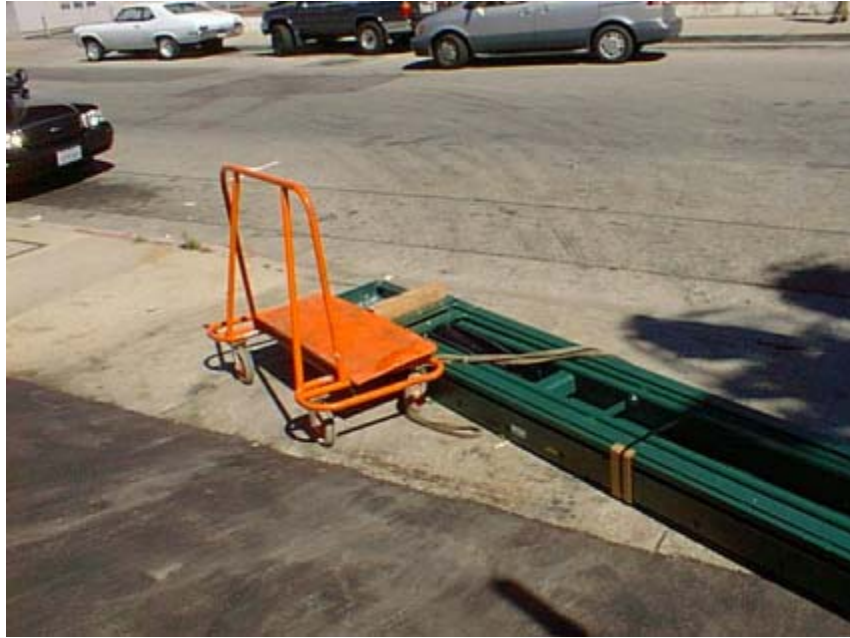
Exhibit #4

View of the incident scene looking down from the driveway entrance of the shop.
