A Construction Worker Jumps Over a Cement Barrier Onto an Interstate Highway Transition Road and Is Killed When Struck By an Oncoming Vehicle

SUMMARY

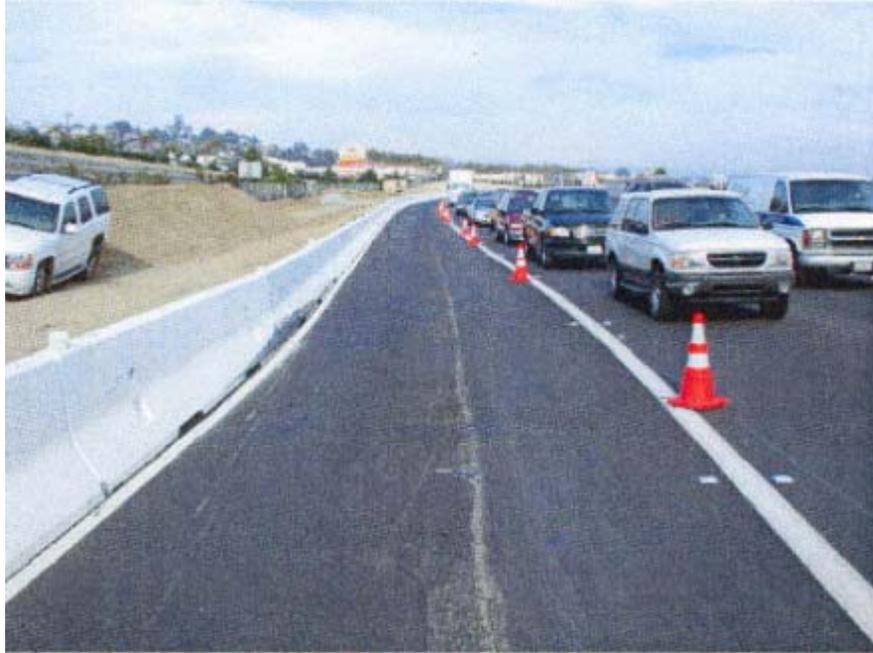
Exhibit #1

View of the "K" rail used to separate the work area from on-coming traffic looking east.

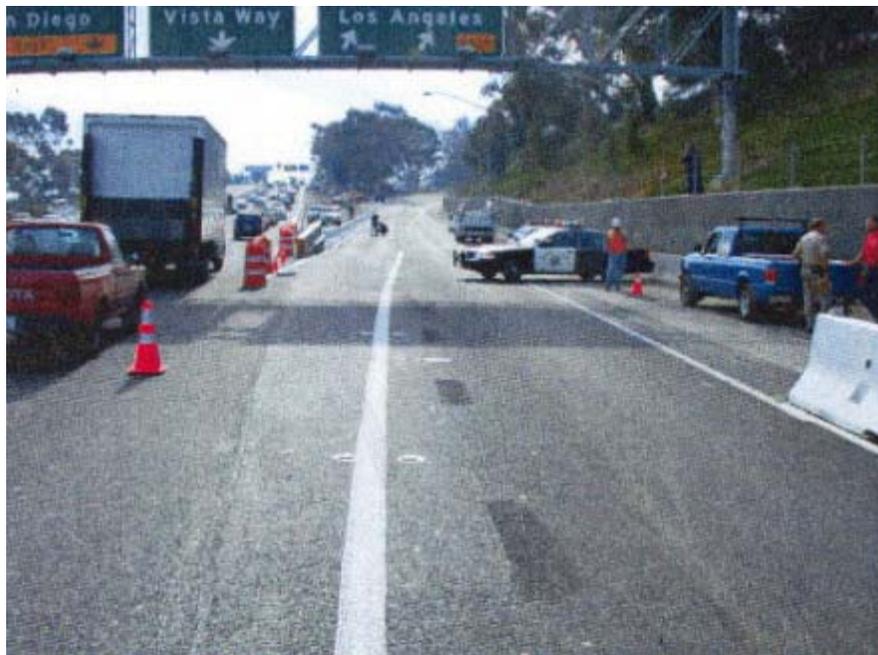
Exhibit #2

View of the transition road where the incident occurred looking west.

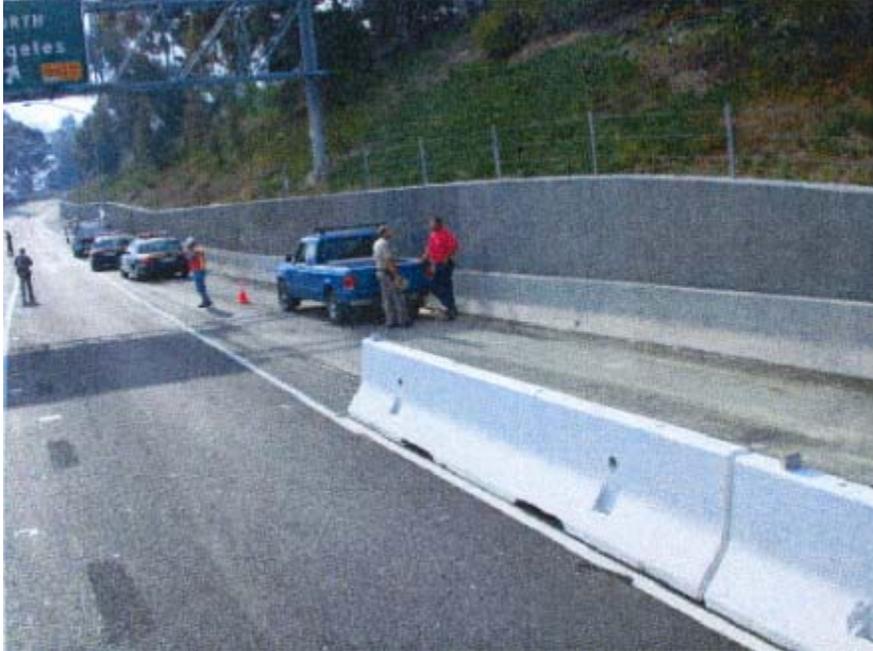
Exhibit #3
View of the end of the protective barrier that the victim jumped over.

Recommendation #1: Ensure employees remain within the safe work zone designated by protective barriers.

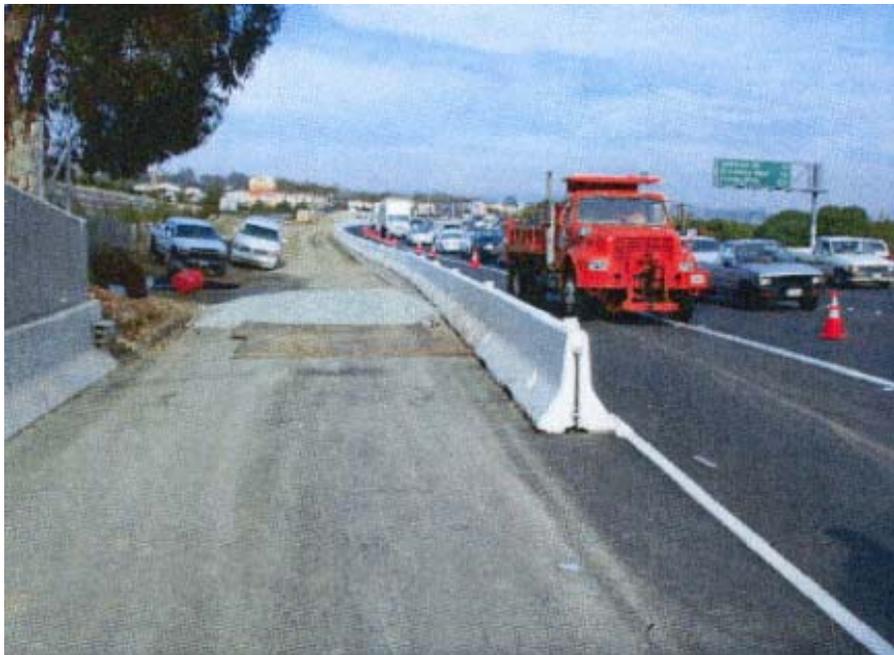
Exhibit #4
View of the work area where the victim was working.

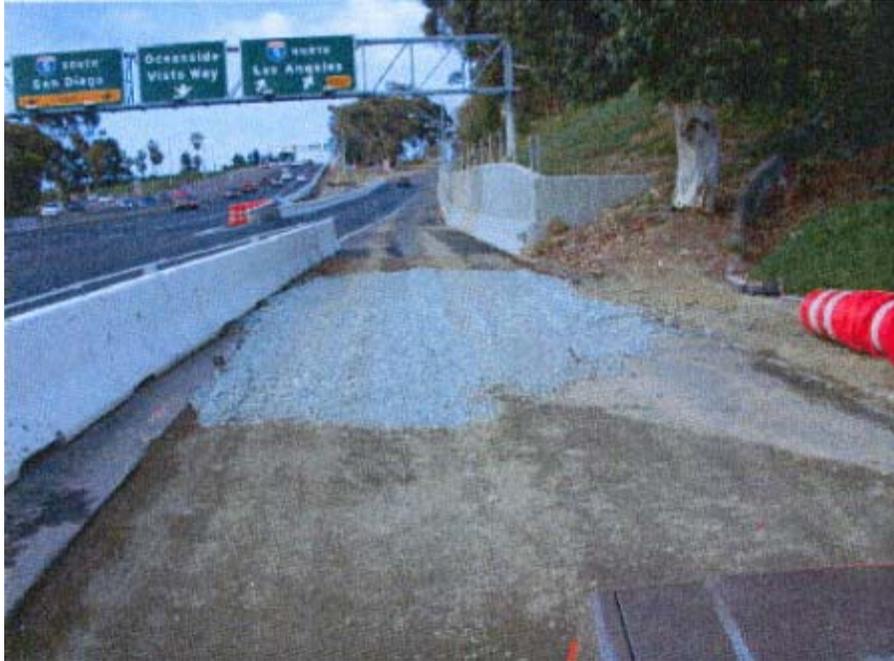
Exhibit #5

View of the work area looking toward the transition road where the incident occurred.
