## **A Heavy Equipment Operator Died When the Dump Truck He Was Backing Slid Down an Embankment and Then Tumbled Over**

A 46 year-old heavy equipment operator was killed when the 58 ton dump truck he was backing slid down an embankment that gave way when the truck got too close to the edge. A signalperson told him to stop approximately 8 feet before the edge then gave the sign to dump, however, the truck continued to back up. The ground under the rear wheels of the truck gave way and the truck went over the edge. The truck then slid backwards down the embankment and then rolled over, back to front, landing on the roof. The embankment berm was insufficient to stop the trucks when they got close to the edge. The dump truck was supplied with a lap-type safety belt that the victim was wearing. The CA/FACE investigator determined that, in order to prevent future occurrences, employers, as part of their Injury and Illness Prevention Program (IIPP) should:

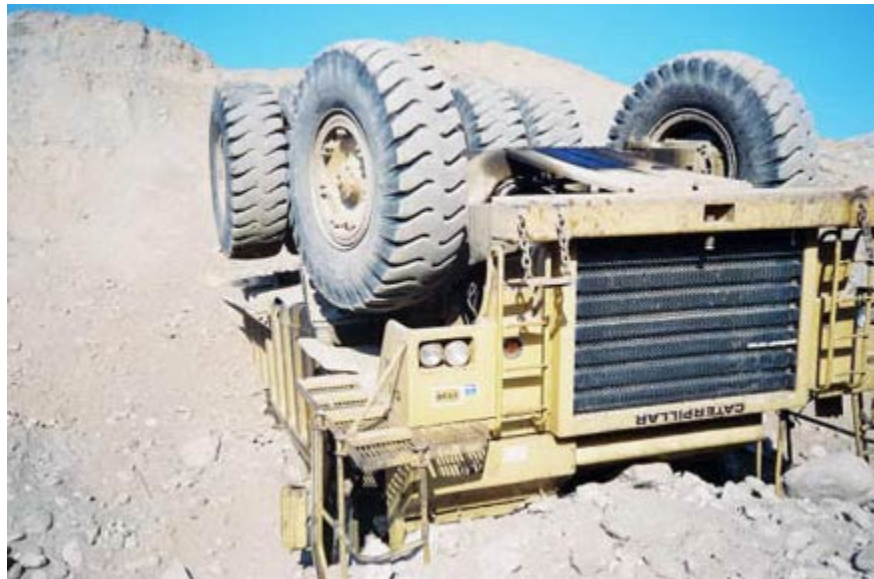
bed of the truck wedged into the dirt causing the front of the truck to go vertical and then it rapidly turned over rear to front with the victim belted in the cab. The dump truck finally came to rest in an upside down position with the cab intact. Witnesses to the incident ran to the dump truck and removed the victim by cutting him out of the lap seat belt. The paramedics arrived and treated the victim. He was then airlifted to a hospital where he was pronounced dead.

**Exhibit #2**  
**View of the truck as it came to rest after tumbling over the embankment.**

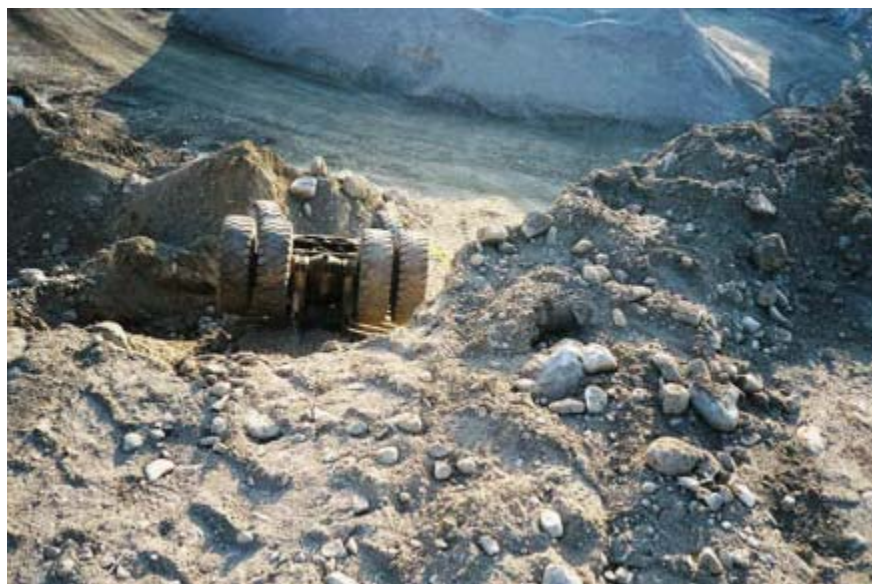
The ground beneath the rear tires gave way and the dump truck started to slide down the embankment. It continued down the embankment slowly for about 50 feet, then the rear of the

**Exhibit #3**  
**View of the truck looking down from the top of the embankment.**

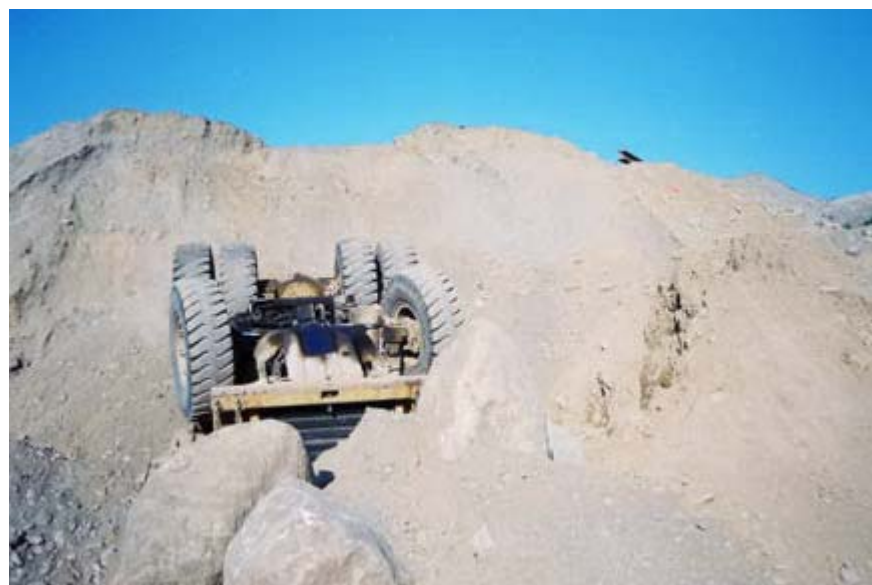
**Exhibit #4**  
**View of the truck looking up from the bottom of the embankment.**

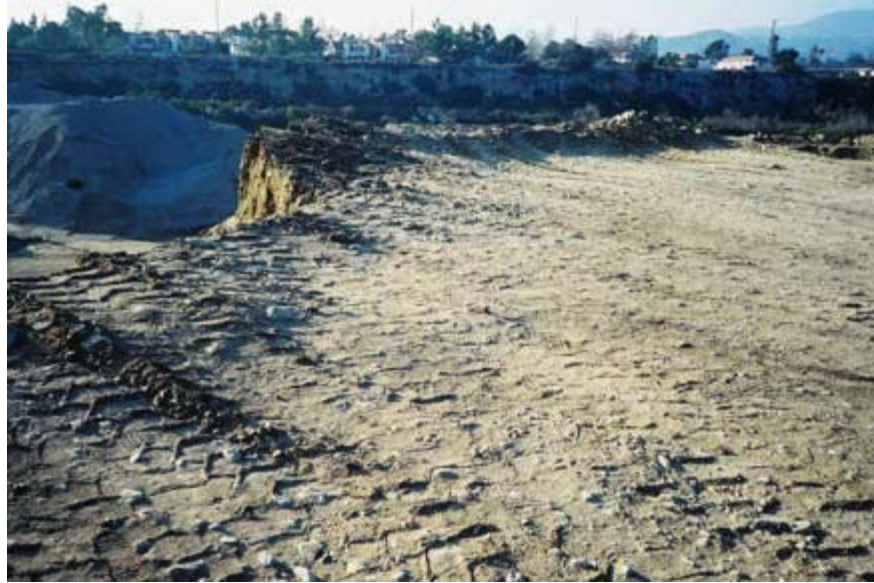
The site of the incident was a gravel pit that crushed rock and dirt. The rock and dirt were excavated in a separate area of the pit, then transported by truck to a designated area called the "dump pad" which was located on top of an embankment approximately 70 feet high (see Exhibits #5 & 6). Trucks would back up to the dump pad and dump their load as close to the edge of the embankment as possible. A bulldozer would then push the rock and dirt over the embankment and reestablish the berm. A berm is a mound of gravel and dirt at the edge of an embankment that is piled high enough to prevent trucks from over-traveling and over-turning. The truck involved in this incident was a 58 ton rock dump truck that was constructed for this purpose only and not subject to vehicle registration. The victim was not required to have a special license or certification to operate the truck.

Discussion: Berms, when properly installed, should prevent trucks from over-traveling and over-turning at dumping locations. In this particular case, the berm was inadequate in height and width to stop the truck. Had the berm been properly installed at this job site, this incident might have been prevented.

**Exhibit #5**  
**View of the area looking north where the truck went over the embankment.**

**Recommendation #1: Ensure berms are adequately built to prevent trucks from over-traveling and over-turning at dumping locations.**

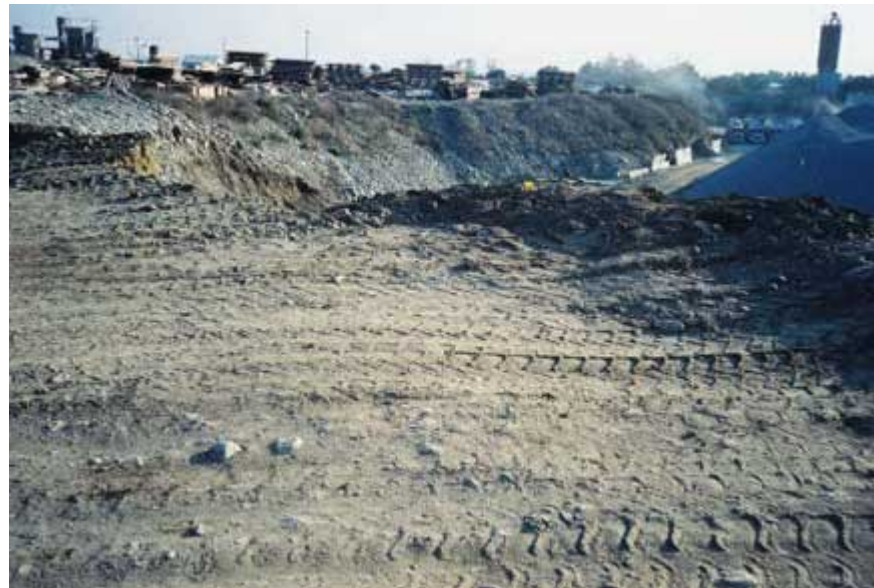
**Exhibit #6**  
**View of the area looking south where the truck went over the embankment.**
