An Industrial Washing Machine Operator Died When Pulled Inside a Machine While Loading Sheets

SUMMARY

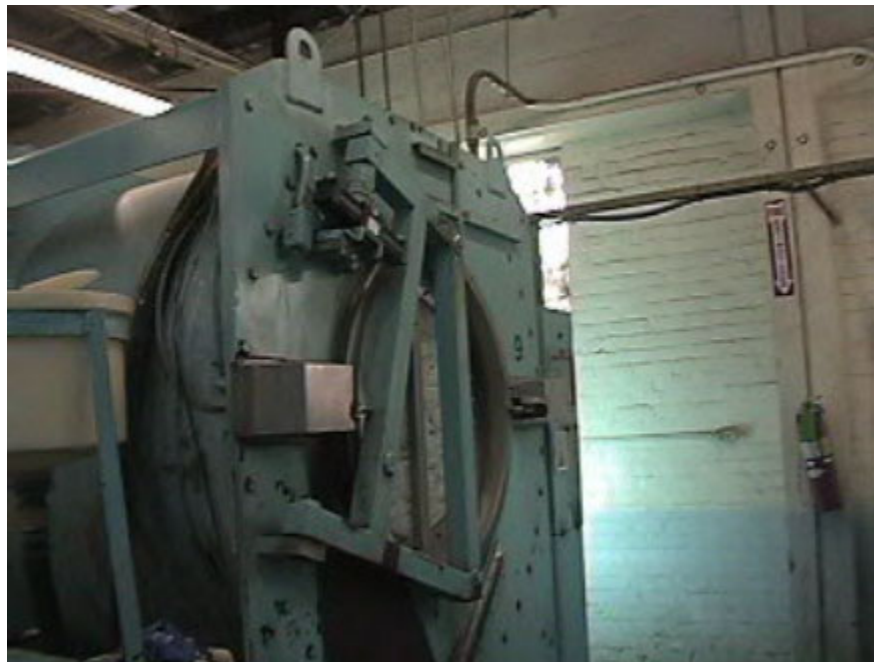
Exhibit #1. Front view of industrial washing machine involved in the incident.

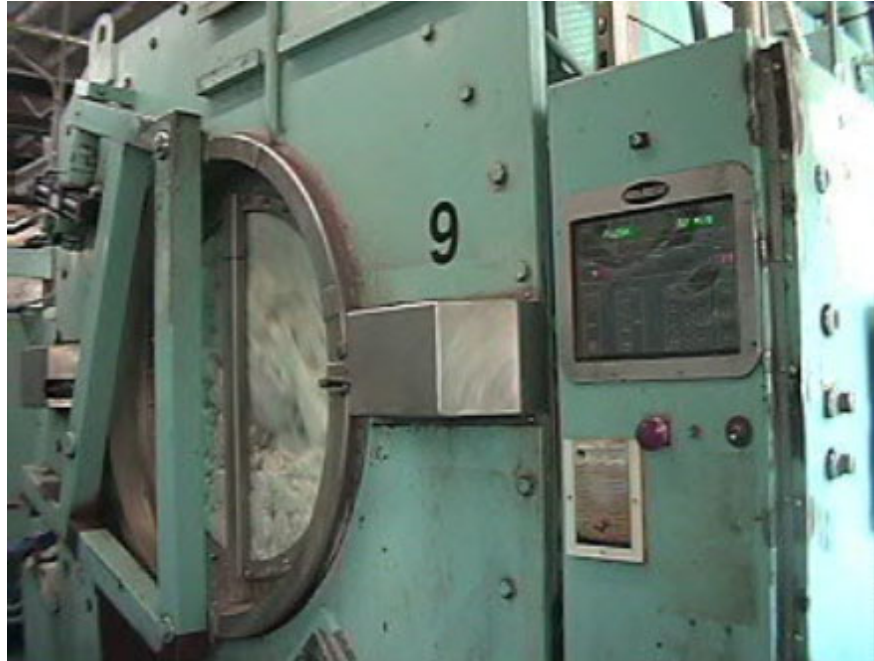
Exhibit #2. Front view of industrial washing machine and control panel.

Recommendation #2: Consider changing the basket button to a switch that only allows the drum to inch forward with every depression.

Discussion: When the basket button is depressed and released, the washing machine drum rotates approximately three revolutions. Holding the switch in will allow the drum to continue to rotate until released. Changing the switch to a mechanism that would only allow the drum to inch forward with every depression would remove any potential hazard created with a rotating drum when the drum door is opened.

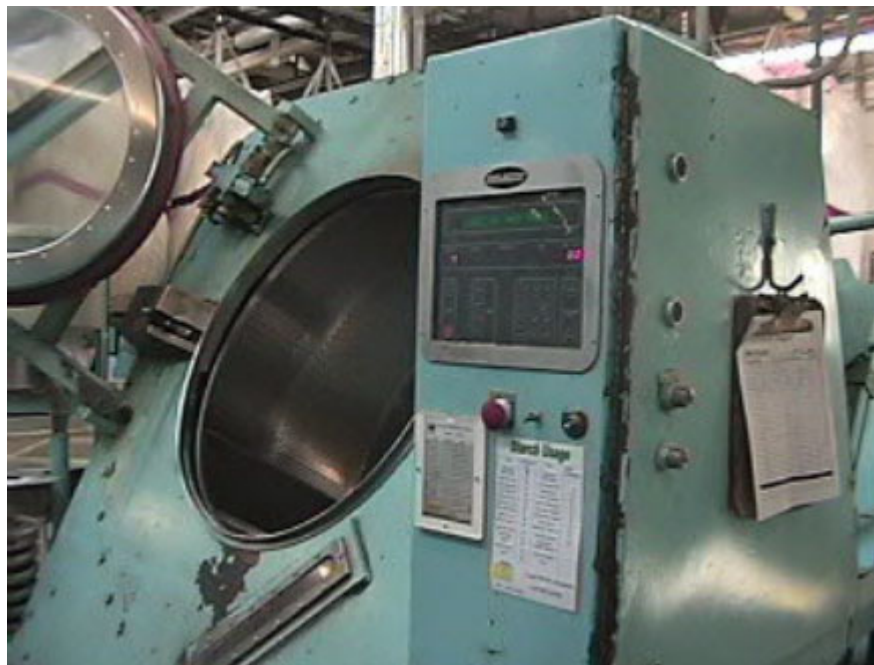
Exhibit #3. View of industrial washing machine in tilt position with loading door open.

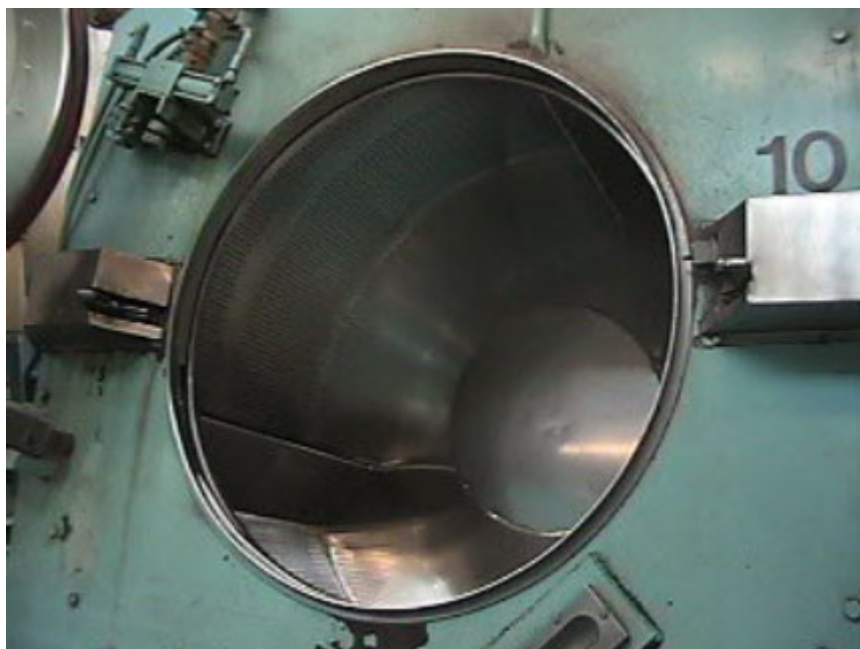
Exhibit #4. View of the industrial washing machine's rotating drum.

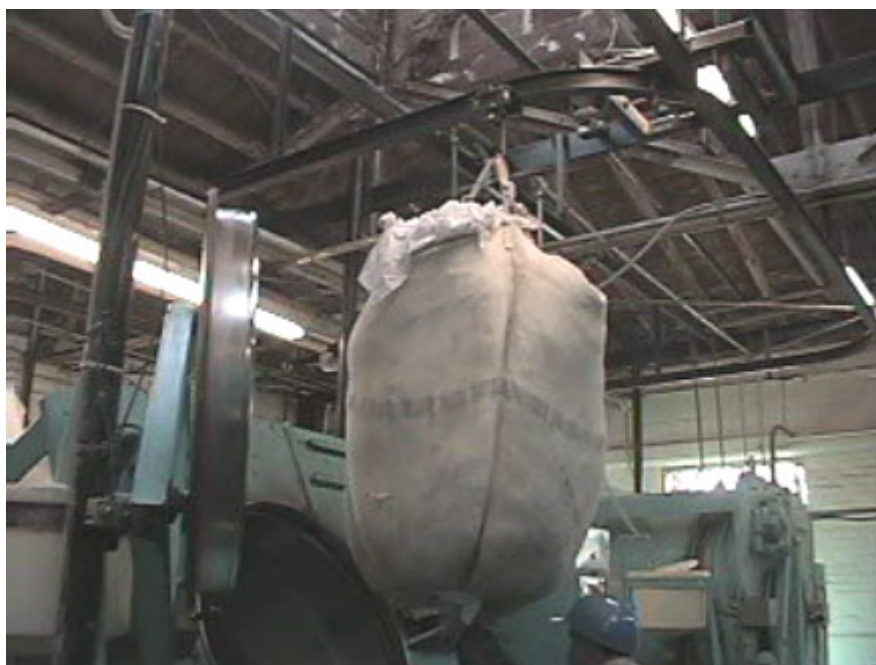
Exhibit #5. View of the laundry sling used to deliver laundry to the machine.

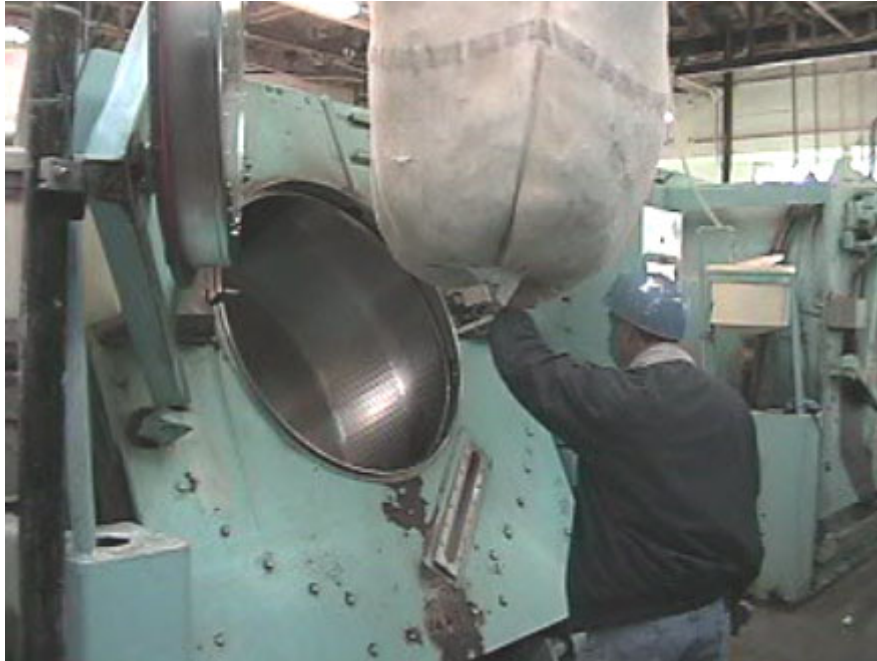
Exhibit #6. View of the laundry sling in front of the industrial washing machine.

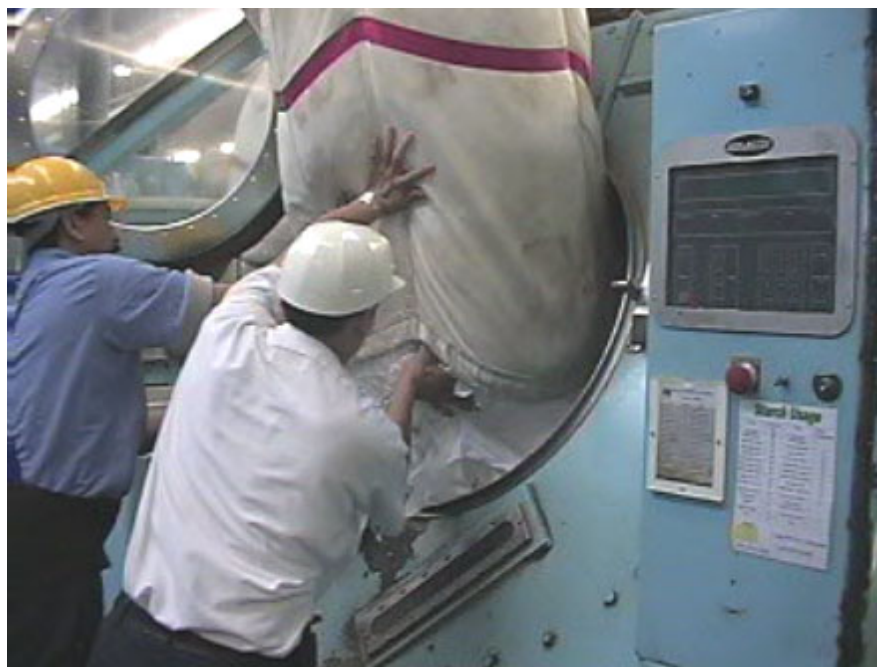
Exhibit #7. View of the laundry sling being unloaded into the industrial washing machine.

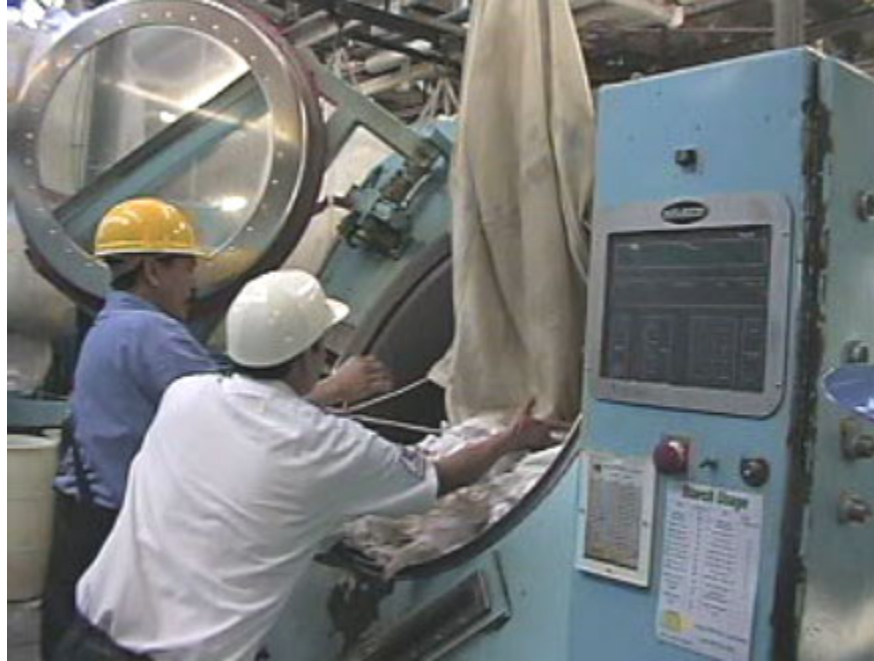
Discussion: The victim attempted to load the sling of sheets alone. He activated the basket button, the drum rotated; he became entangled in the sheets and was pulled inside. Supervisors need to assure that employees follow all rules and regulations involving safety. Employers can ensure worker compliance with safe work practices through programs of training, supervision, safe work recognition, and progressive disciplinary measures.

Exhibit #8. View showing two workers emptying laundry sling into tilted industrial washing machine.

Recommendation #1: Ensure employees do not attempt to work alone for those types of loads that require two people.
