MIFACE INVESTIGATION: #04MI130

SUBJECT: 52-year-old Female Janitor Died as a Result of a Vapor Flashback While Using Flammable Lacquer Thinner to Remove Carpet Glue From Concrete Basement Floor.

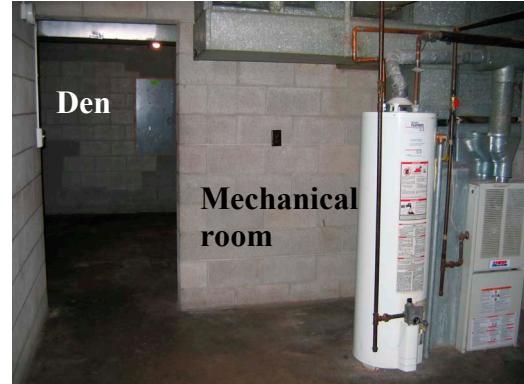
Figure 1. Victim was in "den" area at a different but similarly constructed basement

floor joists above was approximately 7' tall. Both rooms contained a 17" x 11" window that was located approximately 5'9" up from the floor. Both windows were closed while the deceased was working. The basement was divided into two rooms, the mechanical room and the den. The stairway to the basement exited to the mechanical room. The mechanical room was 12' x 12' and contained a natural gas furnace, natural gas hot water heater, plumbing and electrical for a washer and dryer, and a laundry tub. A 3' wide "door" opening allowed passage between the mechanical room and the 12' x 15' den (Figure 1).

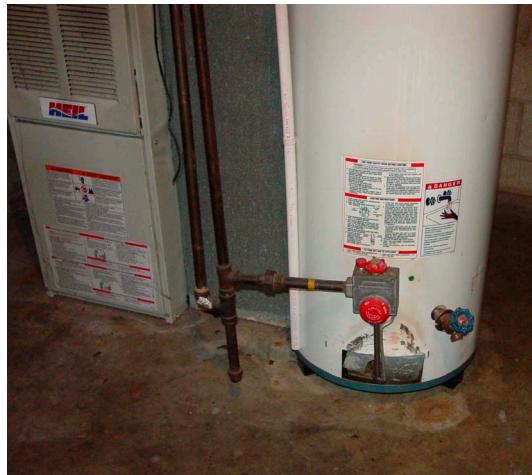
Figure 2. 40-gallon gas hot water heater warning labels near pilot light

Both the gas-fired furnace and the 40-gallon gas hot water heater were lit and operational. The hot water heater pilot light, located less than 4" above the floor was lit because hot water was needed to clean and prepare the townhouse for the next tenants (Figure 2). The hot water heater was located approximately 4 ½' away from the door between the two rooms. The hot water heater had affixed warning signs including a sign warning of an explosion/fire hazard associated with a flammable solvent vapor on the side near the top of the unit (Figure 3). The furnace pilot light and burners were located more than 20" from the floor.

The Fire Department suspected that the pilot or the burner for the hot water heater was the source of the flashback because of its location less than 4" from the floor. The furnace pilot and burners were located more than 20" from the floor level, and based on the properties of the vapor for the lacquer thinner, the water heater is suspected due to the location of the pilot. The report indicated that the volume of the vapor generated from the use of the lacquer thinner could not be accurately calculated due to the potential for numerous unknowns. These unknowns included the amount of thinner that was on the floor, the size of the pool of thinner, and the room temperature at the time of the ignition, the duration that the thinner had been sitting on the floor.

- Housing commission units should consider replacing older hot water heaters with heaters that are equipped with flammable vapor ignition resistant (FVIR) components.

- Gas hot water heater manufacturers should place fire hazard warning labels near the pilot light as well as in another observable location on the unit.

Although the flammable material hazard warning sign was in plain view, its location on the side near the top of this model of hot water heater may not have drawn attention to the dangers posed by using flammable materials in the vicinity because it was not posted near the pilot light. MIFACE recommends that hot water heater manufacturers place the flammable material hazard warning sign near the pilot light in plain view as well as near the top of the unit.

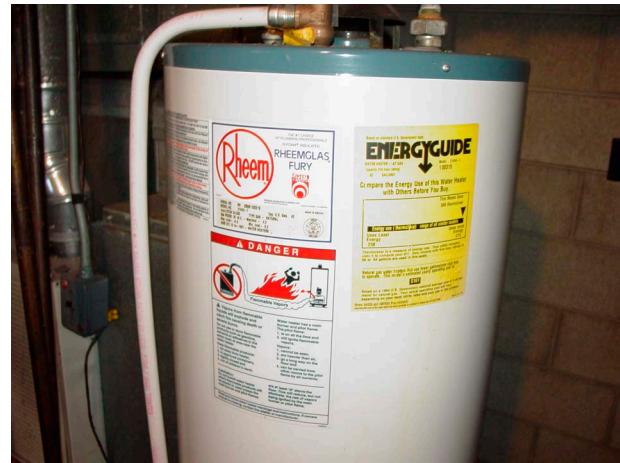
Figure 3. Location of flammable material warning label on side near top of heater

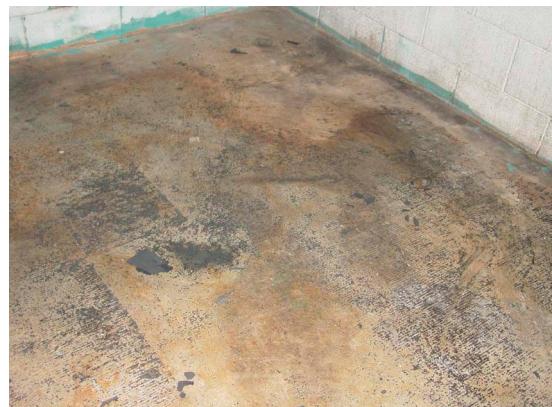
The den floor had remnants of carpet glue that had not been removed when workers had previously removed carpet tiles that had been installed by the previous tenants (Figure 4).

Figure 4. Carpet glue remnants on den concrete floor

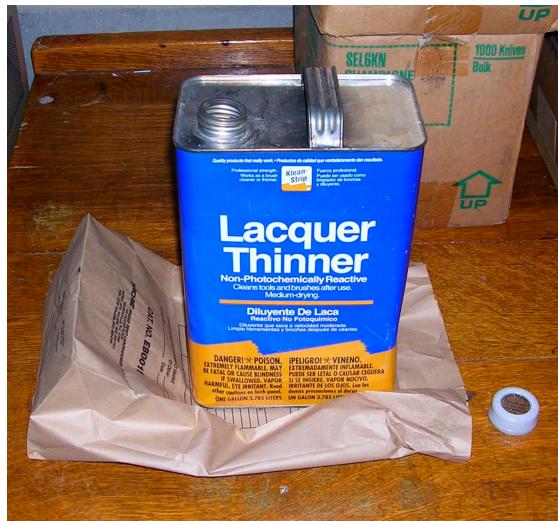
hypothesized that she poured the lacquer thinner (Figure 5) on the floor to soften the glue so she could remove it from the floor. It is unknown what tool she used to remove the glue. A push broom, still smoking from contact with the flames, was found at the scene by firefighters.

Figure 5. Flammable lacquer thinner used by victim to soften glue

- Employers should investigate if substitution of water-based, non-chlorinated cleaning products in place of flammable materials used for cleaning is possible.

Although the flammable lacquer thinner was not formulated for use as a “floor-cleaning agent,” the victim used it as a cleaning agent. Many flammable materials, although not formulated for use as a cleaning agent, may be used as such by employees because the flammable material is perceived to be effective. Employers should determine if products, including flammable materials, are being used in a manner not specified by the product manufacturer. Employers should investigate if substitution of water-based, non-chlorinated cleaning products in place of flammable materials used for cleaning purposes is possible.

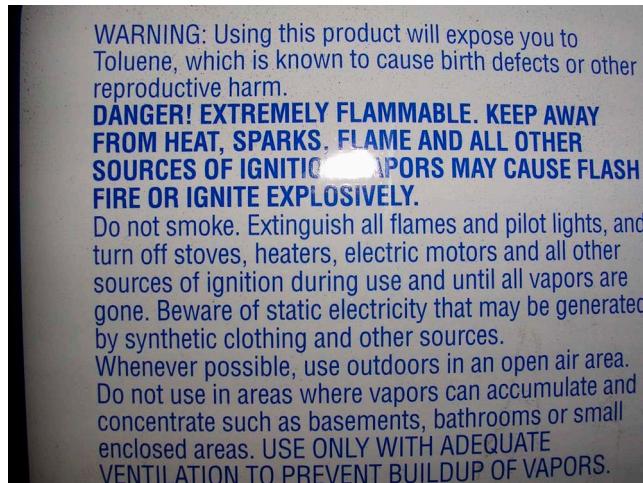
Although the lacquer thinner can had a legible warning label (Figure 6), she apparently was unaware of the hazards associated with using a flammable solvent indoors near an ignition source without ventilation. The flammable vapors from the thinner migrated into the mechanical room, were ignited by the hot water heater's pilot light, and flashed back to their source in the den and burned the victim. The victim screamed and ascended the basement stairs. Her co-worker working upstairs heard the scream and came downstairs to assist her. Smoke filled the

Figure 6. Warning label on lacquer thinner container

- The Housing Commission should develop and implement a hazard communication (Right-to-Know) program.
