# Fatality Investigation Report

OR 2003-10-01

## Home construction worker falls down elevator shaft

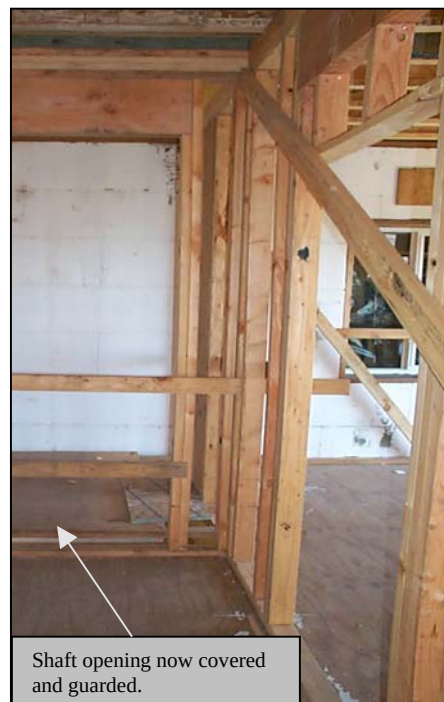
On May 16, 2003, a 41-year-old worker fell 23 feet down an elevator shaft during the construction of a new residence. The worker was part of a three person framing crew raising a third story in the home. The two co-workers were installing ceiling joists while the victim handed up needed materials. The framing crew was busy setting and nailing joists into place when they heard a sound like that of a “nail gun falling and hitting something”. They went to investigate and discovered the victim, at the bottom of the shaft, seriously injured. At the time of the incident, the shaft opening was not covered according to witnesses.

1. Employers should design and use comprehensive fall-protection programs to reduce the risk of serious or fatal injuries.
2. An unprotected opening, side or edge which is 6 feet or more above a lower level should be protected by the use of a guardrail system, safety net system, or personal fall arrest system.
3. Establish routine follow up to assure hazard correction or abatement.
4. In remote or obscure locations, make sure that workers know their location, and can provide directions to emergency responders, if needed. Develop an emergency plan that reflects the response time from local emergency services.
